IR 553792-03, Torus Structural Integrity Basis from 1R21 Inspections

SECTION 3: INSPECTION FINDINGS**FINAL REPORT – TORUS IMMERSION AREA****OYSTER CREEK NUCLEAR GENERATING STATION****BACKGROUND**

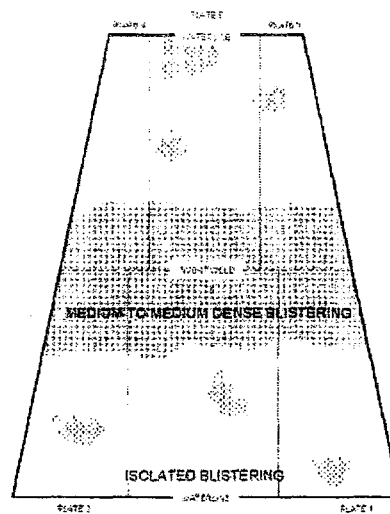
Figure 2 - Typical blister distribution by torus bay

Figure 2 depicts the typical distribution of areas of blistered coating with heaviest blistering near the torus invert. Blister size is No. 2 to No. 6. Degree of frequency is medium to medium dense as rated in accordance with ASTM D 714 "Standard Test Method of Evaluating Degree of Blistering of Paints". Fractured blisters appear to expose 46 X 16 filler or substrate. Blister size in these areas randomly exceeds ASTM rating (1/2" to 1-1/4" diameter).

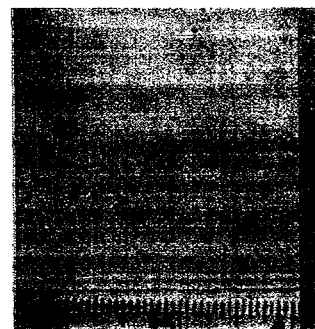
The blistered conditions shown in Figure 3 and Figure 4 are typical. Blistering is also found in areas where Mobil 46 X 16 was not applied. Blister size is No. 2 to No. 4 and degree of frequency is medium to dense. Attachment * contains coating inspection reports documenting the visual inspection.

Figure 4 - typical intact blisters

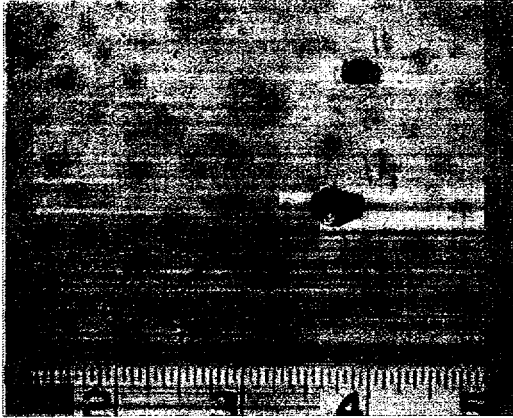
Figure 5 – Dense blistering in invert area

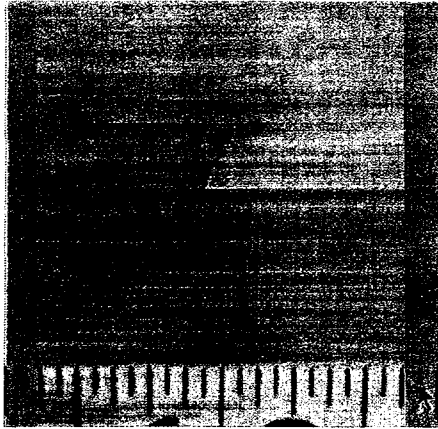
Figure 8 – Typical cracked blister

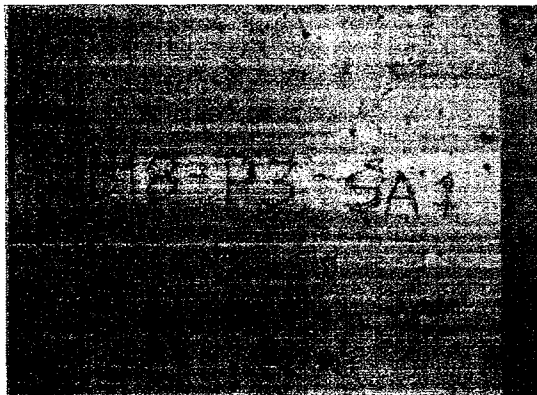
Figure 12 – Typical minor staining and pinpoint rusting

Other coating deficiencies consisted primarily of spot rust, pinpoint rusting, and minor mechanical damage (Figure 12 and Figure 13). Random deficiencies that exposed base metal were identified. They ranged in size from $\frac{1}{16}$ " to $\frac{1}{2}$ " diameter. Some areas contained multiple deficiencies. Pitting in these areas ranged from less than 10 mils to slightly more than 40 mils in a few isolated cases.

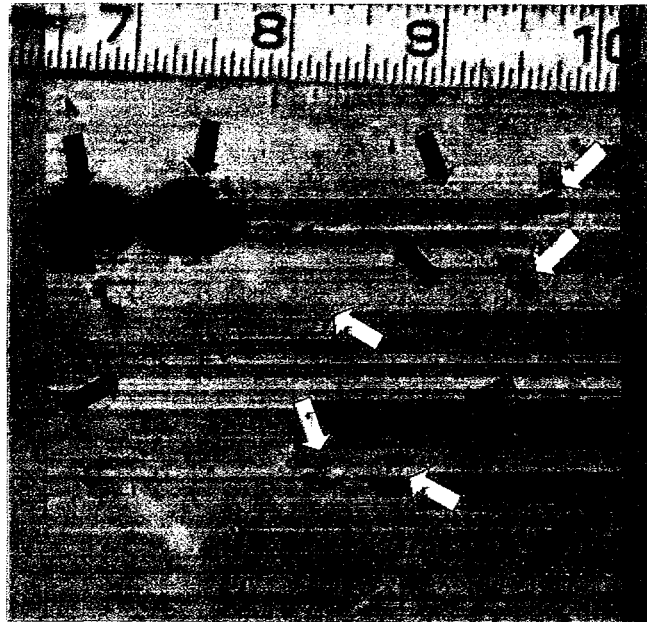
Figure 18 – Categorization of blister conditions on the torus shell.

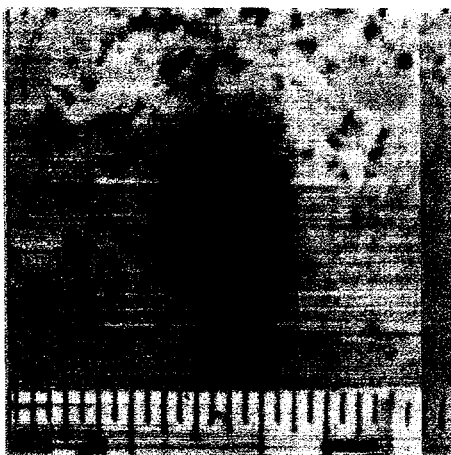
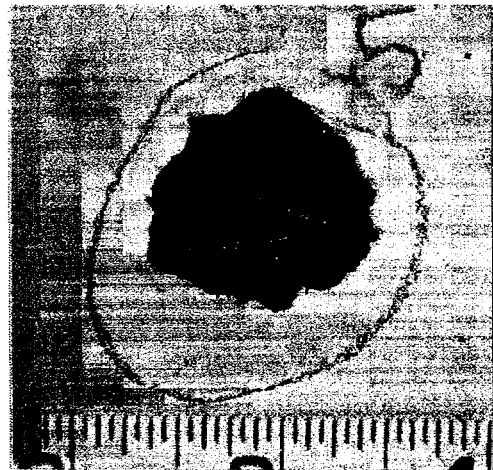
Fractured blisters, by definition, exposed the steel substrate and were designated for coating repair. Figure 19 illustrates the typical condition at fractured blister sites before and after the substrate was cleaned for inspection. Each of the areas was inspected for pitting. With the exception of pits 18-P2-01, 15-P2-01, 05-P1-01, 05-P5-01, and 05-P5-02 (see Table 4), all other pitting was less than 0.040". Approximately **400 fractured blisters were identified. Blister diameters generally range from less than 1/4" to 1-1/2". They represent less than 1% of the total submerged surface area of the torus shell. All fractured blister sites were repaired by the application of underwater coating.

Figure 19 – Typical condition of substrate at site of fractured blisters. Pitting is typically <40 mils.
