**Blister Evaluation – Torus Pressure Boundary in Immersion**

**Quantitative Corrosion Evaluation – Torus Pressure Boundary in Immersion**

## QUALITATIVE INSPECTION RECORD

### QUANTITATIVE EVALUATION OF METAL LOSS RECORD

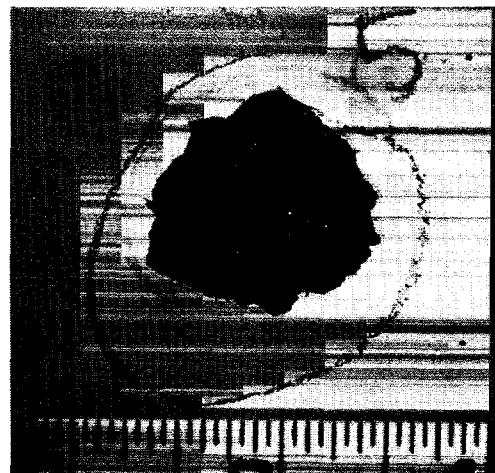
Fractured blisters, by definition, exposed the steel substrate and were designated for coating repair. Figure 19 illustrates the typical condition at fractured blister sites before and after the substrate was cleaned for inspection. Each of the areas was inspected for pitting. With the exception of pits 18-P2-01, 15-P2-01, 05-P1-01, 05-P5-01, and 05-P5-02 (see Table 4), all other pitting was less than 0.040". Approximately \*\*400 fractured blisters were identified. Blister diameters generally range from less than 1/4" to 1-1/2". They represent less than 1% of the total submerged surface area of the torus shell. All fractured blister sites were repaired by the application of underwater coating.

Figure 19 – Typical condition of substrate at site of fractured blisters. Pitting is typically <40 mils.
