AR 00470325 Report

Action Request Details**Subject:** TORUS/TORUS ROOM MINOR DEFICIENCIES**Description:** Originator: ROBERT J BARBIERI Supv Contacted: H. Ray**Condition Description:**

Action Request Details**Subject:** WATER FOUND IN BAY 17 TRENCH IN DRYWELL**Description:**

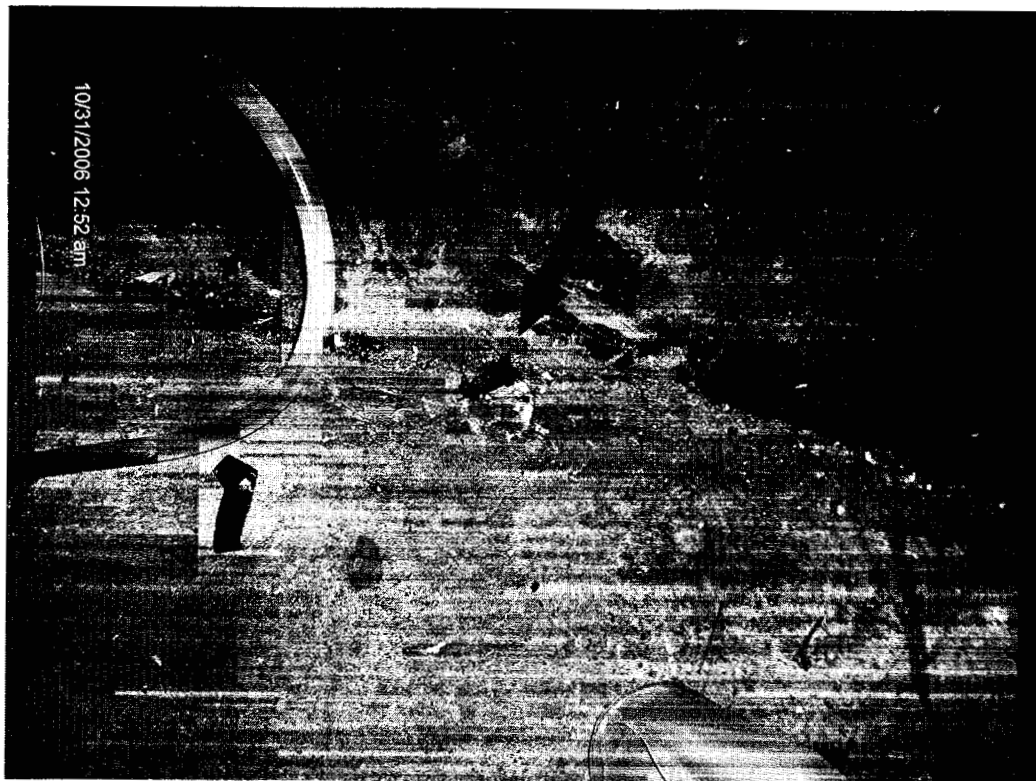
Photo 2 - 1 inch missing caulking, Bay 10

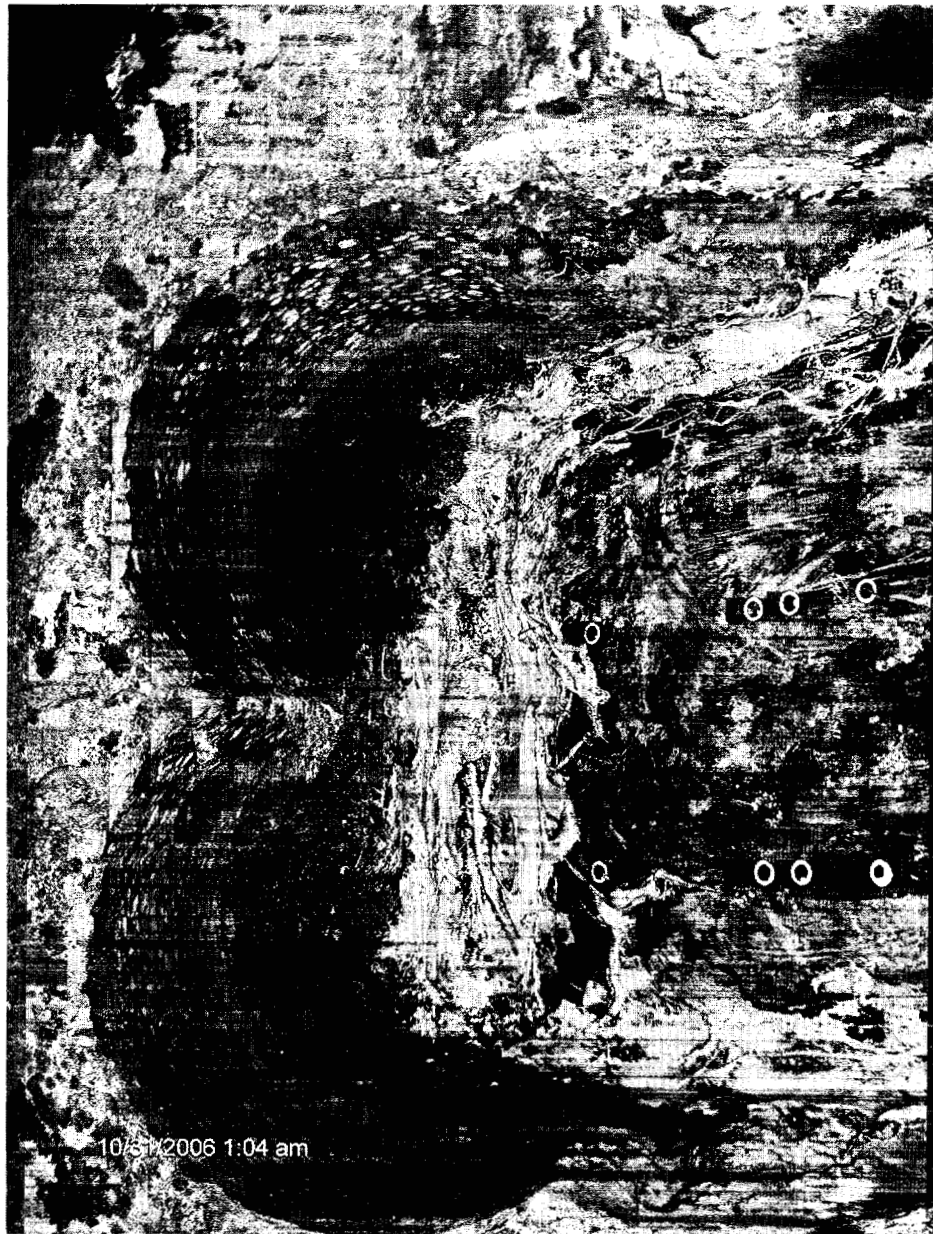
Photo No. 3 – Emptied, towel dried trench. Slight seepage at concrete surface was observed
