**Surge Line Welding Issue  
Southern California Edison (SCE) – SONGS Unit 3**

**WSI Document #:**

**102987-WP-001, Rev. 0**

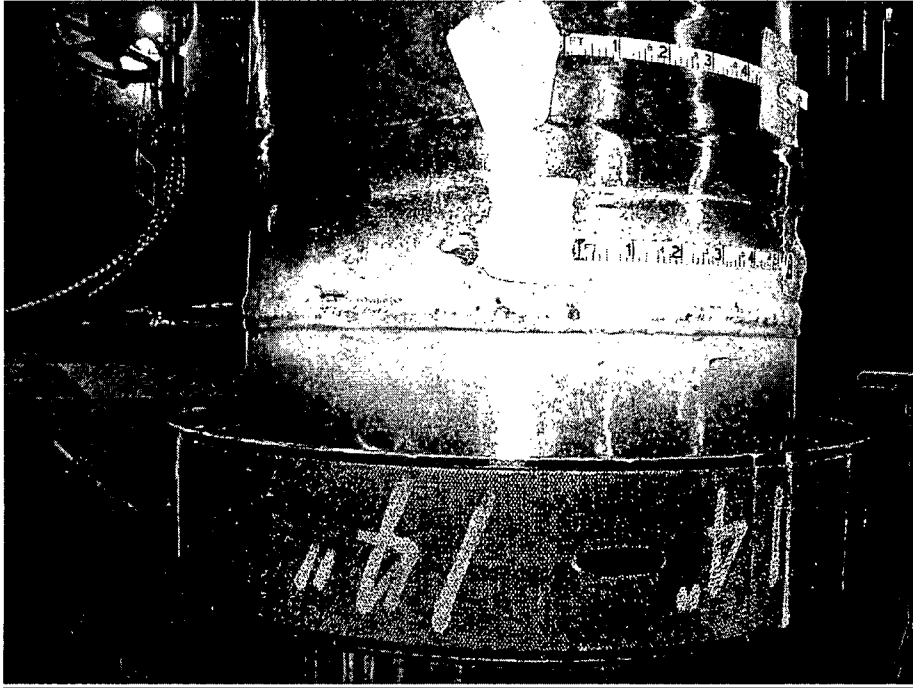
Just before the third bead was completed the breaker in the welding machine tripped, and as a result welding terminated without downslope. After getting the machine back online it was noticed that a crater-type crack had formed due to the abrupt weld stop and the tungsten had plunged into the molten puddle. The tungsten stick and crater crack were removed, and welding resumed; however, further cracking was noticed. It was decided to remove a portion of the welded bead just applied and perform an informational liquid penetrant (PT) inspection. The crater crack was gone but small linear, crack-like indications were noticed that appeared to be associated with the second and third weld beads.

**Figure 1 Overall Photograph of Initial Indications observed in the Surge Line Overlay Deposit**

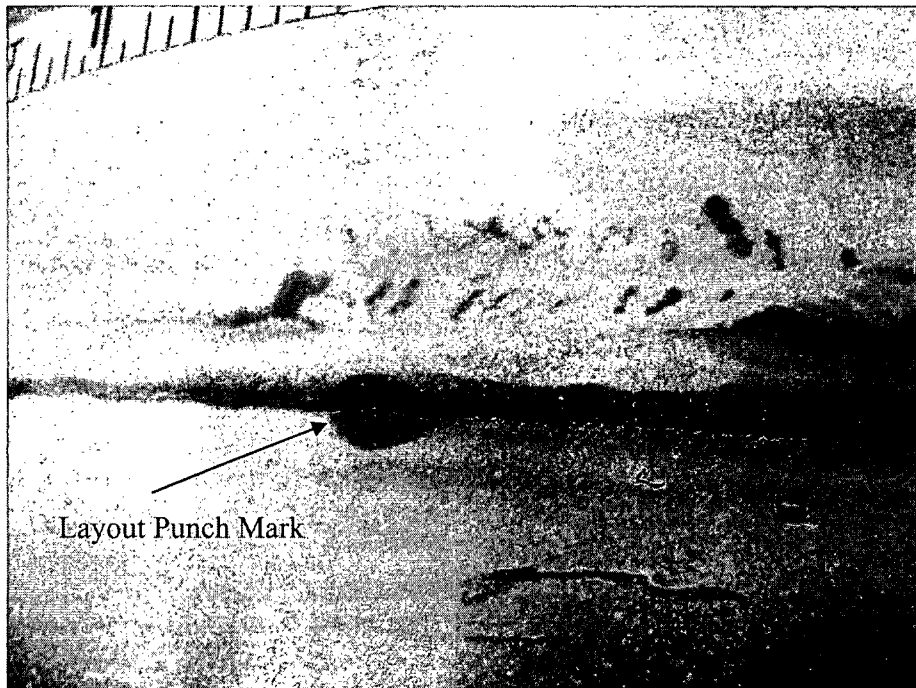
The area containing the indications was buffed lightly, and a portion of the weld layer approximately 12 inches from the initial indications also was removed. A PT inspection of both areas was performed and similar indications were found in both areas. All indications were oriented in similar directions – principally 90 degrees to the surface contours of the bead. It appeared that the indications were associated with the thicker portions of the deposited beads. In addition, the PT results showed that the indications were surface connected. See Figures 1 through 3. Eventually the weld deposit was ground approximately flush with the surface of the pipe in an attempt to remove the defects and that condition is shown in Figure 4. Note the clearly defined cracking on either side of the second bead (i.e. at the interface between the first and second bead and at the interface between the second and third bead). It was noted that the initial bead appeared to be free of surface cracking.

**Figure 2 Close-up Photograph of the Initial PT Indications where Bead was Ground**

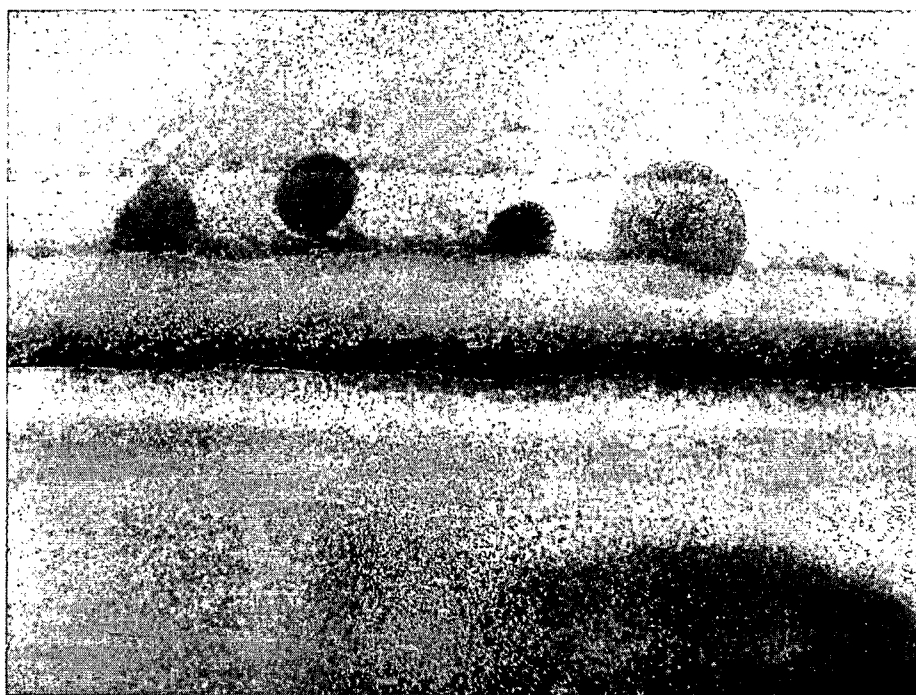
After the power supply was changed, welding recommenced. The weld puddle still appeared hot and overly fluid for an Alloy 52M deposit. The initial bead shape appeared to have a tendency to roll over, and the site manager lowered the amperage from 230 amps to 210 amps in an attempt to cool the weld puddle. These parametric changes are within the boundaries of the qualified WPS. In addition, the torch tilt angle was increased upward from 5 degrees to approximately 11 degrees to improve the bead profile. These measures appeared to smooth the bead profile, and welding was continued

7. The orientation of defects appears to be perpendicular to the bead solidification front. (Figures 3 & 4)
8. Adjusting the welding parameters within the qualified welding procedure lowered both the penetration and weld dilution but still produced a highly reactive weld puddle that appeared to be overheated (subjective observation by supervisory welding personnel)

**Figure 3 Closeup of Weld Layer Surface (notice roll on bottom bead from reactive weld puddle)**

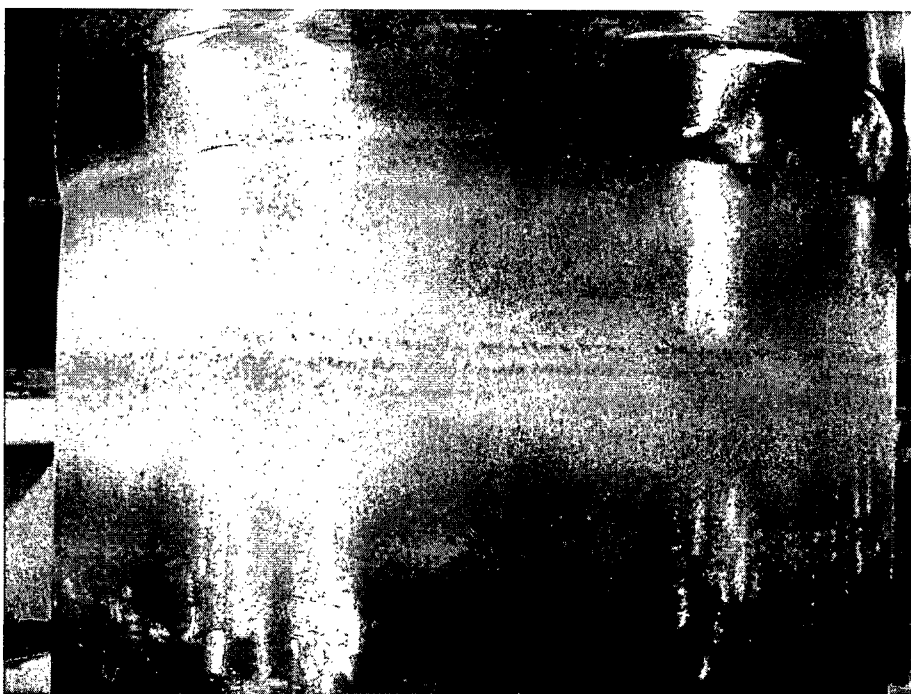
Based on these results it was decided to remove the deposit and existing indications using manual grinding techniques then verify defect removal with a PT inspection. Figure 4 shows the indications as shown by PT after the deposit was manually ground approximately flush with the surface of the pipe. Additional grinding slightly below the surface of the pipe was required to remove the indications. It was noted that in no case did the grinding encroach on the minimum wall thickness. After indication removal the plan was to deposit a first layer using the modified parameter changes used in the final test weld. The second and subsequent layer welding would proceed in accordance with the original technique sheets (the wire feed rate on subsequent layers is already 90 ipm and thus the Power Ratio and thus dilution already is low).

5. Defects appear to be limited to the volume of material melted by the welding arc (reports from depth of grinding required to remove defects).
6. Defects appear to be located primarily at the interface between adjacent weld beads but not on the first bead by itself (Figure 4)

**Figure 4 Photograph of PT Indications in Initial Overlay after weld deposit has been ground approximately flush with the Surge Pipe (note the pipe to safe-end weld above the indications)**
