CR-PNP-2006-03497

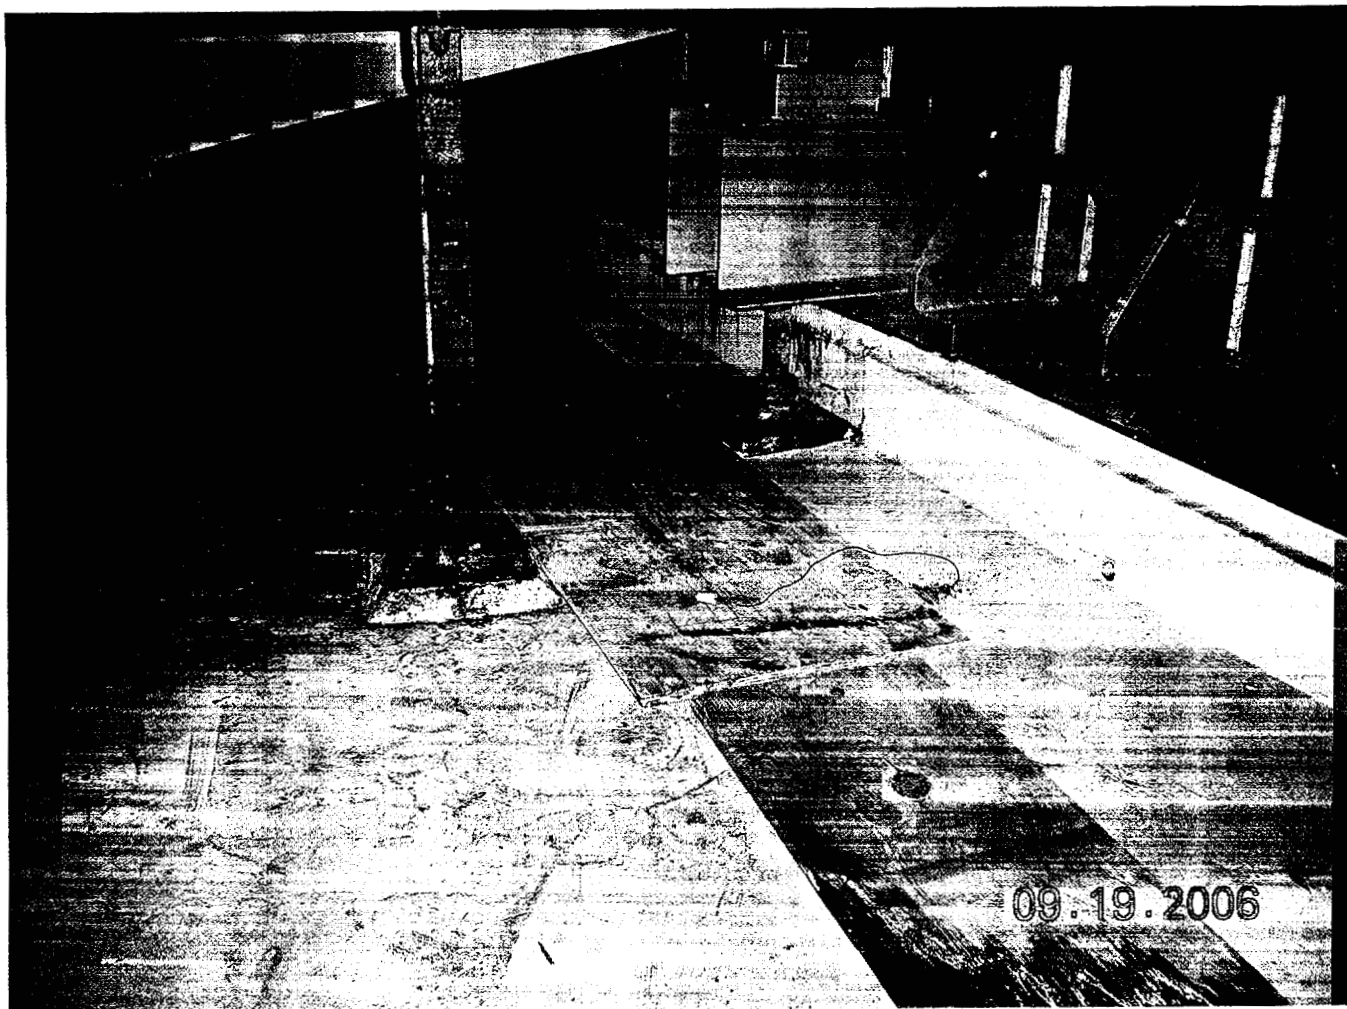
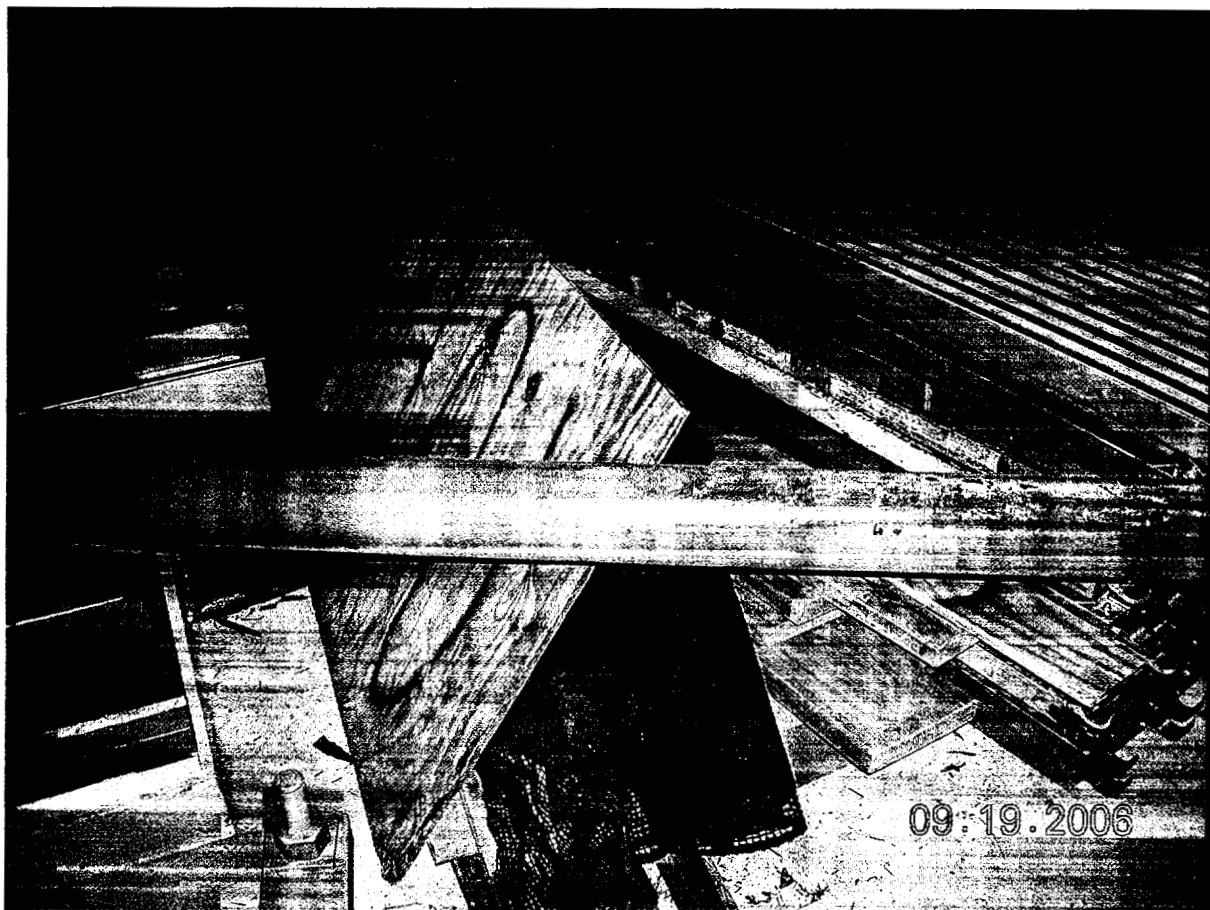
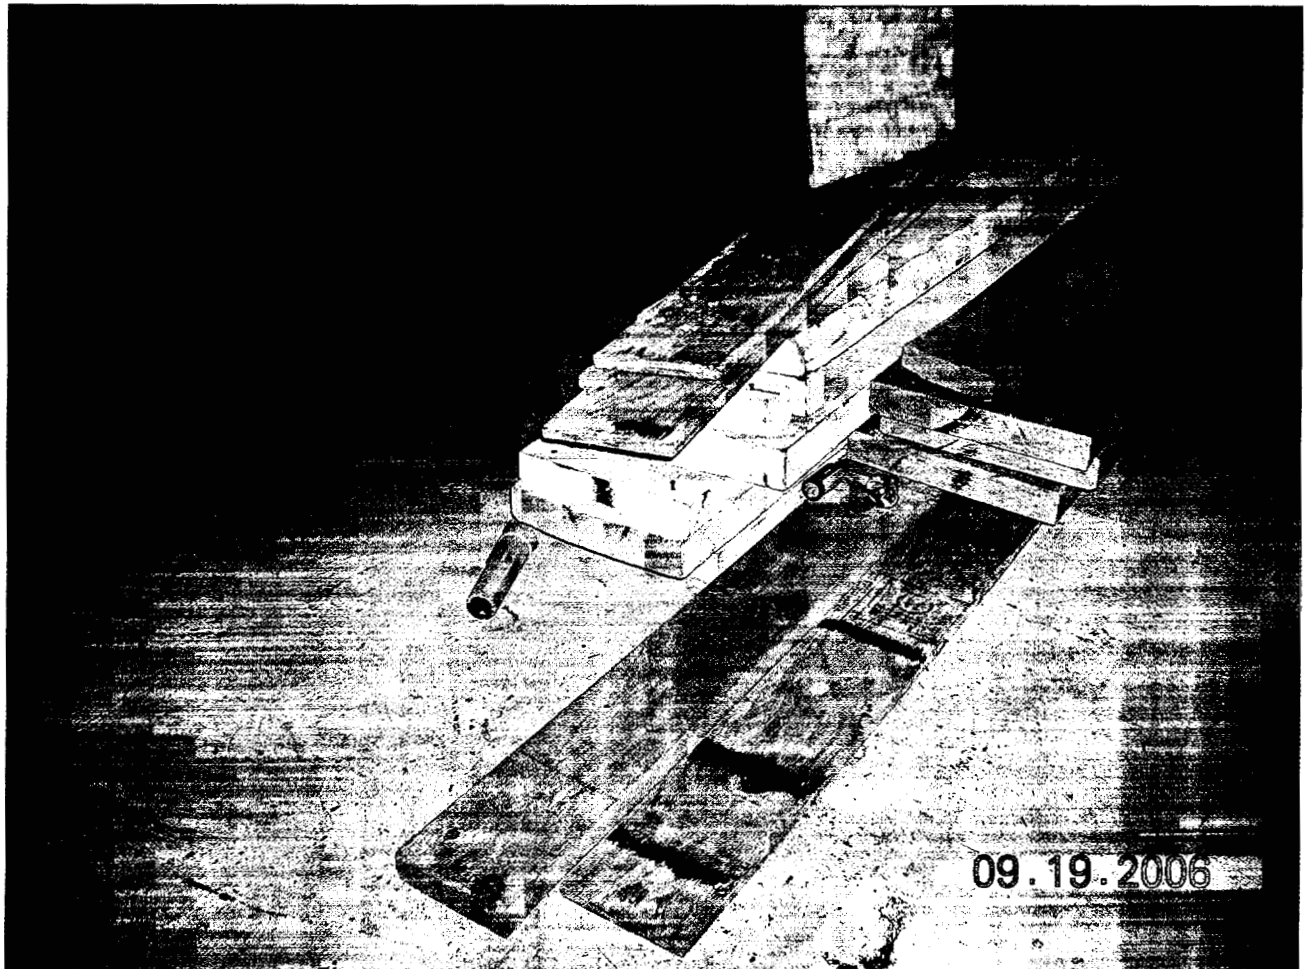
During the NRC's walkdown of the Torus Compartment as part of the License Renewal review, the inspectors noted the presence of combustible material. Fire Protection walked down the area and found that the material was not in conformance with procedure ENN-DC-161. The wood appears to have been used for scaffolding. In addition, wood cover over the dewatering sump is constructed of wood. There was no posting of the work number or supervisor in the area.

Remove wood from the Torus compartment especially Bay 15.. Reinforce procedural adherence to ENN-DC-161 with Maintenance. Replace wood cover over dewatering sump in Bay 15 with non-combustible cover.
