SUBJECT: Entergy Nuclear Operations, Inc.
Pilgrim Nuclear Power Station
Docket No. 50-293
License No. DPR-35

Request for Authorization Under the Provision of 10 CFR 50.55a(a)(3)(i)
for Modification of the Core Shroud Stabilizer Assemblies

TIE ROD MODIFICATION EVALUATION SUMMARY

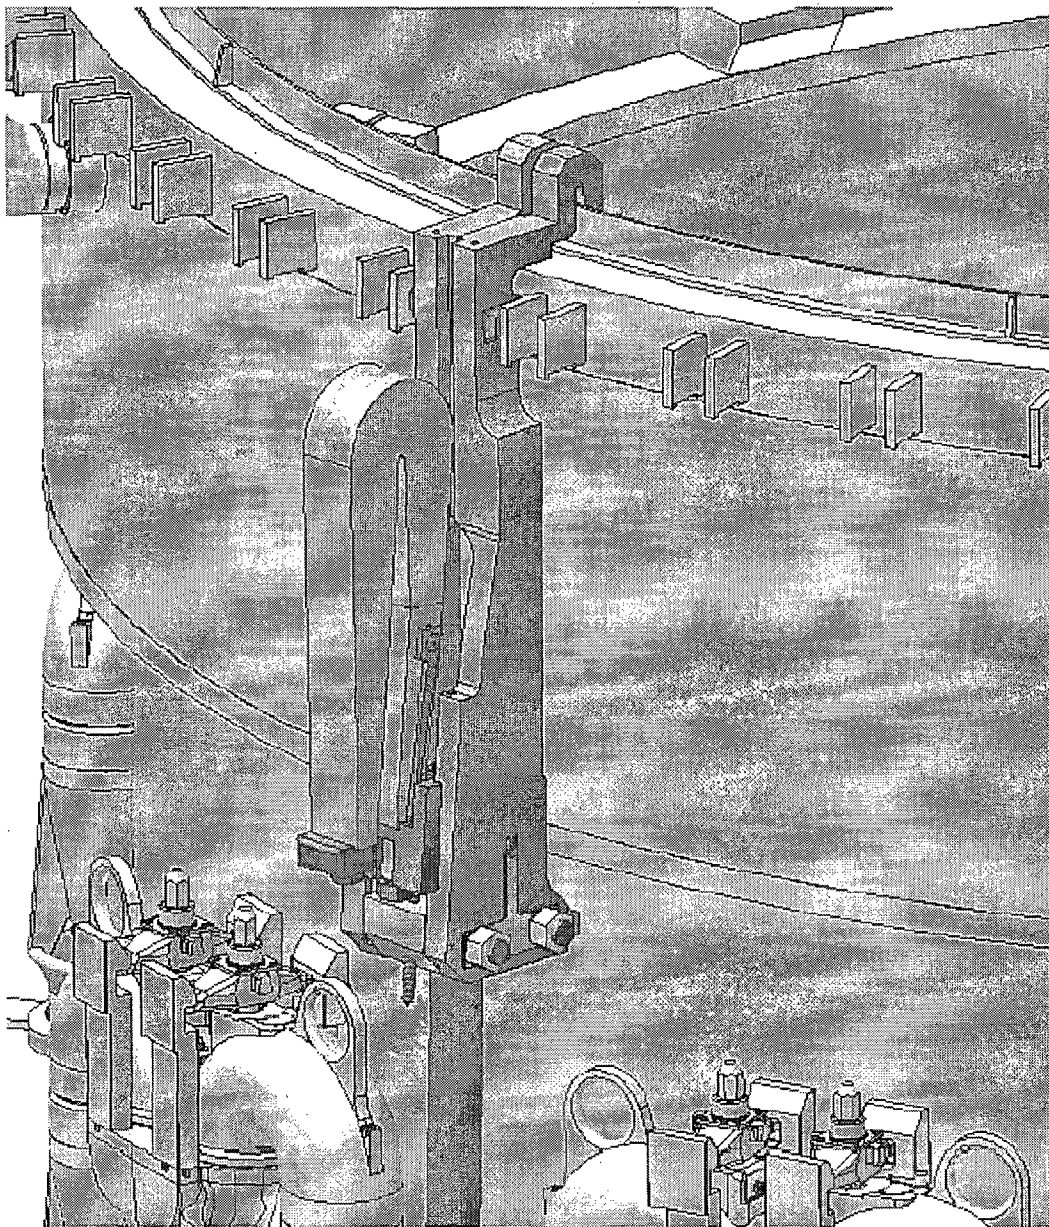
FIGURE 1: SHROUD STABILIZER TIE ROD INSTALLATION

The geometry of the replacement hardware for Pilgrim (upper support, tie rod nut, and other associated upper support components) is shown in Figures 1 and 2. Figure 3 shows a complete tie rod assembly. These newly-designed components incorporate features that improve their ability to resist IGSCC. These features include: (1) a large fillet radius at the corner of the upper support; (2) increased width and thickness of the upper support; (3) sharp edges eliminated; (4) a larger root radius of the tie rod nut threads; and (5) modification of the upper support spring

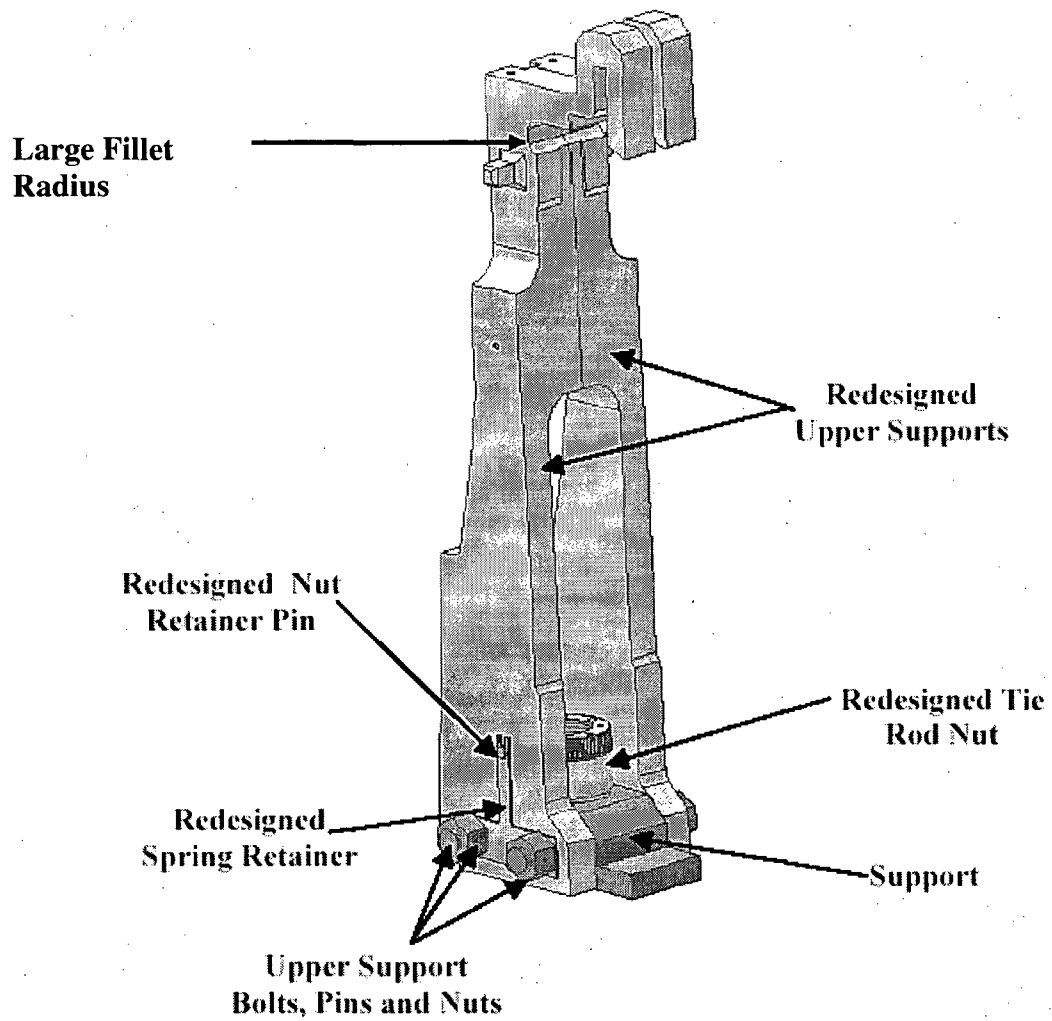
FIGURE 2: X-750 REPLACEMENT PARTS

The potential for high peak stress in the tie rod upper support assembly design at Pilgrim and the other affected plants is attributed to the lack of a specified radius at the corner junction between horizontal and vertical legs of the upper support bracket (see Figure 2), which creates a high stress concentration.

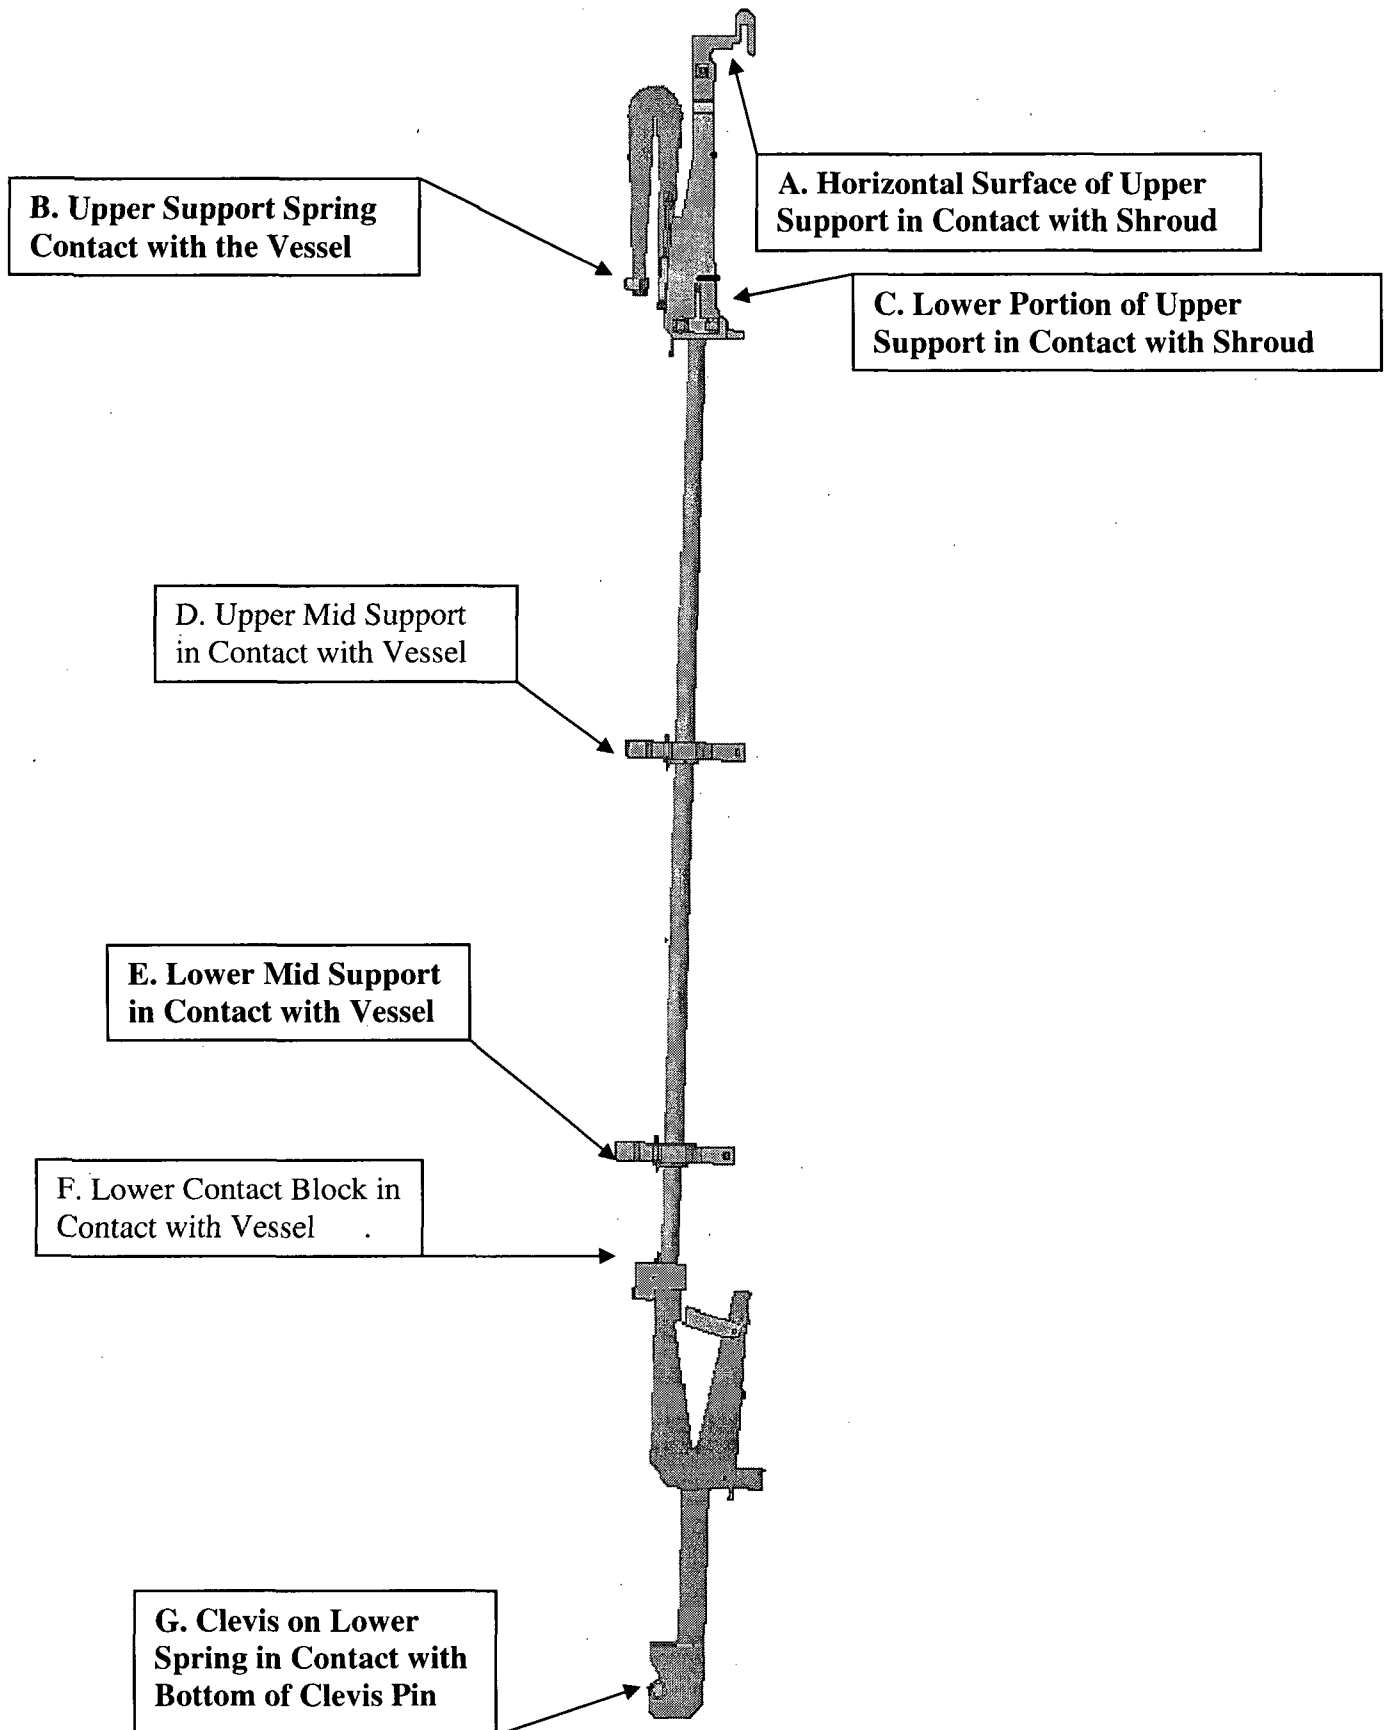
FIGURE 4: TIE ROD ASSEMBLY INSPECTION POINTS

A post-modification inspection prior to RPV reassembly will include a general post-maintenance visual inspection and recording of the fit of the shroud support hardware onto the shroud to confirm that there are no interferences at the support locations and that the installation is in accordance with the requirements of the modification drawings and the GE installation specification 26A7096. This inspection will include (as shown in Figure 4), as a minimum, the following attributes:

- a. The upper supports are located between the shroud head bolt lugs (45°, 135°, 225°, and 315° azimuth locations). Verify the upper supports are fully engaged over the steam dam, and there is contact between the horizontal surface of upper support and the shroud flange.

- b. Verify the upper spring contact pad is in contact with the RPV wall. Verify that the spring retainers are properly engaged to lock the jacking bolts.

- c. Verify that the lower contact pads on the upper support are in contact with the shroud exterior on both sides of the upper support. Verify that the upper support retainer pin is engaged.

- d. Verify that the upper mid-support is in contact with the RPV wall. Verify that the mid support latches are engaged on the tie rod collar.
- e. Verify that the lower mid-support is in contact with the RPV wall. Verify that the mid support latches are engaged on the tie rod collar.

- f. Verify that the lower contact block is in contact with the RPV wall. Verify that the lower contact block latch is engaged.
- g. Verify that the lower spring hooks are in contact with the bottom side of the clevis pin.

- h. Perform a final video-tap or DVD inspection of the completed modification.
