Entergy Meeting with NRC

Topic: Waterford 3 Batwings

March 22, 2007

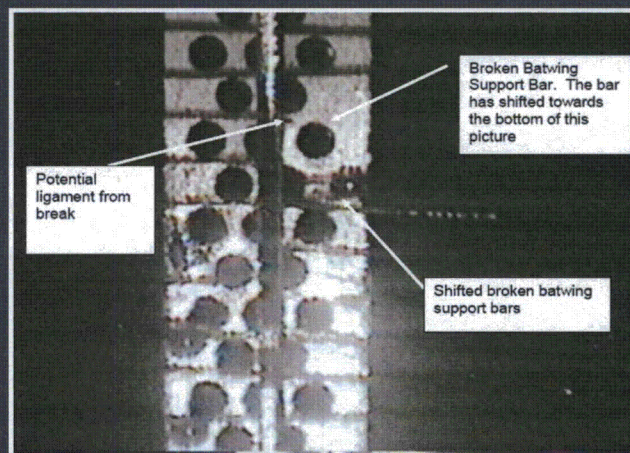
RF13 (4/05) SG#2 Visual Exam

- ▶ SG #2 batwing #9 shifted down
- ▶ Detected by eddy current signals
- ▶ Confirmed by visual inspection

- ▶ Displaced batwing was a new degradation mechanism
- ▶ Caused by fatigue failure at the batwing notch due to flow induced vibration
- ▶ Mitigated by a plugging and stabilization strategy
- ▶ Final corrective action was to accept the condition "As-Is"
 - Additional inspections were performed in RF14 to confirm analytical assumptions
 - Wear model was determined to be conservative

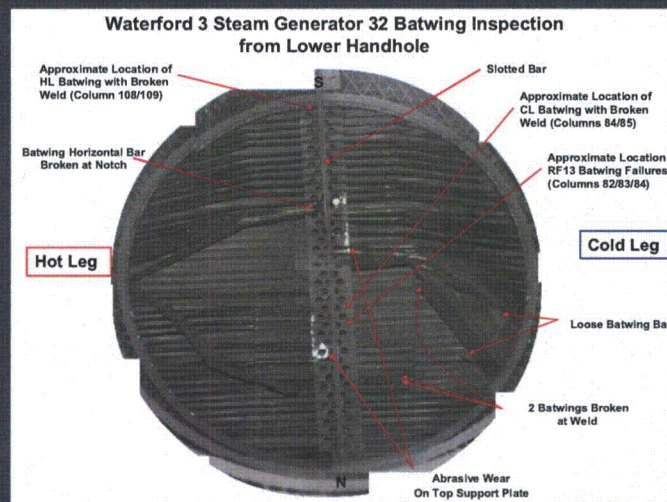
RF14 SG#2 Visual Exam

- ▶ SG#1 inspections found no batwing damage
- ▶ SG#2 inspections found additional batwing damage – all associated with the stay cavity
 - 18 additional batwings broke at the notch
 - 2 batwings also broke at the diagonal bar weld
 - 2 batwing to wrap-around bar welds broke
 - ▶ One of these had also broken at the batwing to slotted bar notch connection, the other had an intact notch
 - ▶ The batwing with both the broken (upper) weld and (lower) notch had dropped several inches into the tube bundle

- ▶ Different SG degradation mechanisms from RF13
 - Two loose segments, two broken wrap-around bar welds, and a batwing displaced into the tube bundle
- ▶ Batwings in the stay cavity area failed due to cyclic fatigue
 - Low margin in the design for the actual forces being applied
 - Susceptibility of batwings to FIV identified in 1984
 - ▶ W3 plugged and stabilized 142 tubes in each SG during Cycle 1
 - RF13 caused progressive damage on adjacent batwings
- ▶ Batwing wrap around bar welds failed due to being of poor quality and not meeting original design requirements
 - One of the welds that failed had an intact batwing notch at the slotted bar connection in the stay cavity area

- ▶ Batwing wrap around bar welds
 - Accessible welds in SG#2 were re-welded
 - The dropped batwing was mitigated by stabilizers and Sentinel plugs
 - One batwing in SG#1 had single sided welds and was mitigated by stabilizers and Sentinel plugs.
 - Additional Sentinel plugs installed at top of tube bundle and the eighth eggcrate for defense-in-depth

- ▶ Batwing degradation in stay cavity
 - Plugged to no-load contact force point (16.4 year wear point for limiting twisted batwing)
 - Mitigated by stabilizers and Sentinel plugs
 - Additional Sentinel plugs installed around the stay cavity as defense-in-depth measure

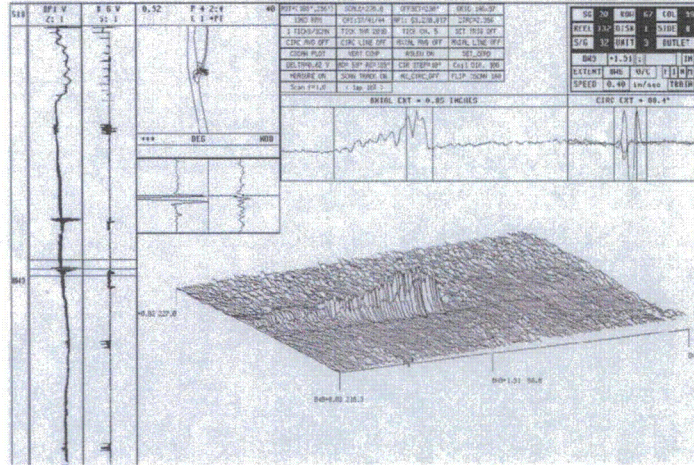
R67 C99 Wear Profile

- The attenuation model does not include localized alignment/fitup conditions
- Tube vibration alone can be a source of wear
- No other tubes in the vicinity of R67 C99 have wear scars; RF13 experience showed “strings” of wear scars over multiple rows in columns 82, 83, and 84
- Conclusion: Wear on R67 C99 is due to localized alignment/fitup and is not related to failed batwing

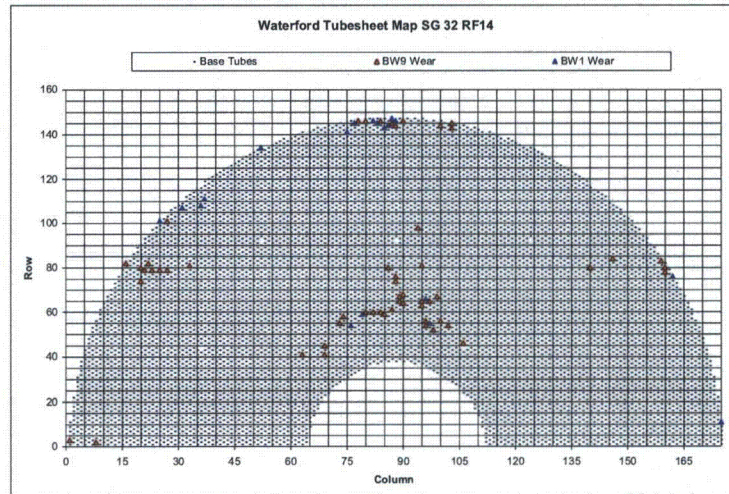
SG32 Wear Map: BW1 and BW9

- BW9 wear is primarily located near center area of stay cavity, at peripheral regions and near edge of partial eggcrates and not generally throughout SG
- R67 C99 wear and growth is isolated and not related to batwing in its dropped condition
- Only RF14 wear depth $>40\%$ TW was outside of stay cavity (R3 C1)

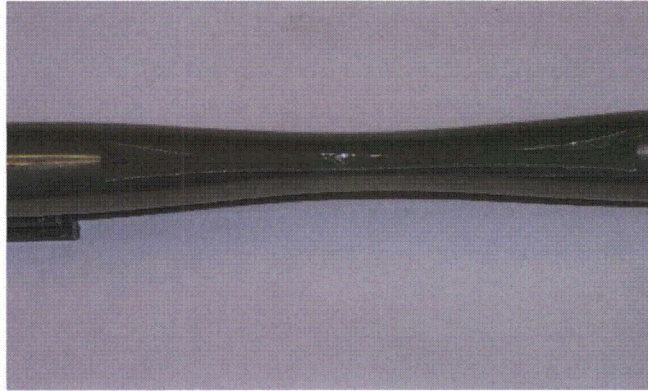
2007 Collapse Test

- Bounding wear scar shapes at limited secondary to primary pressure differential (980 psi)
- 4 inch long, uniformly deep wear scars
 - Localized collapse at 85%TW; wear scar “creased”, tube mostly retained its shape
 - Limited change in cross section to flow
 - No anticipated change in axial load bearing capability due to large remaining wall thickness
- Control samples using 1.5 degree wear tapers still to be tested
