Subject: Licensee Event Report 2007-001 Revision 0 for the Fort Calhoun Station

1. FACILITY NAME Fort Calhoun Station							DCKET NUMBER 05000285			3. PAGE 1 OF 4					
4. TITLE	Inoper	ability of a	Post	Accident	Main S	team L i	ne Rad	iation M	fonitor	Due	to Proce	dural Fr	ror		
Inoperability of a Post Accident Main Ster 5. EVENT DATE 6. LER NUMBER 7. REPORT DAT

LICENSEE EVENT REPORT (LER)

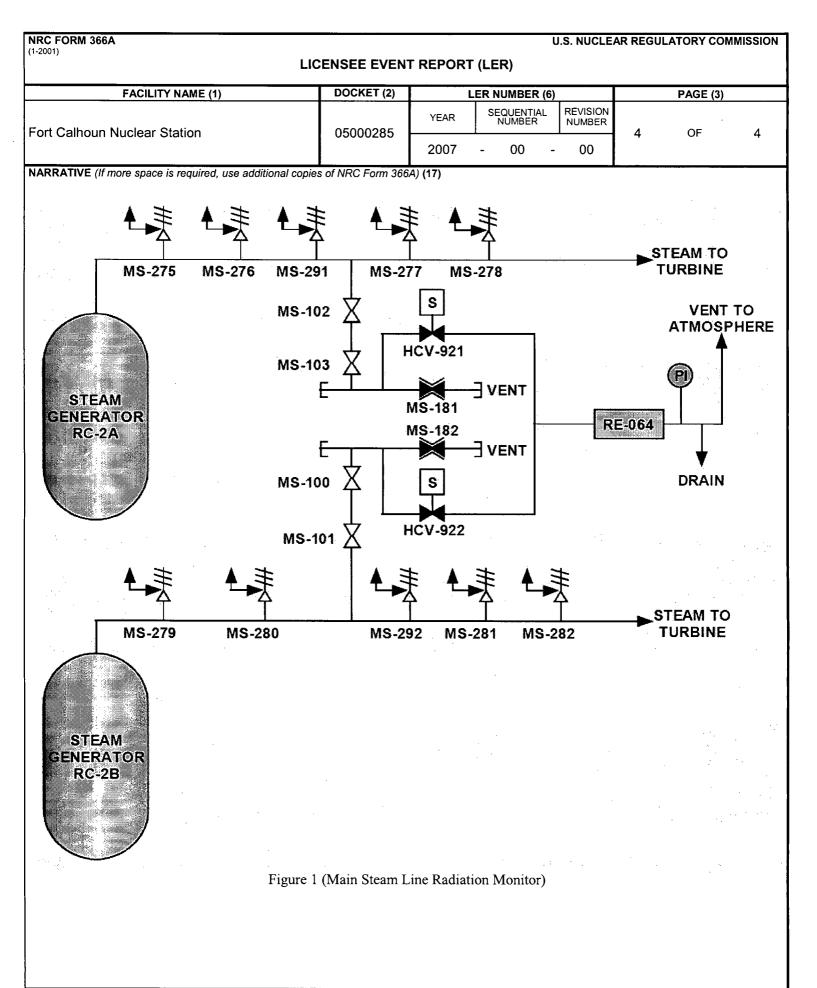
Post-accident main steam line monitor, RM-064, (see Figure 1 (RE-064 is the element that contains RM-064)) is an off-line sampler designed to monitor activity in the main steam system by sampling the main steam headers. Since RM-064 was designed for post-accident indication only, it does not initiate any system actuations or any alert/high alarms. The sample isolation valves for the monitor are opened manually from the control room.

On February 1, Fort Calhoun Station (FCS) was operating at 100 percent power. A station employee, who was cleaning in room 81, identified that all four manual steam isolation valves for radiation monitor RM-064, (MS-100, MS-101, MS-102, and MS-103) were closed. These valves are normally open and function to supply steam from steam generators RC-2A and RC-2B, via HCV-921 and HCV-922, to RM-064 for post accident monitoring. When directed by the applicable Abnormal Operating Procedure (AOP) or Emergency Operating Procedure (EOP) to sample the steam for radioactivity, isolation valves HCV-921 and HCV-922 would be opened by the control room operators to sample the main steam lines for radioactivity.

At the time of discovery, the control room was immediately contacted and the control room supervisor directed the valves to be opened. Upon opening them, the turbine building operator identified a steam leak from a fitting above steam line isolation valve MS-103; all four steam supply isolation valves were then closed. Compensatory actions for post accident monitoring per procedure Emergency Plan Implementing Procedure (EPIP)-EOF-6, "Dose Assessment," were instituted, as directed by procedure OI-RM-1 until the steam leak could be repaired. The repairs and post maintenance testing were completed for the leaking fitting on February 6, 2007. RM-064 was returned to service and declared operable.

The root cause of this event was that procedure OI-FW-6, Attachment 2 guidance was written assuming its performance prior to completing the main steam system valve lineup. The procedural guidance in OI-FW-6 closed MS-100, 101, 102 and 103, which is contrary to the previously completed main steam system valve lineup. No other procedures were identified that had similar dependencies.

Appropriate procedures will be revised to ensure that MS-100, MS-101, MS-102 and MS-103 remain open to so that RM-064 is not isolated during plant startup activities. The procedure revisions will be completed by May 31, 2007.
