# Preliminary Durability Performance Evaluation of Torus Base Mat in Pilgrim Station

By: Franz-Josef Ulm  
Massachusetts Institute of Technology  
Cambridge, MA 02139

Date: March 27, 2007

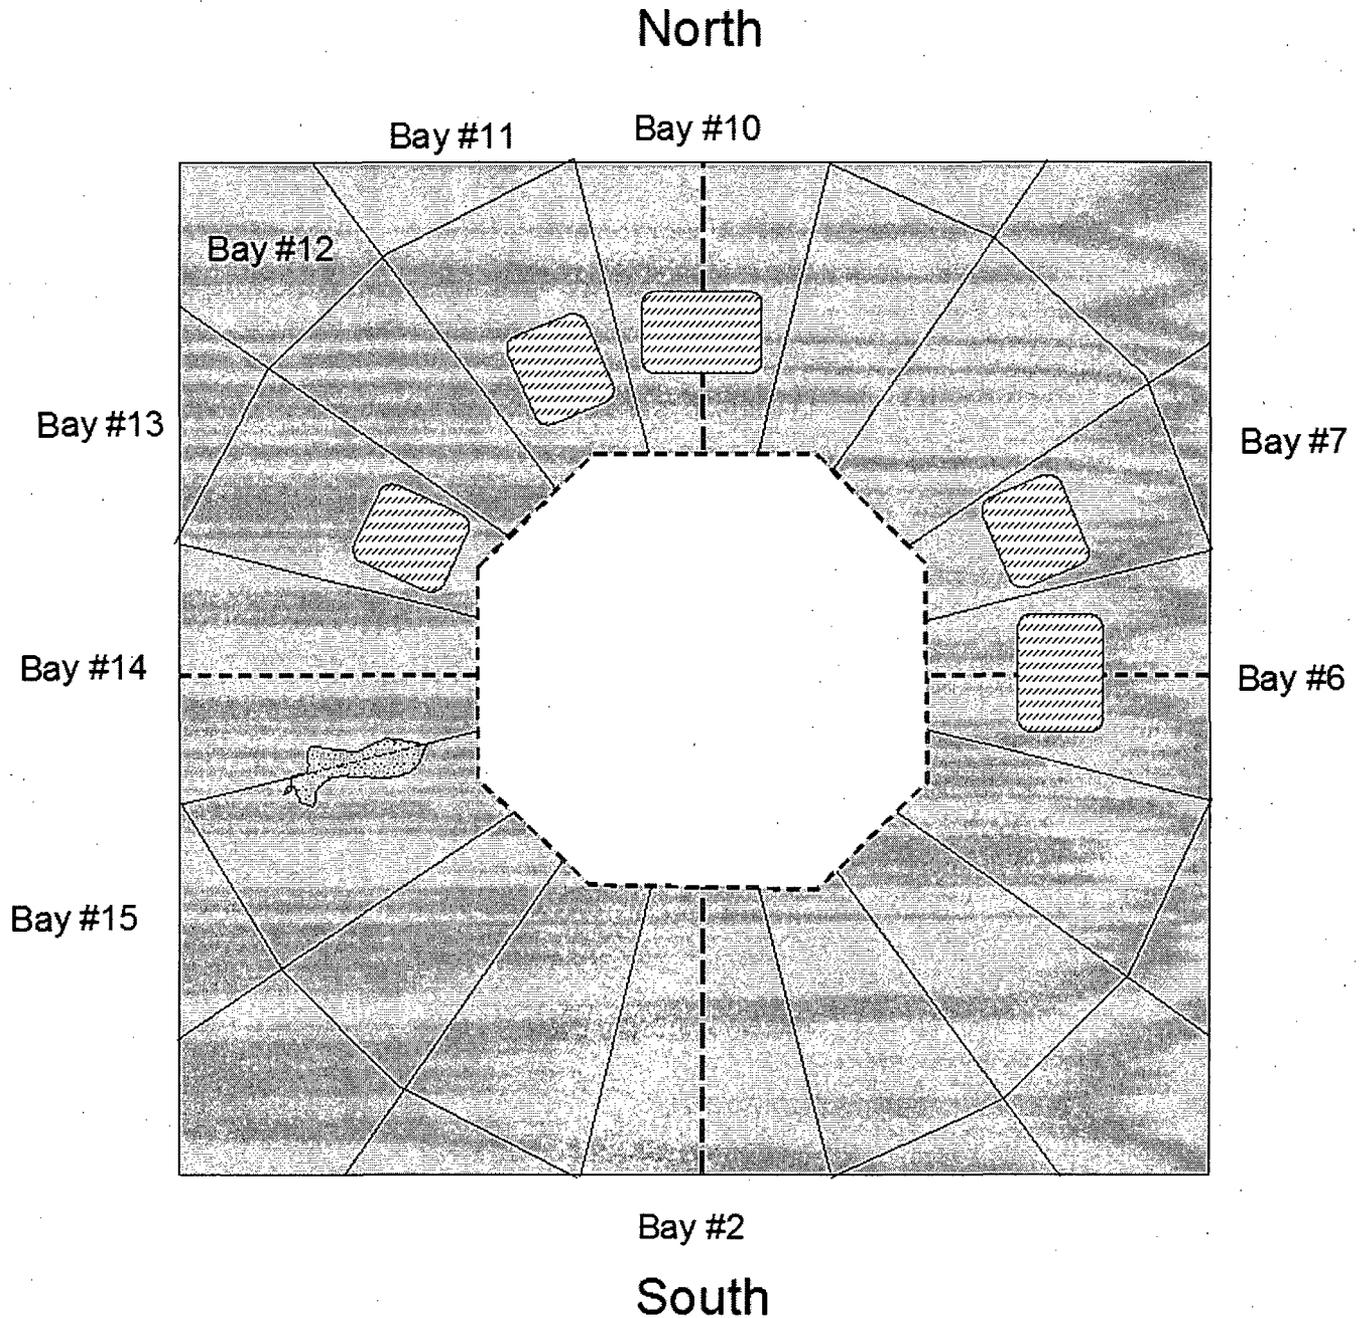
In order to check this suggestion, Figure 1 overlays in a plan view the pouring sequence with concrete joints and the bays in which water seepage has been observed. There appears to be a clear correlation between the construction sequence and the locus of occurrence of water. In particular:

- (1) The water seepage observed in Bay #6 and #10, situated respectively on the North and the East side of the reactor foundation are situated in bays delineated to the inside by the core-mat construction joint, and separated in the center of the bay by one mat-to-mat construction segment joint.

- (2) The water seepage observed in bays #7, #11 and #13 are all delineated to the center by a core-mat construction joint characterized by a kink forming a more-or-less sharp wedged geometrical discontinuity.

- (1) In bay #6 and #10, it is most likely that the water seepage originates from the 'T' junction of the mat-mat joint with the core-mat joint.
- (2) The fact that the core foundation was constructed only after the mat may have had some important implications on the stresses that were most likely generated during the concrete hydration. In fact, since hydration is an exothermic reaction, heat is generated during hydration, which leads to high temperature rises in massive concrete elements. This heat is transported through the concrete surface leading to a cooling over time of the concrete, until the concrete element reaches the ambient temperature [1]. Given the construction process, the base mat which had been poured first, must have been already in a state of cooling, when the much thicker core foundation was poured. Given the massive dimensions of the core foundation, the temperature in the core foundation is expected to have followed an almost adiabatic temperature rise. This temperature differential between the cooler mat and the hot core generates circumferential tension stresses in the mat immediately adjacent to the concrete joint. Indeed, a rough analysis of the stresses surrounding the core foundation shows that the circumferential (or hoop) stresses in the immediate vicinity of the joint are in tension if the temperature rise in the core had been twice the temperature rise in the mat. These stresses are amplified, in bay #7,#11,#13 by the presence of the wedge-shaped joint, leading to a significant stress amplification due to stress concentration which is typical for geometrical discontinuities. It is, therefore most likely that those wedge-shaped corners may have been additionally weakened during the differential hydration, forming some preferential path for water seepage.

**Figure 1: Correlating concrete construction sequence with water seepage occurrence: The dashed lines represent construction joints (re-constructed from shop-drawings), the patches represent observed water seepage in specific bays.**

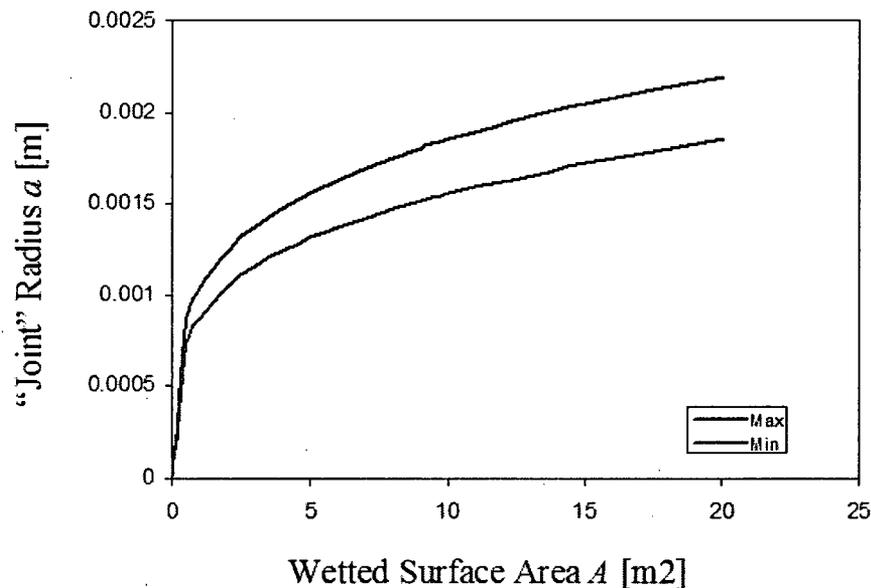
One can attempt to link this high flux rate to the space through which the flow occurs, by considering the flow of water through a cylinder of radius  $a$  in a cross section  $A$  (see, for instance [5]). In this simple model representation of the flow along the joints, the cylinder represents the joint opening, while the cross section represents the wetted surface in consequence of the flow through the cylinder. These calculations provide an upper-bound estimate of the cylinder radius representing the characteristic size of the joint opening, and yield values for the pore throat radius in functions of the wetted surface area. The results which are displayed in Figure 2, indicate that the equivalent cylindrical “joint” opening, is on the order of 1-2 mm ( $\sim 1/25 - 1/12$  in) for wetted surface areas of 5-20  $\text{m}^2$  ( $\sim 50-200 \text{ ft}^2$ ) which was observed in some bay areas.

It should be noted that this rough model overestimates the joint opening because it cumulates all possible joint openings into one single cylindrical shape. On the other hand, it provides an upper-bound estimate of the order of magnitude of the joint opening, which is expected to be in the sub-millimeter range, but substantially greater than the typical capillary pore size of concrete which is in the micrometer range.

**Figure 2: Estimated equivalent cylindrical joint size as a function of the wetted surface area. The upper curve is based on water re-appearance within one day, the lower curve on water re-appearance in two days.**

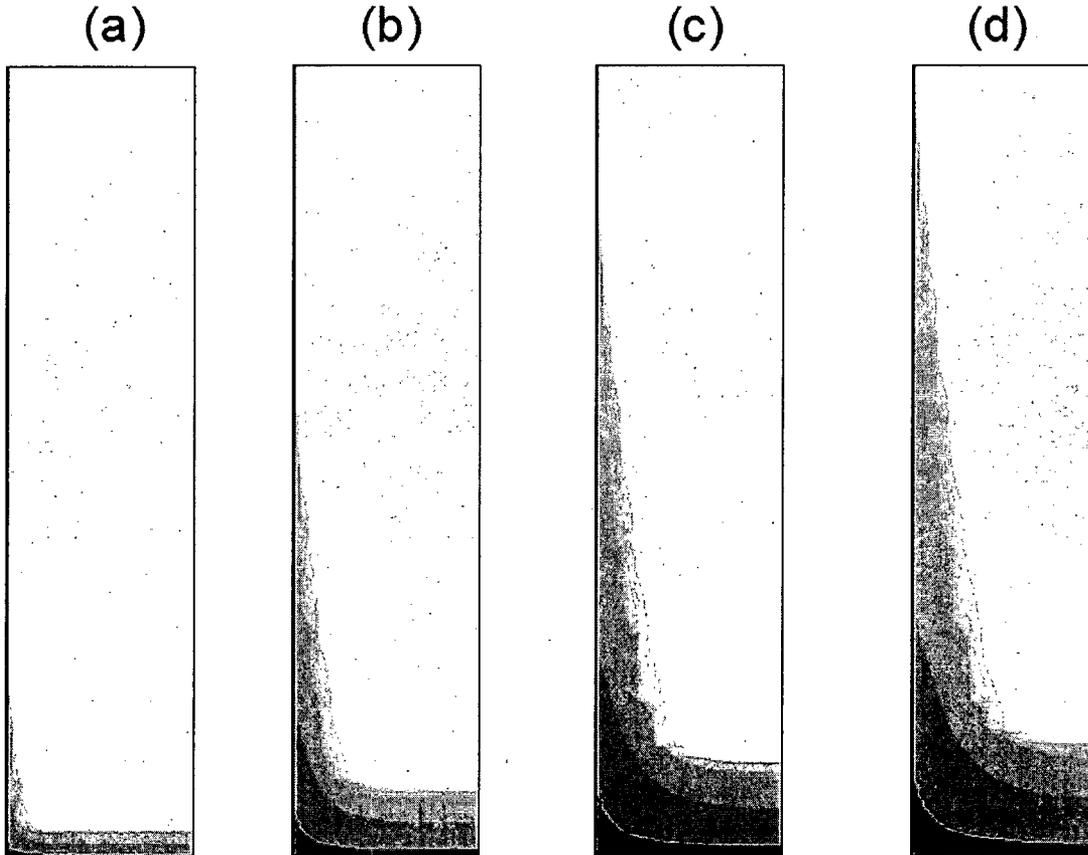
Fortunately, calcium leaching is a very slow process: the calcium leaching front advances 0.115 mm/ $\sqrt{\text{day}}$ ; which means that over the last 35 years the leaching may have dissolved the calcium in a layer maximum 13 mm (~1/2 in) thick. In other words, in the life span of the power plant, calcium leaching has no effect on the bulk integrity and structural performance of the concrete foundation. On the other hand, it cannot be excluded that calcium leaching may have contributed to the weakening of the construction joints over the years. In fact, the calcium leaching may have contributed to the joint opening through which groundwater (at a lower calcium concentration than the equilibrium concentration) penetrates. The way by which calcium leaching is most likely to affect the joint opening is sketched in Figure 3, showing dissolution fronts originating from the bottom side around a joint (left). The figure shows that the dissolution generates a vertical wedge-shaped dissolution pattern around the joint, which propagates upward through the slab in a self-similar fashion. These dissolution fronts scale linearly with the water-velocity in the joint and the joint opening [9]; which means that the higher the water flow through the joint, the more advanced the vertical position of the degraded zone.

**Figure 3: Dissolution Fronts around a joint through which water flows with a lower calcium concentration than the equilibrium concentration. For a flow velocity of  $V=10$  cm/d and a joint opening of 0.4 mm, (a) 27 years; (b) 158 years; (c) 318 years; (d) 438 years. The vertical height in this figure is 5 cm (reproduced from [9]).**
