Subject: Licensee Event Report 2007-002 Revision 0 for the Fort Calhoun Station

1. FACILITY NAME Fort Calhoun Station	2. DOCKET NUMBER 05000285	3. PAGE 1 OF 8
---	-------------------------------------	--------------------------

4. TITLE
Common Mode Failure of Medium Voltage (4160) Circuit Breaker

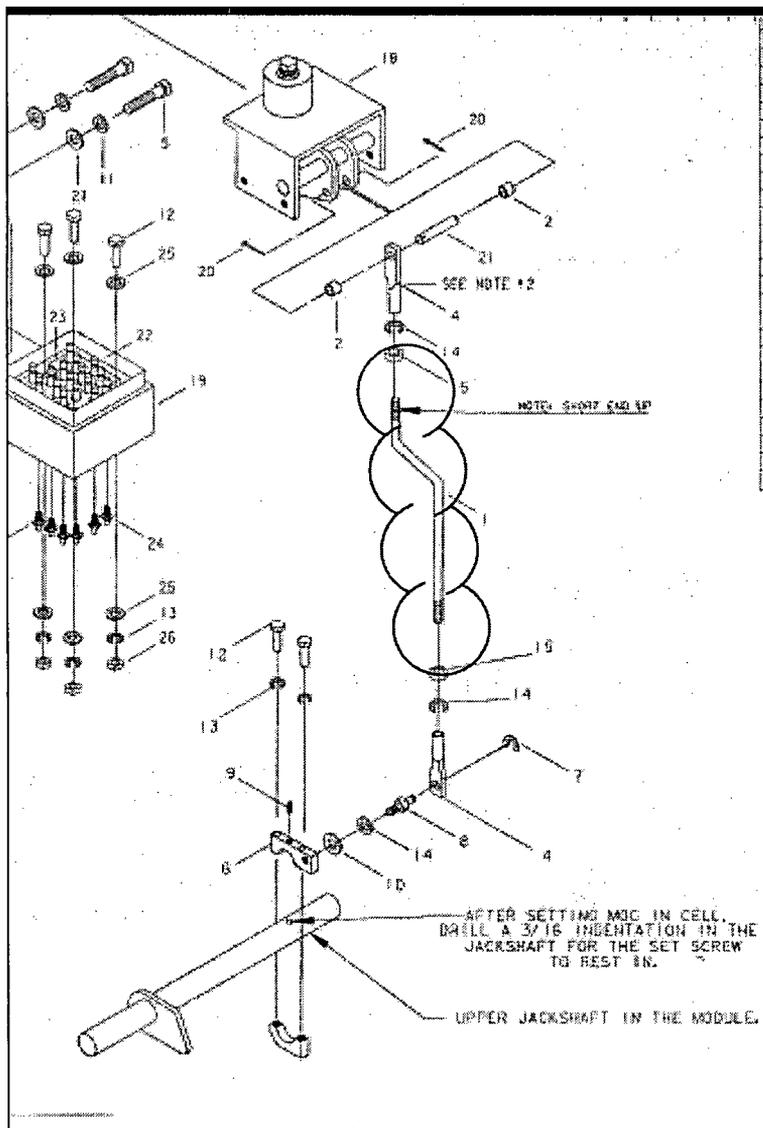
Figure 1 MOC Offset Rod in Clouded Area

The MOC linkage offset rod is made of American Iron and Steel Institute (AISI) C-1018, (plain) cold rolled carbon steel, and has a nominal diameter of 5/16 inch. The rod has a smooth outer surface that was plated with zinc and a dichromate coating for corrosion protection. The rod has nominally 1 inch of cut thread (5/16-18) on each end. The rod is oriented approximately vertical inside the circuit breaker frame. The bottom of the rod is actuated by the rotation of a jackshaft through a clamped crank link and shoulder stud with a pivoting rod attached to the MOC linkage offset rod. There is approximately a 1-7/8 inch horizontal centerline offset between the pinned ends. The upper end of the rod connects to a pinned bell crank (using an identical rod end to the bottom connection) which causes a plunger to rise and fall.

On January 25, 2007, the 4160V circuit breaker for RW pump AC-10B closed on demand but the MOC switch did not actuate. The failure was determined to be a broken MOC offset rod. Inspection of the MOC offset rod determined that the rod had failed due to cyclic fatigue. The MOC offset rod was replaced and AC-10B was returned to service. A visual inspection of the other three RW pump circuit breakers, performed at that time, did not reveal any similar damage.

The visual examination of the failed rods shows that both rods failed in the same general area of the thread. The use of die cut threads in the MOC offset rod introduced high intensity stress locations which served as fatigue crack initiation sites. The selection of this fabrication method by ABB caused the effects of high stress loading on the MOC offset rods to manifest themselves earlier than if rolled threads had been selected. This is considered a contributing cause for the MOC offset rod failure.

1. The MOC offset rods in the circuit breakers of RW pumps AC-10C, A and D were replaced with rods having less than 1000 cycles of operation.
2. The other affected 4160V safety related circuit breakers having more than 1000 cycles of operation have been rebuilt with rods having fewer than 1000 cycles of operation.
3. An administrative method to track number of cycles on MOC offset rods has been developed.

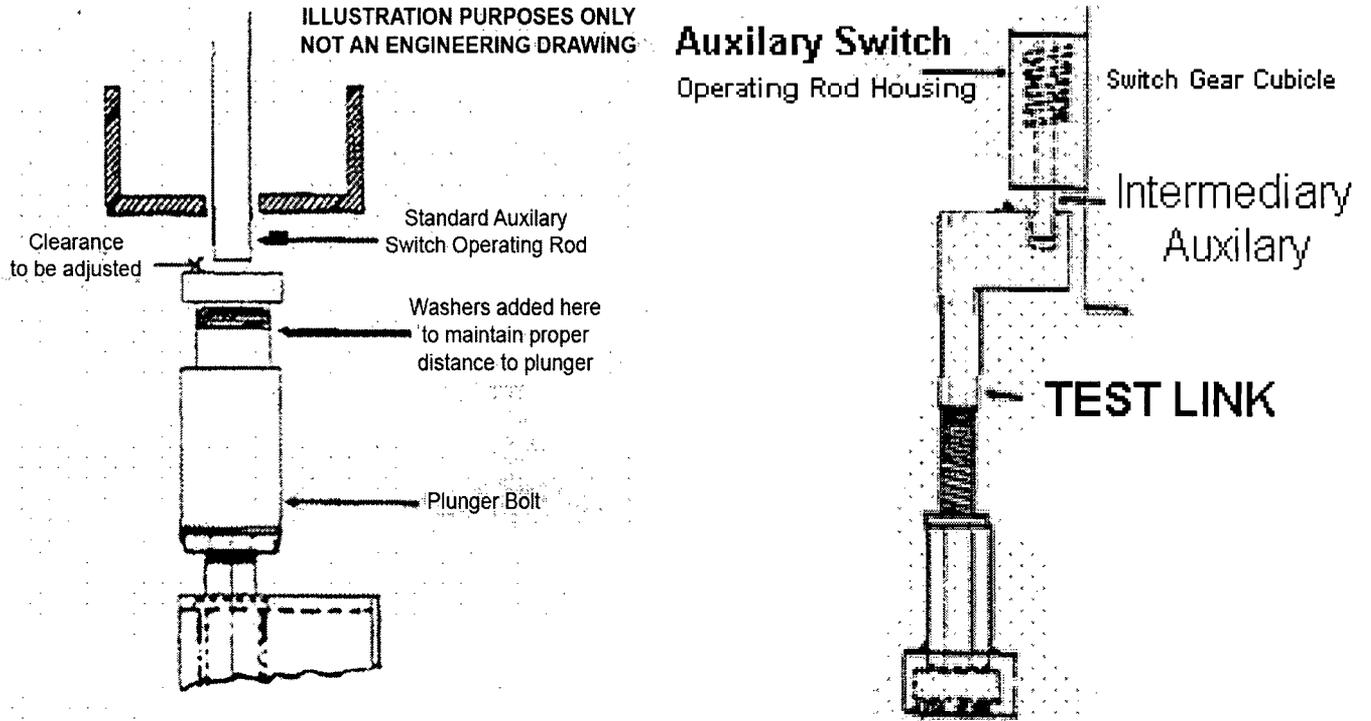
Figure 2 Test Flag (Link) Configuration

The MOC switch provides feedback to various control circuits as to the open/close status of the circuit breaker. When the circuit breaker has been elevated to the fully connected position (racked in), the switch will be actuated whenever the circuit breaker is closed. The MOC switch is actuated by the plunger interlock (plunger) mounted on the top of the circuit breaker mechanism (see Figure 2).

In normal operation, the circuit breaker is racked vertically into the switchgear, the top of the circuit breaker MOC plunger is spaced 1/8-inch away from the end of the switchgear MOC actuating rod when the circuit breaker is in the open position. For testing, a feature is provided to operate the circuit breaker without sending 4160V power to the load. In this "test" configuration, the circuit breaker is racked down and partially withdrawn from the cubicle. An offset metal "test flag" device (explained below) is installed to bridge the vertical gap between the MOC plunger bolt on the top of the circuit breaker and the end of the switchgear MOC actuating rod.

The test flag is a metal device weighing approximately two pounds that imposes additional stresses on the MOC linkage when used. The test flag shape causes the normally linear forces ('y' direction) between the circuit breaker MOC plunger and the switchgear MOC actuating rod to have a side force component ('x' direction) that increases the frictional loading on the MOC plunger and the switchgear MOC switch actuator. The weight of the test flag is also substantial enough that during the high speed operation of the circuit breaker, significant additional loading on the MOC linkage is imposed by the test flag. Breaker timing tests on the ABB circuit breakers demonstrate closure times of about 30 milliseconds (ms) and opening times of about 15 ms, which are estimated to generate accelerations on the order of 10 gravities (g) to 100 g on the circuit breaker plunger, test flag and MOC switch plunger masses. The resultant inertial loads are judged to be significant contributors to the fatigue failure of the rods.

The test flag installation at FCS was not adequately controlled to ensure that critical gaps were maintained when the test flag was used. This is considered a contributing cause for the MOC offset rod failure. Operating Instruction (OI)-EE-1A, "4160 Volt Circuit Breaker And Control Switch Operation," provides instructions for placing a 4160V circuit breaker in the test position. This procedure instructs the electricians to install the test flag loosely to avoid damage to the circuit breaker. A tightly installed test flag significantly increases the stress loading of the MOC linkage. Field testing of the MOC actuator spring force shows that the force required to move the MOC actuator increases significantly (1/8-inch movement past the normal compression results in a 20 to 25 percent increase in force) and could cause the spring to become fully compressed and present a "hard-stop" condition for the MOC actuator.
