Vogtle Electric Generating Plant – Unit 2
Pressurizer Nozzle Full Structural Weld Overlay
Nondestructive Examination Results Spring 2007 Outage (2R12)

Vogtle Electric Generating Plant Unit 2
Pressurizer Nozzle Full Structural Weld Overlay
Nondestructive Examination Results Spring 2007 Outage (2R12)

Vogtle-2 Figures showing Indication Locations

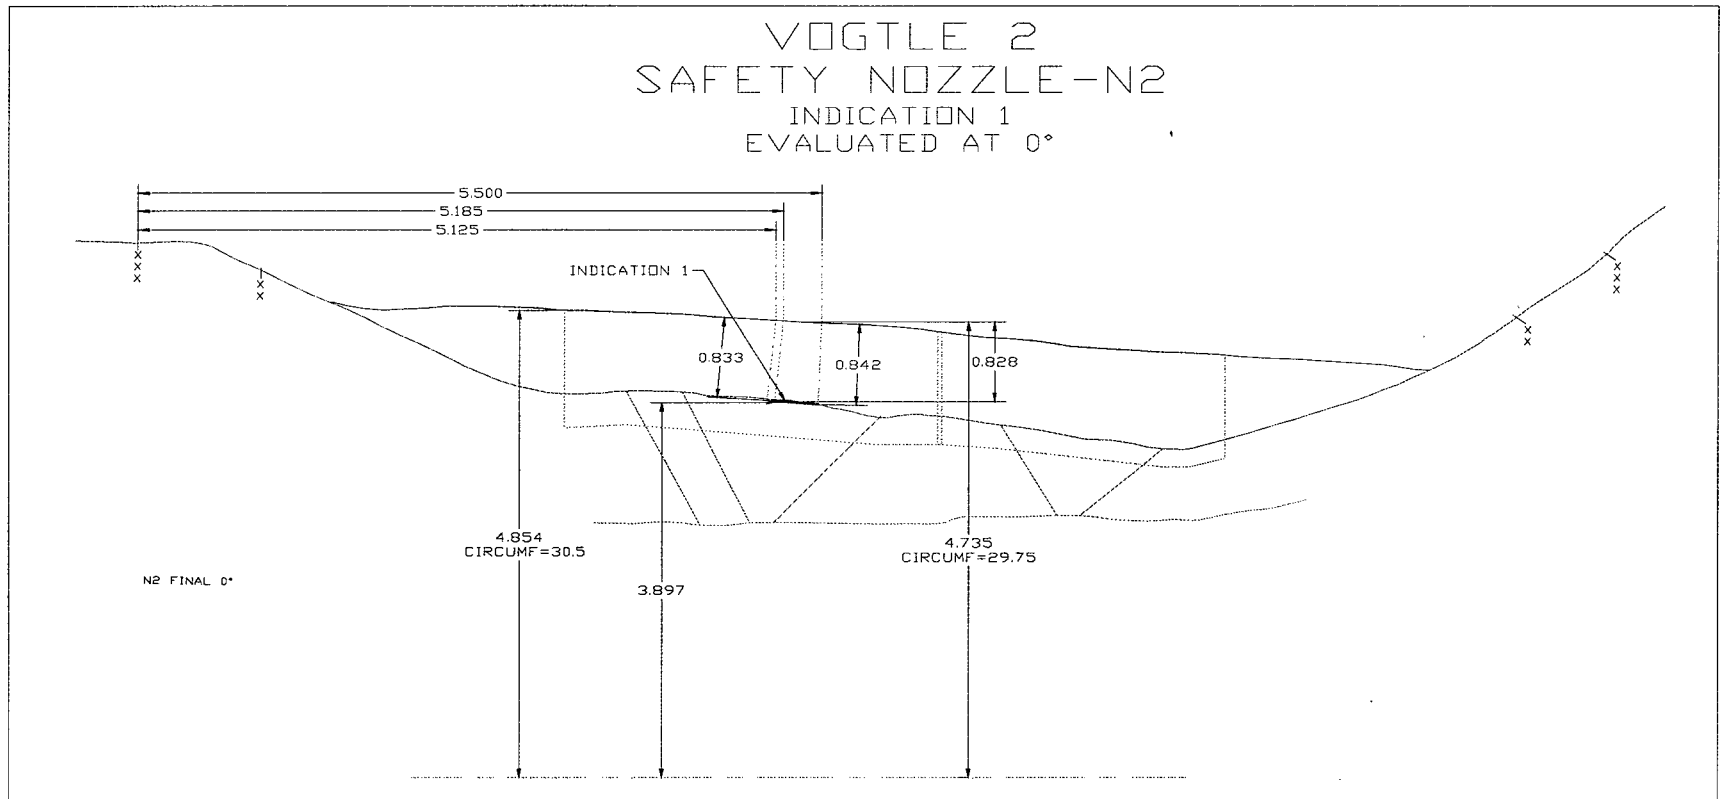
Vogle Unit No. 2 Weld Overlay Examination Results and Repairs Table						
Nozzle	Results PT of Base Metal	PT of Mitigation Layer Results/Repairs	PT of Overlay Results/Repairs	PDI UT Exam Results	Post PDI UT Repairs	PDI UT Re-exams
N-1 SAFETY	NRI	NRI	NRI	NRI	NONE	NA
N-2 SAFETY	Two linear indications; lengths were 0.07-inch and 0.12-inch. The indications were repaired and a new PT was performed with acceptable results.	Numerous rejectable indications found at the 180 ⁰ Quadrant; indications were in the range of 0.062-inches to 0.250-inches. The indications were repaired and a new PT examination was performed with indications observed at 90 ⁰ 1/16-inch to 0.25-inches and at 270 ⁰ 1/16-inch to 0.25-inches. The indications were repaired and a new PT was performed with acceptable results.	NRI	UT exams detected an acceptable lamination located at the interface of the overlay and the dissimilar metal weld. The surface area of the lamination is 0.2 square inches with a max dimension of 0.62-inches. There was no loss of coverage in the overlay material, thus a planar flaw was not postulated. The reduction in coverage of the preservice inspection volume is less than 0.2% and the lamination is sufficiently small such that there is reasonable assurance that a PWSCC indication growing into the upper 25% (of the original dissimilar metal weld) would be detected. See the attached figure to show indication location.	NONE	NA

The acceptable laminar indication for Nozzle N-2 is shown in the figure above and exists at the interface between the final weld overlay and the original Alloy-600 weld.

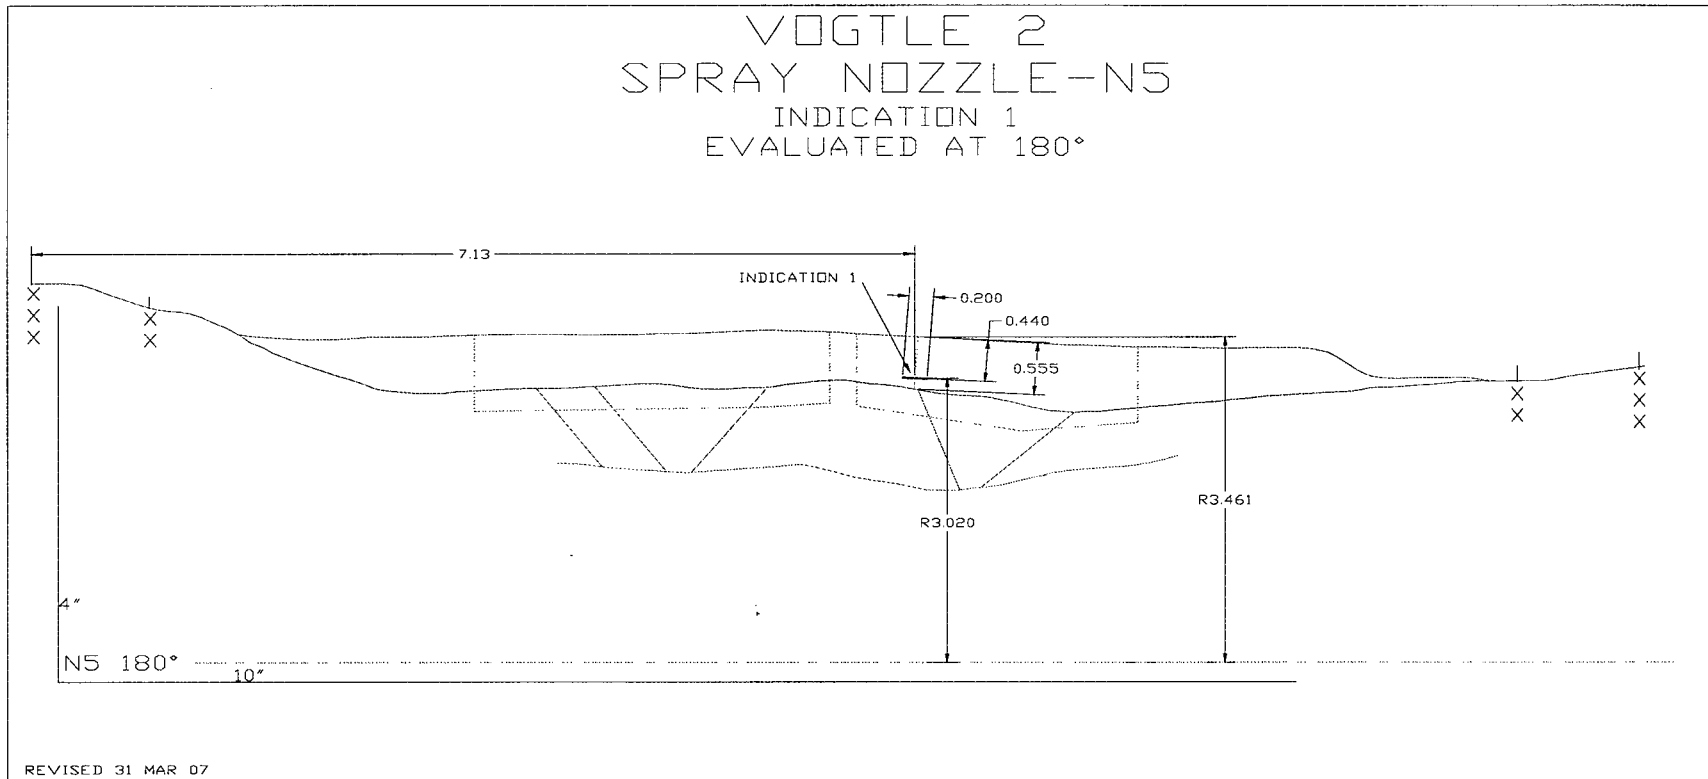
Vogtle-2 Figures showing Indication Locations

The unacceptable laminar indication for Nozzle N-5 is shown in the figure above and was removed during the fabrication process and therefore, does not exist in the final weld overlay.
