Palo Verde Nuclear
Generating Station

Subject: Palo Verde Nuclear Generating Station (PVNGS)
Unit 2
Docket No. STN 50-529
License No. NPF 51
Licensee Event Report 2005-006-00

1. FACILITY NAME Palo Verde Nuclear Generating Station (PVNGS) Unit 2				2. DOCKET NUMBER 05000529		3. PAGE 1 OF 10			
4. TITLE Condition Prohibited by Technical Specifications Due to Partial Fouling of "B" Diesel Generator (EDG) Fuel Oil Strainer

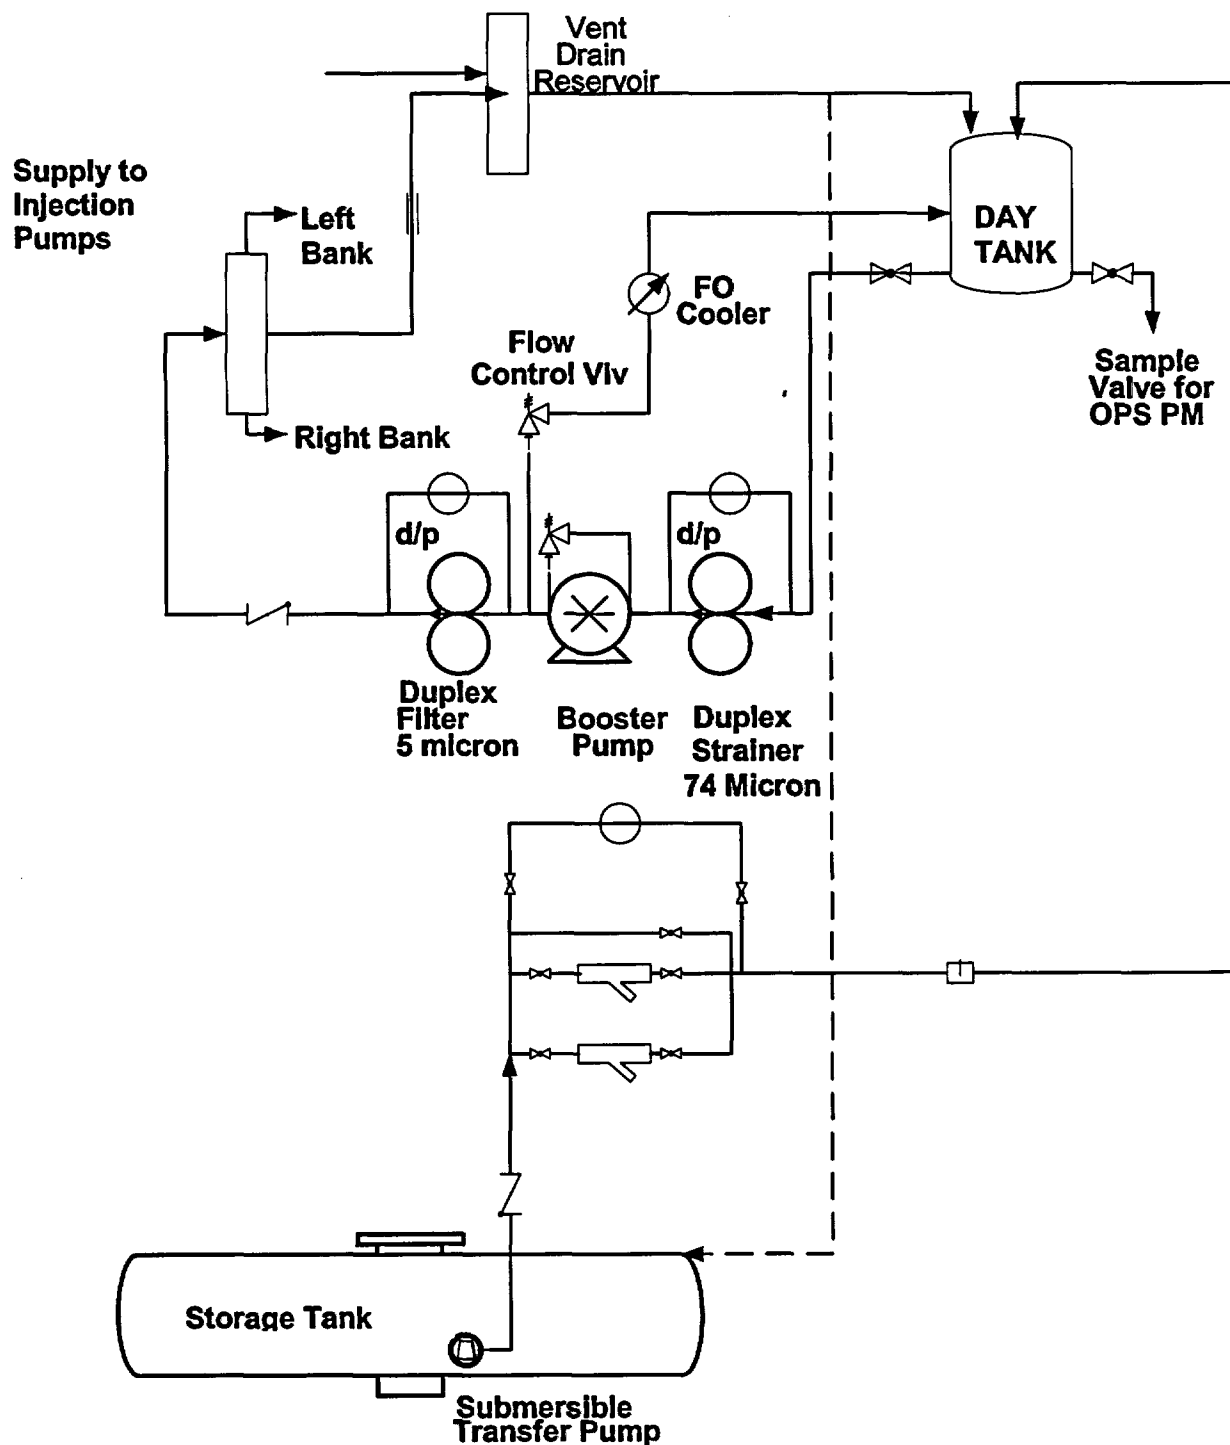
Figure 1
DG FO System - Basic Sketch

Refer to Figure 1 at the end of the LER for a simplified fuel oil system piping diagram.

Each EDG has its own separate fuel oil system which delivers fuel from its underground fuel oil storage tank located outside the EDG building to an 1100 gallon horizontal cylindrical diesel fuel oil day tank (EIS: TK). The fuel enters the day tank through the top, spilling into the tank. A feed line located approximately $\frac{3}{4}$ " from the bottom on one end of the day tank directs flow through a 74 micron duplex strainer to a booster pump. Each side of the duplex strainer houses two strainer elements (four total for each strainer). One side of the duplex strainer is aligned for service and the other side is in standby in the event the in-service strainer differential pressure (d/p) increases excessively. The engine driven booster pump provides approximately 11 gpm fuel flow at 30 psig through a duplex 5 micron filter, which is aligned and operated in a manner similar to the strainers. Each side of the duplex filter houses two filter elements (four total for each filter). The EDG uses

approximately 6.45 gallons per minute (gpm) of fuel at full electrical load and excess fuel is directed back to the day tank via a fuel oil cooler (EIS: CLR). The day tank level control system automatically maintains level in the day tank above the minimum level. The strainer and filter differential pressures (d/p) are monitored and alarm at 5 pounds per square inch differential (psid) and 10 psid increasing, respectively, to alert the operators of potential excessive strainer or filter loading. The alarms annunciate on the local EDG control panel (EIS: PL) and generate a control room annunciator (EIS: ANN) and alarm typer "DGYS4 DG B LO PRIORITY TRBL" report. The alarms provide timely indication of the potential need to shift the respective duplex filter or strainer to the standby side to permit continued operation of the EDG. The loaded filter or strainer side may then be cleaned or replaced while the diesel engine continues to run.
