May 3, 2007

NOTE TO FILE:

The pictures on the following pages were sent to me by Marc Ferdas, Senior Resident Inspector at Oyster Creek Generating Station on May 2, 2007.

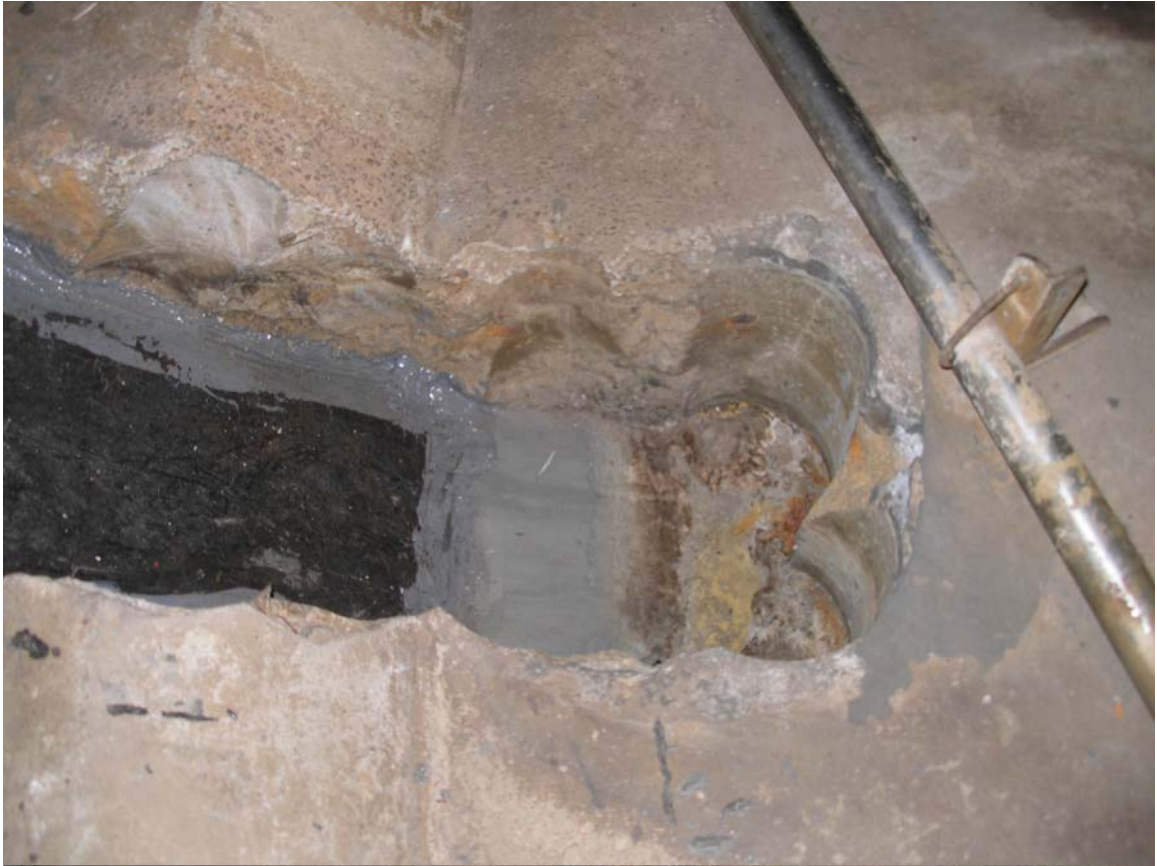
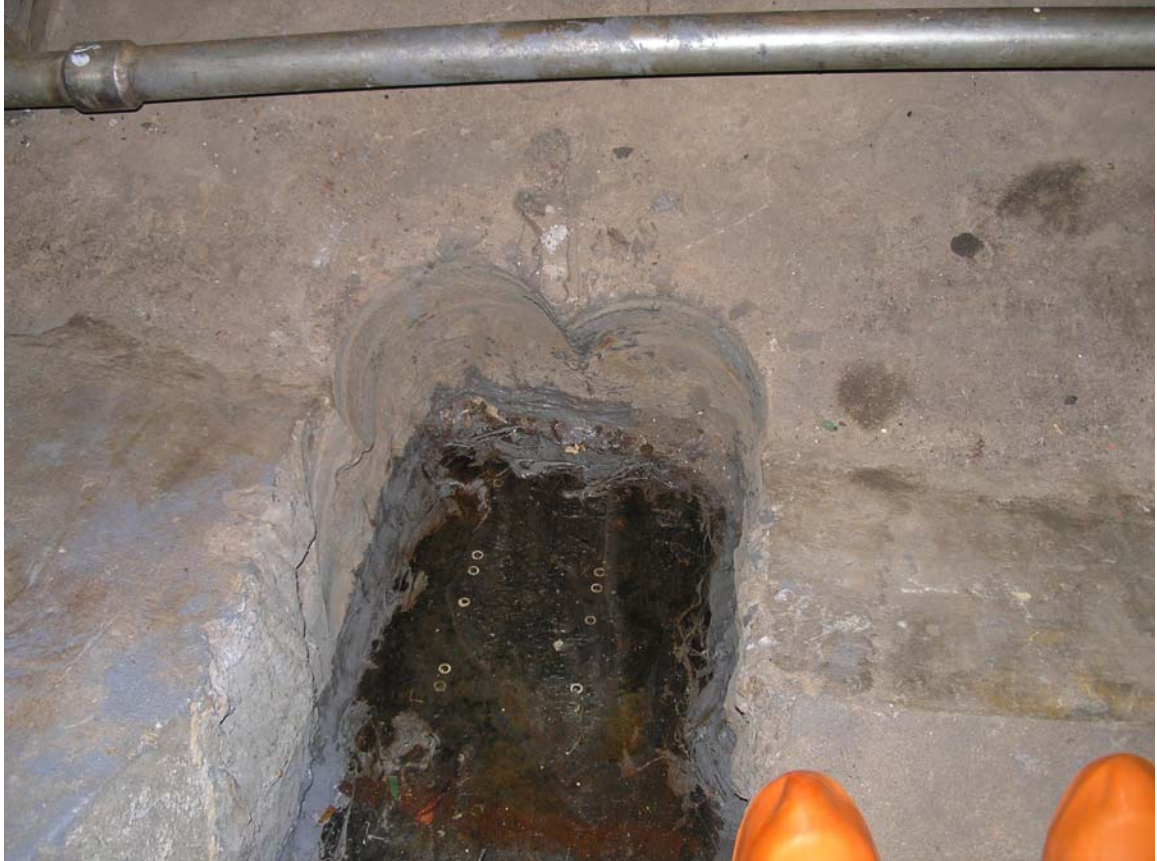
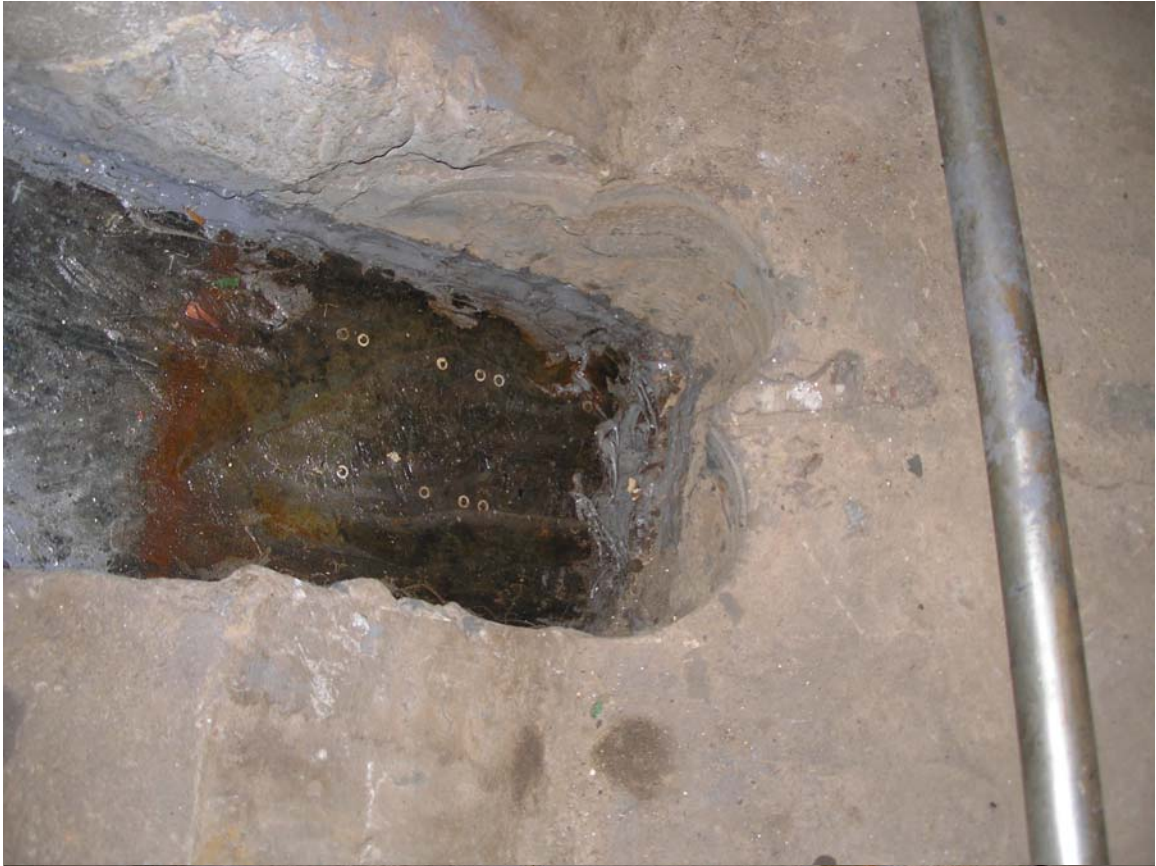
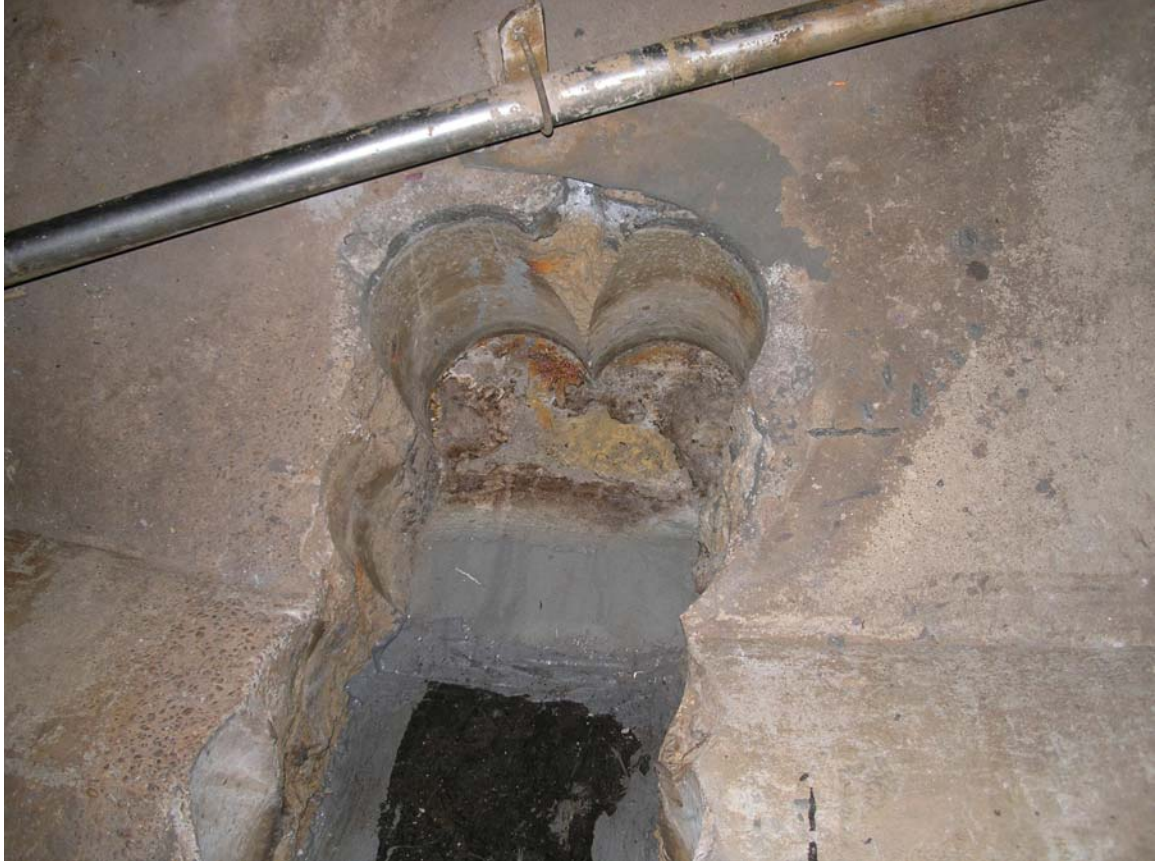
The four pictures show the condition of the trenches in the "as found" condition during a walkdown of the Oyster Creek Drywell at the start of a Maintenance outage on April 29, 2007. Both trenches were found to be dry with no evidence of water present. The digital pictures were made by Ryan Treadway, Resident Inspector at Oyster Creek.
