**From:** "Davis, James T." <JTDAVIS@southernco.com>  
**To:** "Christian Araguas" <CJA2@nrc.gov>  
**Date:** 4/16/2007 6:18:10 PM  
**Subject:** RAI Letter #6 Hydrology Response 2 of 4

FINAL REPORT ON DEWATERING AND REPAIR OF EROSION  
IN CATEGORY I BACKFILL IN POWER BLOCK AREA

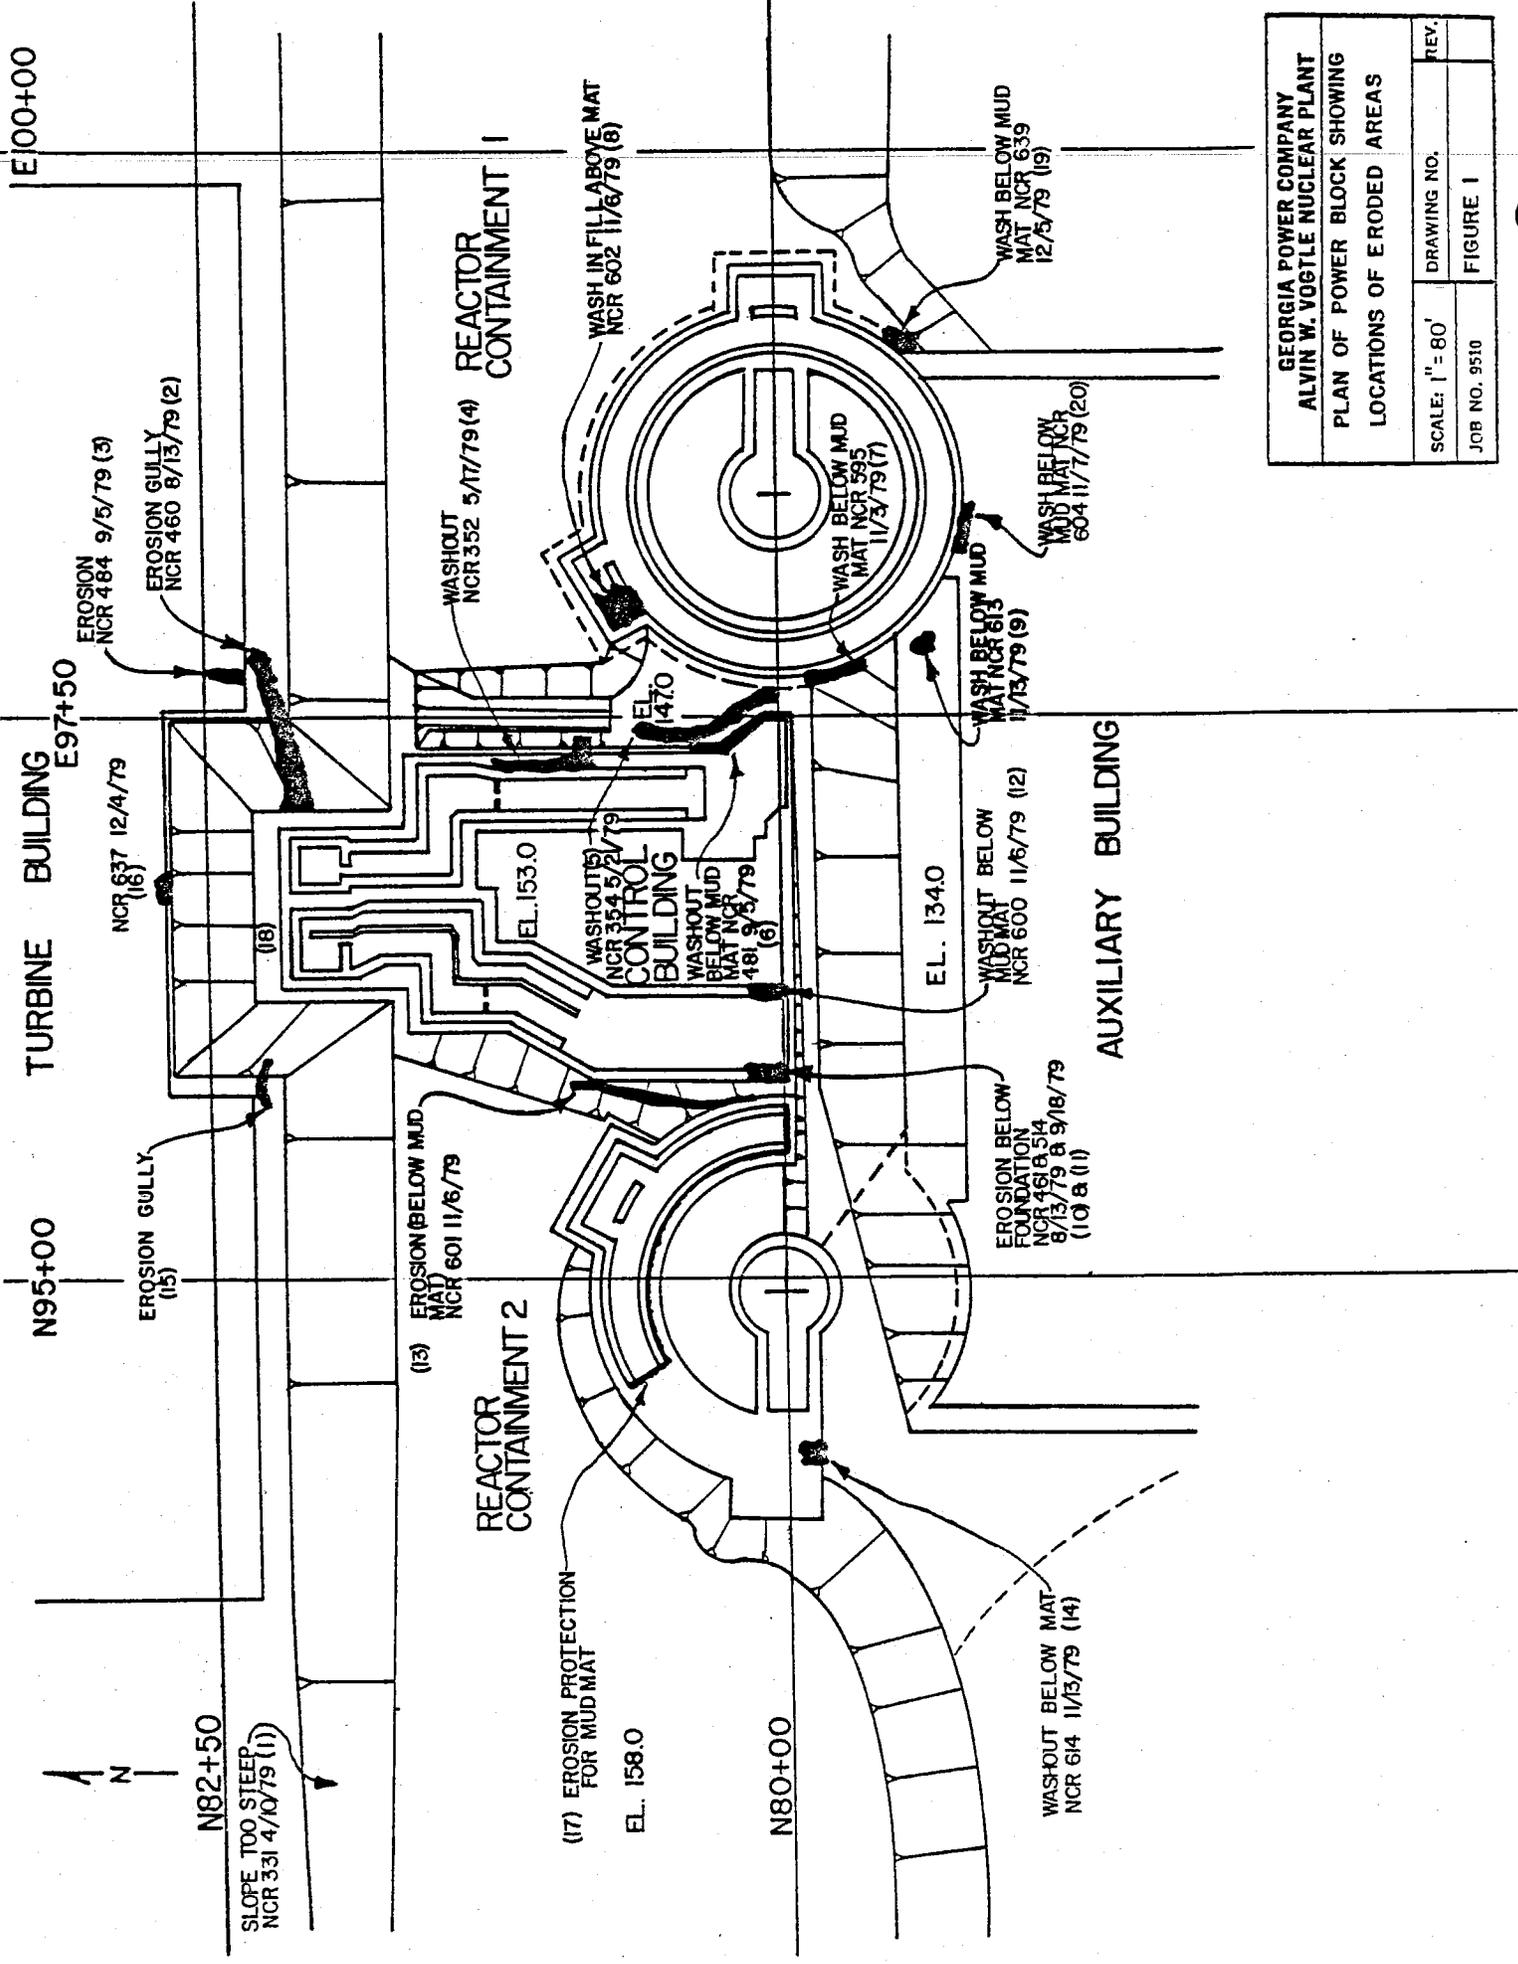
GEORGIA POWER COMPANY	
ALVIN W. VOGTLE NUCLEAR PLANT	
PLAN OF POWER BLOCK SHOWING	
LOCATIONS OF ERODED AREAS	
SCALE: 1" = 80'	DRAWING NO.
JOB NO. 9510	FIGURE 1
	REV.

Erosion in this vicinity was identified as Areas 1, 2, 3, 15, 16 and 18 respectively (Figure 1). Areas 1, 2, 3, 15 and 16 referred to erosion areas along the Turbine Building south slope; Area 18 referred to the area between the toe of the Turbine Building south slope and the edge of the Control Building shafts' mudslab. All these areas were repaired in accordance with the procedures specified in Reference 1.

Erosion areas for repair in this area were identified as Areas 4, 5 and 6 respectively (Figure 1).

Erosion in the Unit 2 Containment area was designated as Areas 14 and 17 (Figure 1). Area 14 referred to erosion below the Tendon Gallery mudslab on the west side. However, the construction of the Tendon Gallery had not begun on this section of the mudslab. Erosion in Area 14 was quite limited in extent. Repairs in this area involved removal of the mudslab over the eroded area, excavation to undisturbed material and then backfilling the excavation. Area 17 pertained to erosion below the mudslab of the partially built

Erosion outside the Unit 1 Containment area was identified as Areas 7, 8, 9, 19 and 20 respectively (Figure 1). Area 7 had been repaired earlier in November, 1979 (Reference 1). Areas 8, 9 and 19 were repaired in accordance with specified procedures. The depth of the disturbed zone was determined by proving ring penetrometer probing. The disturbed fill was excavated to competent fill material and backfilled. At least one sand cone density test was made in each of the above areas prior to fill placement. Area 20,

Erosion in this area was identified as Areas 10, 11, 12, and 13 (Figure 1). Areas 10 and 11 were repaired in late 1979, as described in Reference 1. Areas 12 and 13 were repaired in February, 1980, in accordance with approved procedures.

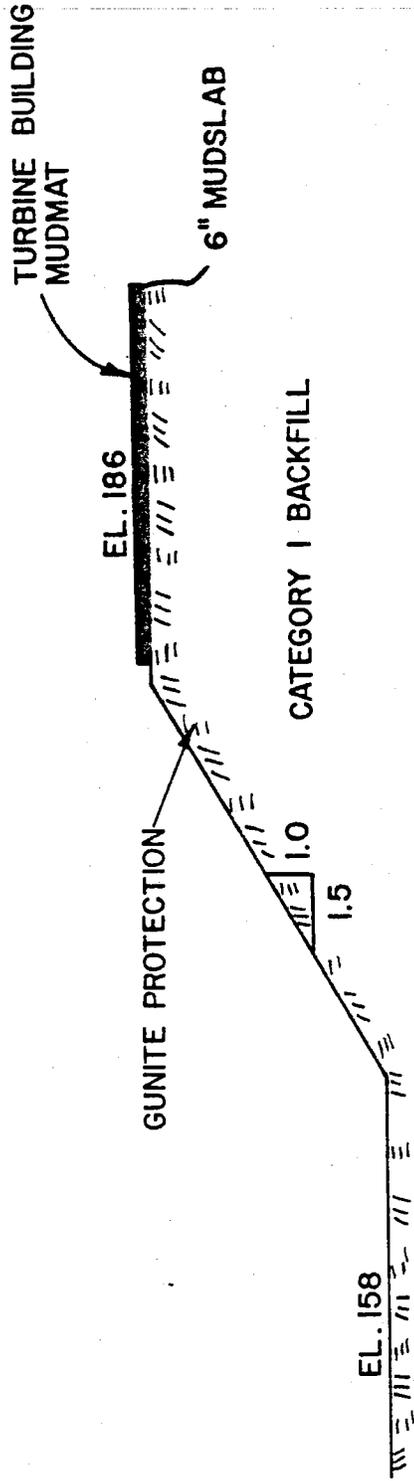
GEORGIA POWER COMPANY ALVIN W. VOGTLE NUCLEAR PLANT	
TYPICAL REWORKED SECTION OF TURBINE BUILDING SOUTH SLOPE	
SCALE:	REV.
JOB NO. 9510	DRAWING NO. FIGURE 4

The Turbine Building foundation base slab was not subjected to any erosion. The erosion that occurred was confined to the south slope, off the south side of the Turbine Building mudslabs. Erosion gulleys extending to a maximum of 4-feet below the mudslab caused cracking to occur in the mudslab. During repair all cracked sections of the mudslab were removed and the erosion gulleys were cut back to sound material at a slope of 1.5 horizontal to 1.0 vertical.

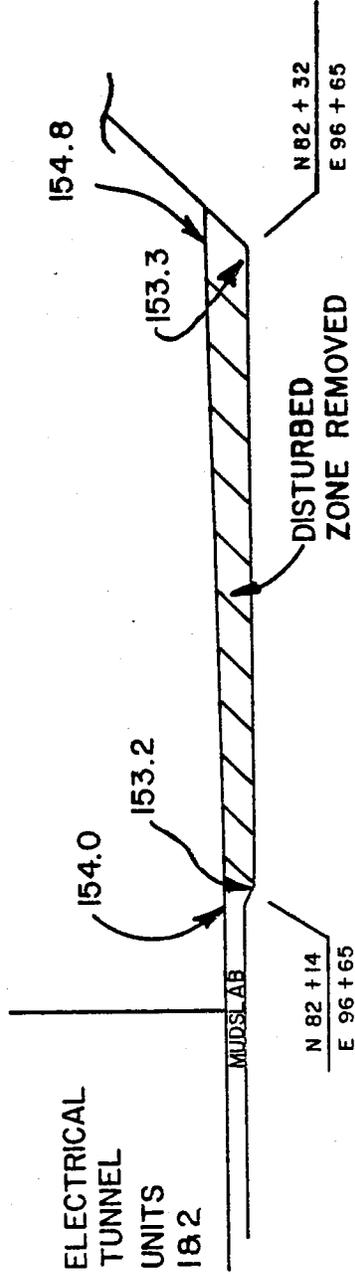
GEORGIA POWER COMPANY ALVIN W. VOGTLE NUCLEAR PLANT	
TYPICAL SECTION SHOWING EXTENT OF DISTURBED ZONE REMOVED IN CONTROL BLDG. SHAFT AREA	
SCALE:	DRAWING NO. REV.
JOB NO. 9510	FIGURE 5

Erosion of backfill in the Control Building shafts area occurred at least 2-feet away from the permanent foundations. Visual inspection showed that the foundations were not affected by erosion. All disturbed areas in the proximity of the Control Building shafts were repaired in accordance with the specified procedures. Settlement in these areas is discussed under Items "D" and "E" below.

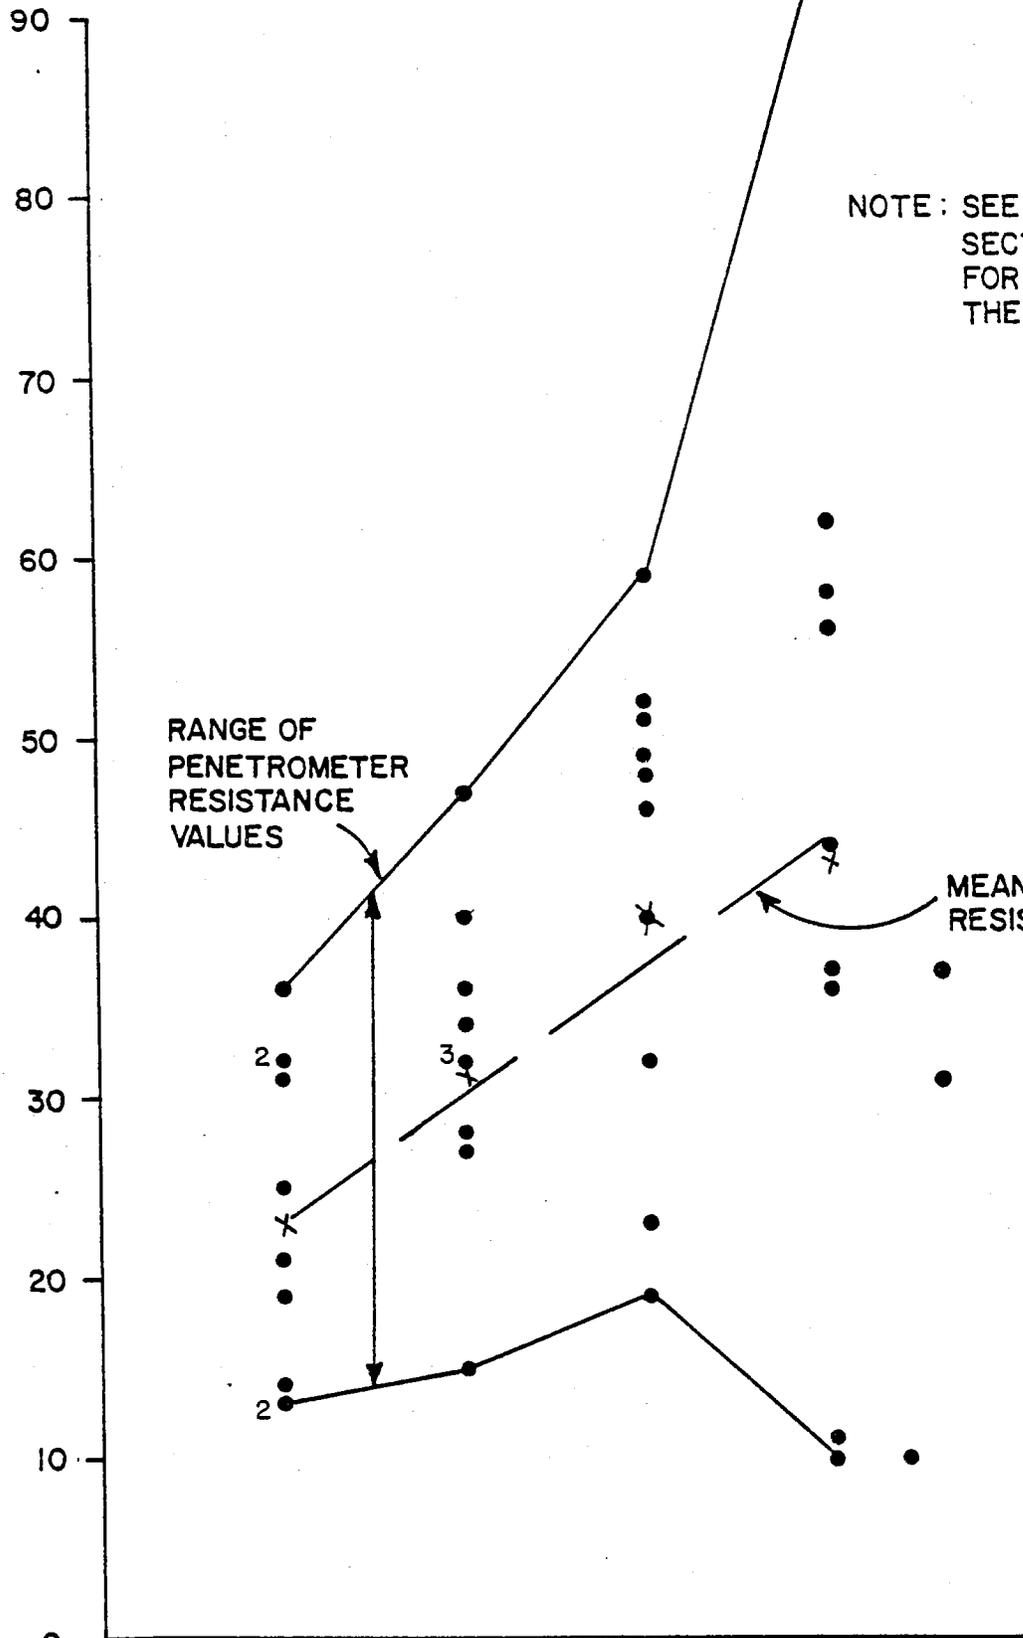
GEORGIA POWER COMPANY ALVIN W. YOGTLE NUCLEAR PLANT		
ELECTRICAL TUNNEL EAST WALL DCP RESISTANCE VERSUS DEPTH		
SCALE:	DRAWING NO.	REV.
JOB NO. 9510	FIGURE 7

relating to these dynamic cone penetrometer tests are presented in Table 3. The data indicate that with the exception of Test Locations 3A and 5A, high resistances were obtained in the backfill adjacent to the tunnel wall. In addition, these resistances were observed to generally increase with depth.

Along the Unit 1 Electrical Tunnel east wall, the data obtained from cone penetrometer and sand cone density tests indicated that the backfill adjacent to the tunnel foundation was in sound condition. The disturbed material in the two erosion areas along the slope adjacent to the foundation was carefully removed by hand excavation and the areas backfilled in accordance with the procedure described in Section II.C.2. A visual inspection made prior to backfill revealed that the zone of erosion in both areas did not extend to below the tunnel foundation.

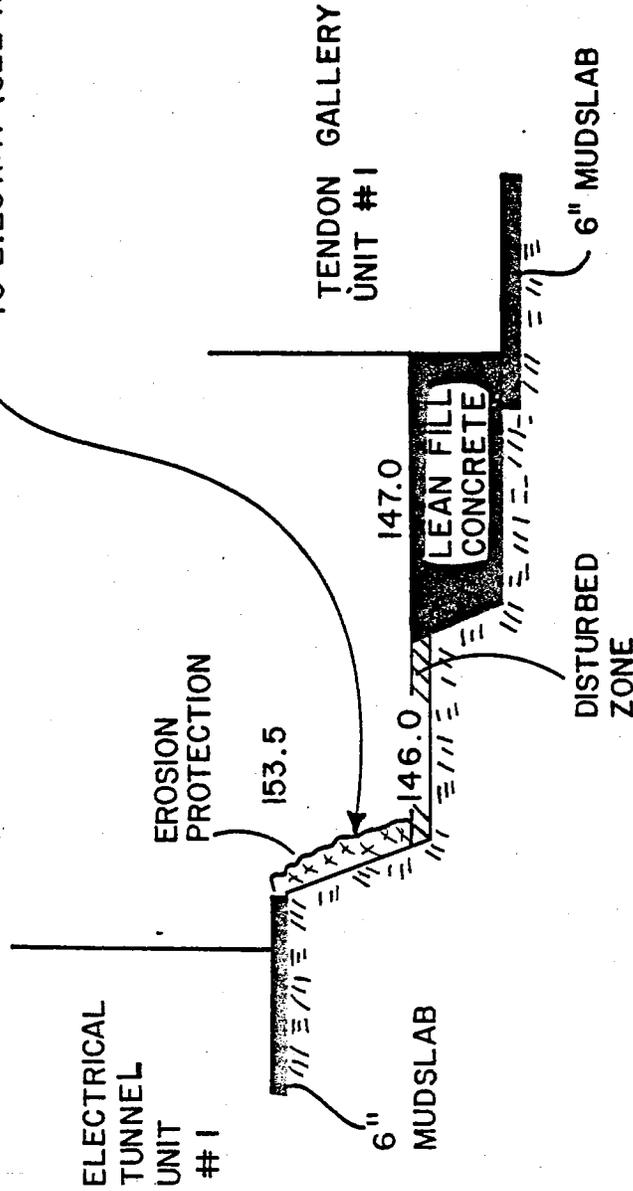
GEORGIA POWER COMPANY ALVIN W. VOSTLE NUCLEAR PLANT	
TYPICAL SECTION OF REMOVED DISTURBED ZONE BETWEEN UNIT #1 CONTAINMENT & UNIT #1 ELEC. TUNNEL	
SCALE:	DRAWING NO. REV.
JOB NO. 9510	FIGURE 8

TYPICAL SECTION SHOWING EXTENT OF DISTURBED  
ZONE REMOVED IN AREA BETWEEN UNIT I ELECTRICAL  
TUNNEL AND CONTAINMENT.

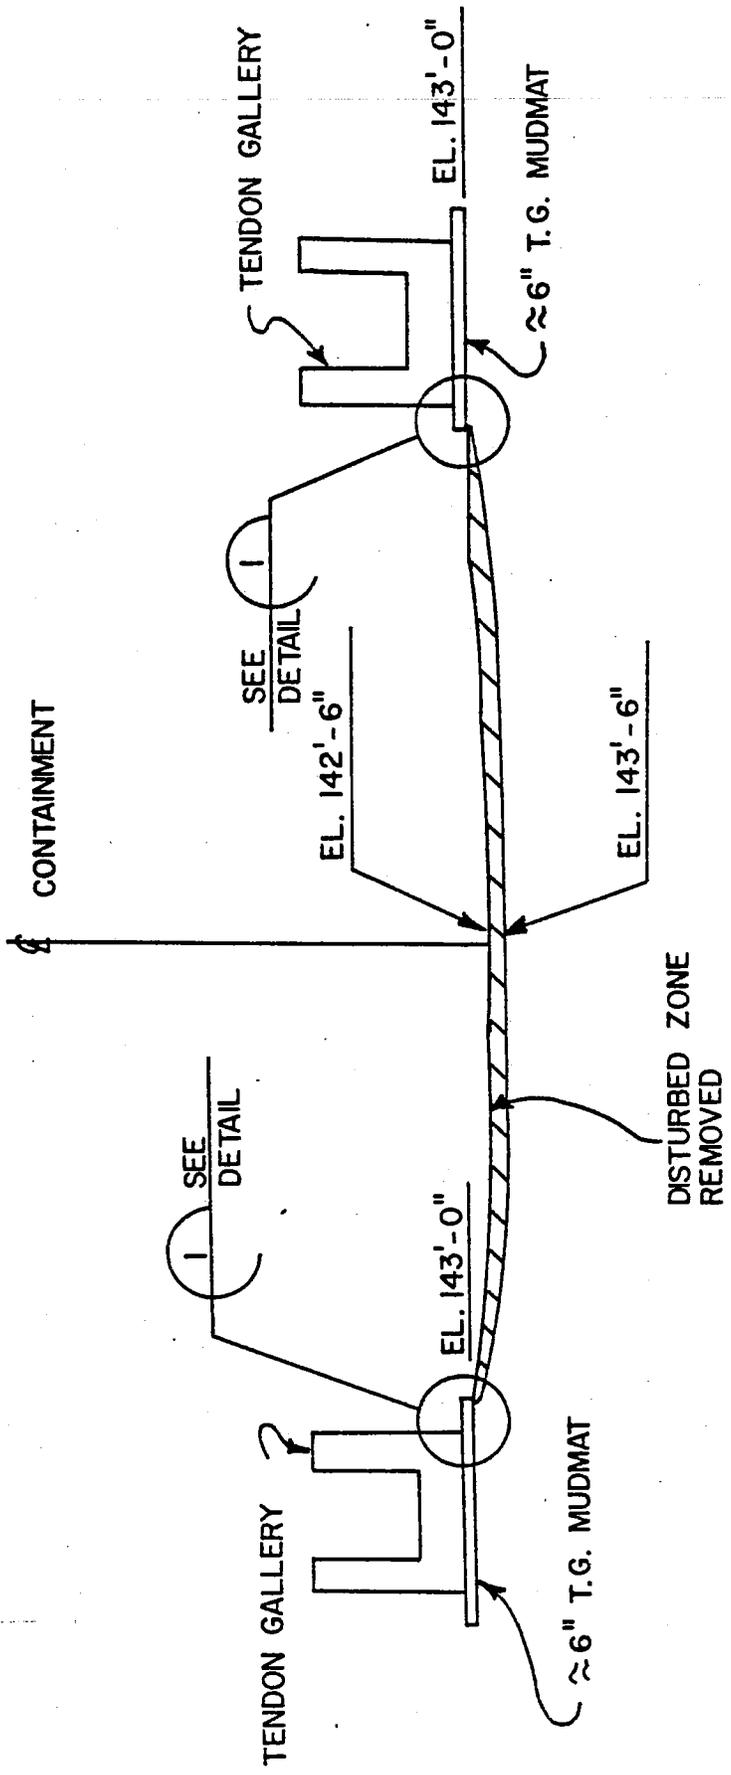
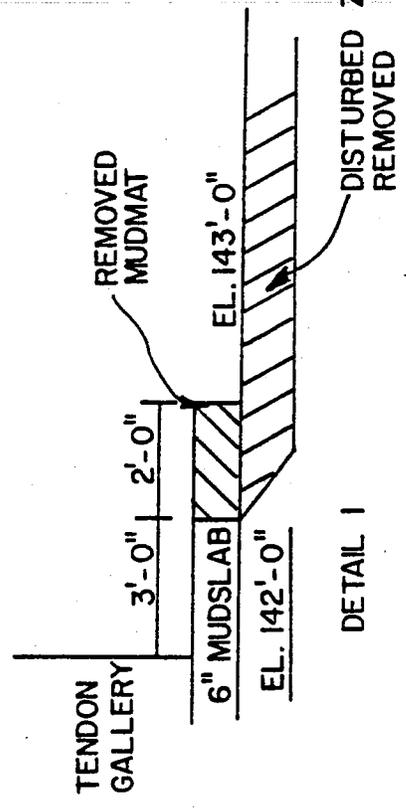
GEORGIA POWER COMPANY ALVIN W. VOGTLE NUCLEAR PLANT	
TYPICAL CROSS SECTION IN UNIT 1 CONTAINMENT AREA SHOWING EXTENT OF DISTURBED ZONE REMOVED	
SCALE:	DRAWING NO.
JOB NO. 9510	FIGURE 11
REV.

Some typical cross-sections of the Containment area showing the extent of loose material removed are shown in Figure 11.

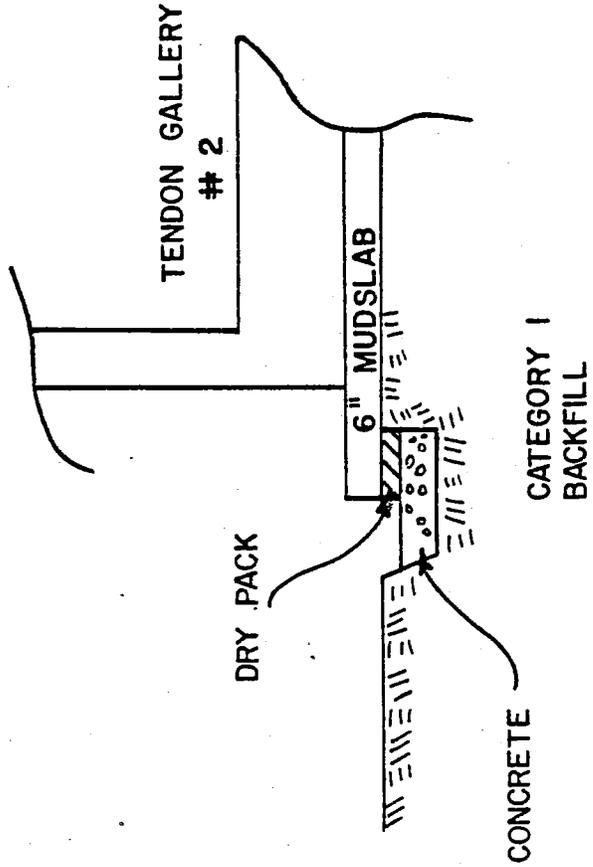
GEORGIA POWER COMPANY ALVIN W. YOGTLE NUCLEAR PLANT	
SKETCH SHOWING PROCEDURE USED TO REPAIR UNIT 2 TENDON GALLERY MUDSLAB	
SCALE:	DRAWING NO.
JOB NO. 9510	REV. FIGURE 14

Immediately after the tests were completed, minor additional erosion occurred as a result of a rainstorm. The area was retested and repaired in accordance with approved procedures. The maximum extent of disturbed backfill under the mudslab was increased to about 10-inches. This situation was remedied by the procedure illustrated in Figure 14 and outlined below.

- a. All loose material was removed from below the mudslab and 1-foot away from it. Proving ring penetrometer tests were made to assure that all disturbed material was removed.
- b. A form was placed 1-foot away from the edge of the mudslab.

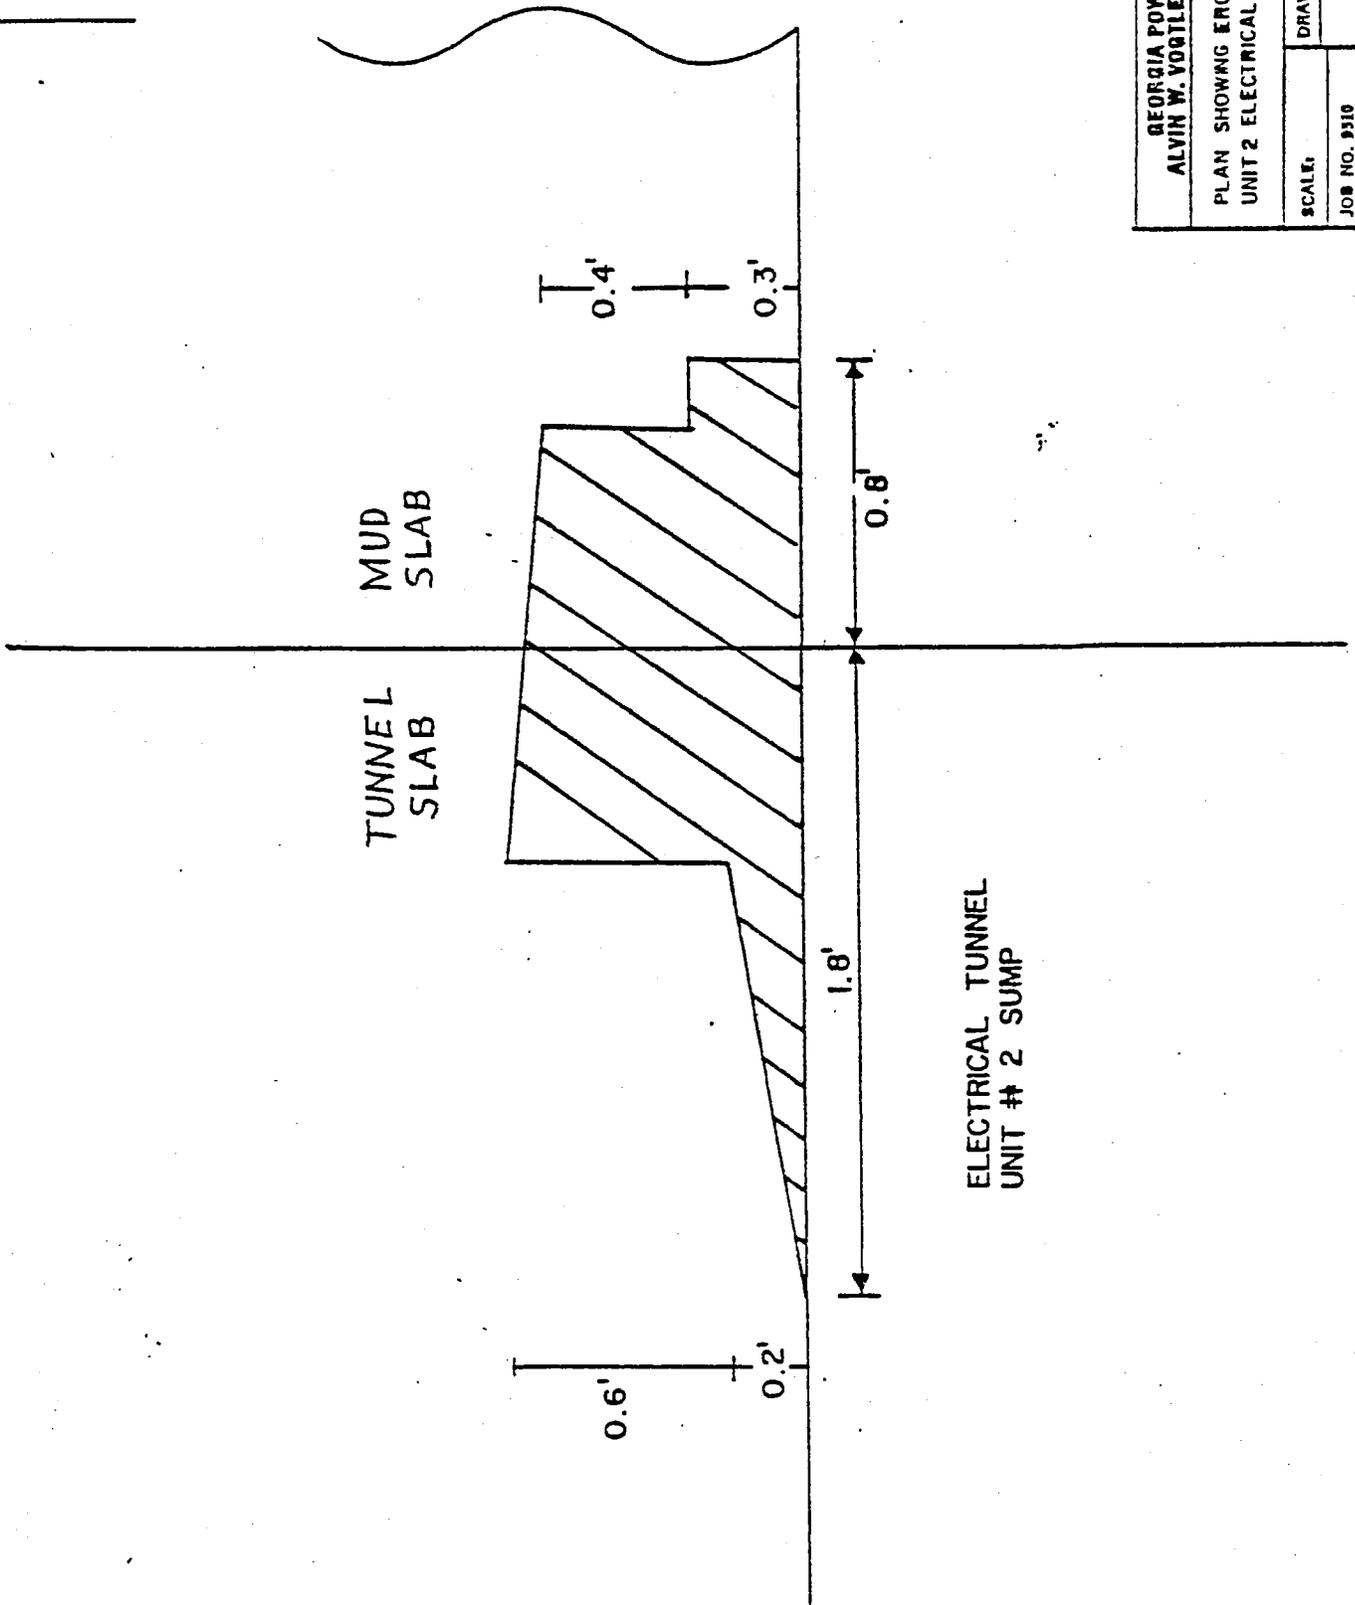
GEORGIA POWER COMPANY ALVIN W. VOORLE NUCLEAR PLANT	
PLAN SHOWING EROSION IN JULY 1980 UNIT 2 ELECTRICAL TUNNEL MUDSLAB	
SCALE:	DRAWING NO. REV.
JOB NO. 9310	FIGURE 15

An additional erosion area occurred below the mudslab of the Electrical Tunnel, Unit 2, in July, 1980. This erosion, was caused by construction water due to a hose failure. The maximum depth of erosion below the basemat was 0.8-feet and it extended approximately 1.8-feet below the tunnel base slab for a distance of approximately 0.8-feet. (See Figure 15). The area was repaired in accordance with approved procedures.

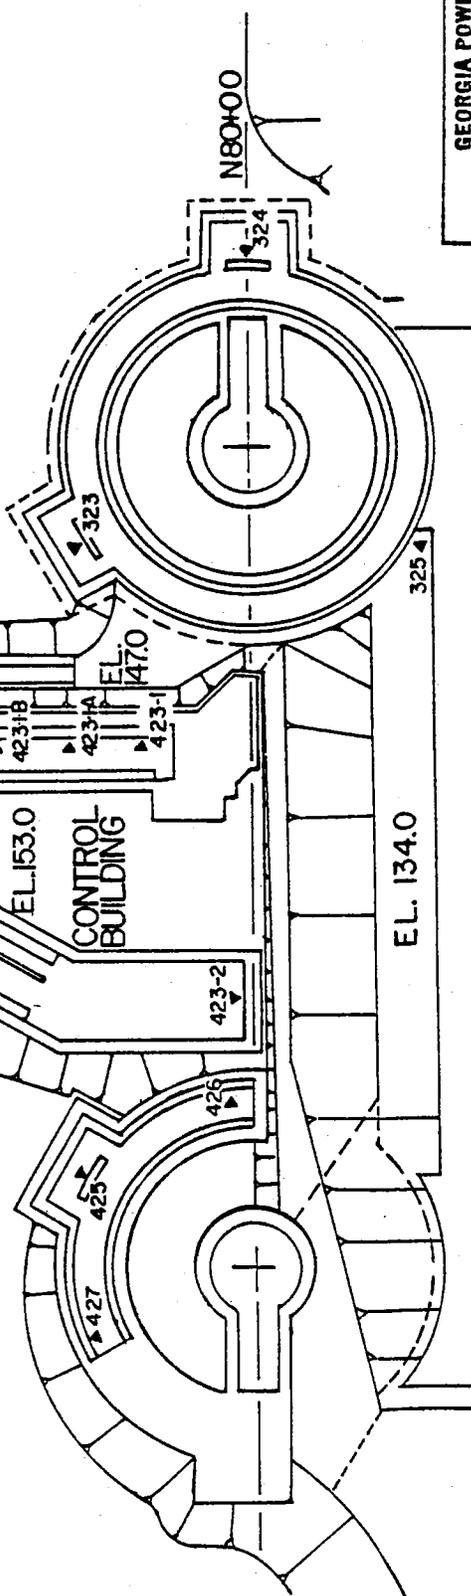
GEORGIA POWER COMPANY ALVIN W. VOGTLE NUCLEAR PLANT	
PLAN SHOWING LOCATIONS OF SETTLEMENT MARKER POINTS	
SCALE:	DRAWING NO.
JOB NO. 9510	FIGURE 16
	REV.

Two settlement markers were installed to monitor settlement of the Tendon Gallery foundation. These markers, designated as Nos. 323 and 324, were located as shown on Figure 16. A plot of settlement versus time for the period January 1 through July 1, 1980, is shown on

Figure 16-1. The plot indicates that the observed settlements to date are small. The maximum settlement recorded is on the order of 0.26 inch, which is reasonable considering the current loading and the limits of the survey accuracy.

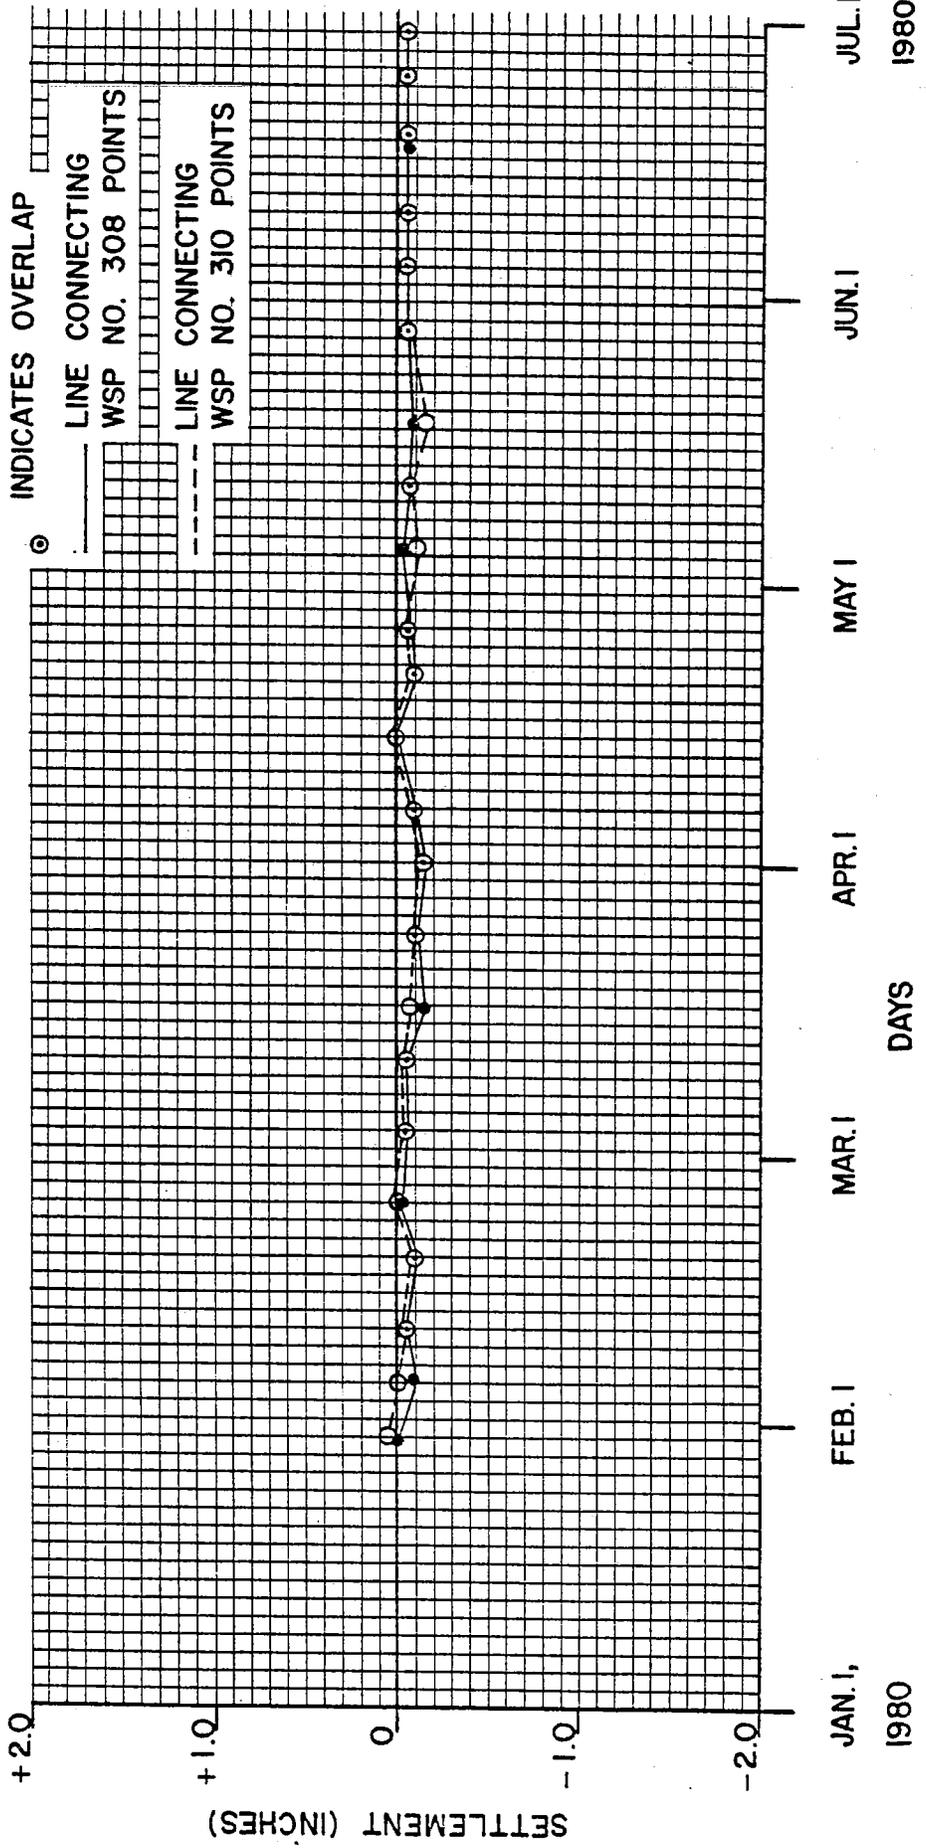
GEORGIA POWER COMPANY ALVIN W. VOGTLE NUCLEAR PLANT	
SETTLEMENT VERSUS TIME FOR TURBINE BUILDING UNITS 1 & 2	
SCALE:	DRAWING NO.
JOB NO. 9510	FIGURE 16-2
	REV.

Settlement of the Turbine Building base slab was monitored by two settlement markers, Nos. 308 and 310 (Figure 16). Readings were taken on a weekly basis during the period January 1 through July 1, 1980. These readings are shown plotted on Figure 16-2. The maximum observed settlement is on the order of 0.16 inch, which is reasonable considering the current loading condition and the limits of the survey accuracy.
