Entergy Nuclear Operations, Inc.
Pilgrim Nuclear Power Station
600 Rocky Hill Road
Plymouth, MA 02360

SUBJECT: Entergy Nuclear Operations, Inc.
Pilgrim Nuclear Power Station
Docket No. 50-293
License No. DPR-35

Revised Request for Authorization under the Provision of
10 CFR 50.55a(a)(3)(i) for Modification of Core Shroud Stabilizer
Assemblies (TAC NO. MD4918)

Information in Support of Proposed Core Shroud Stabilizer Assembly Configuration

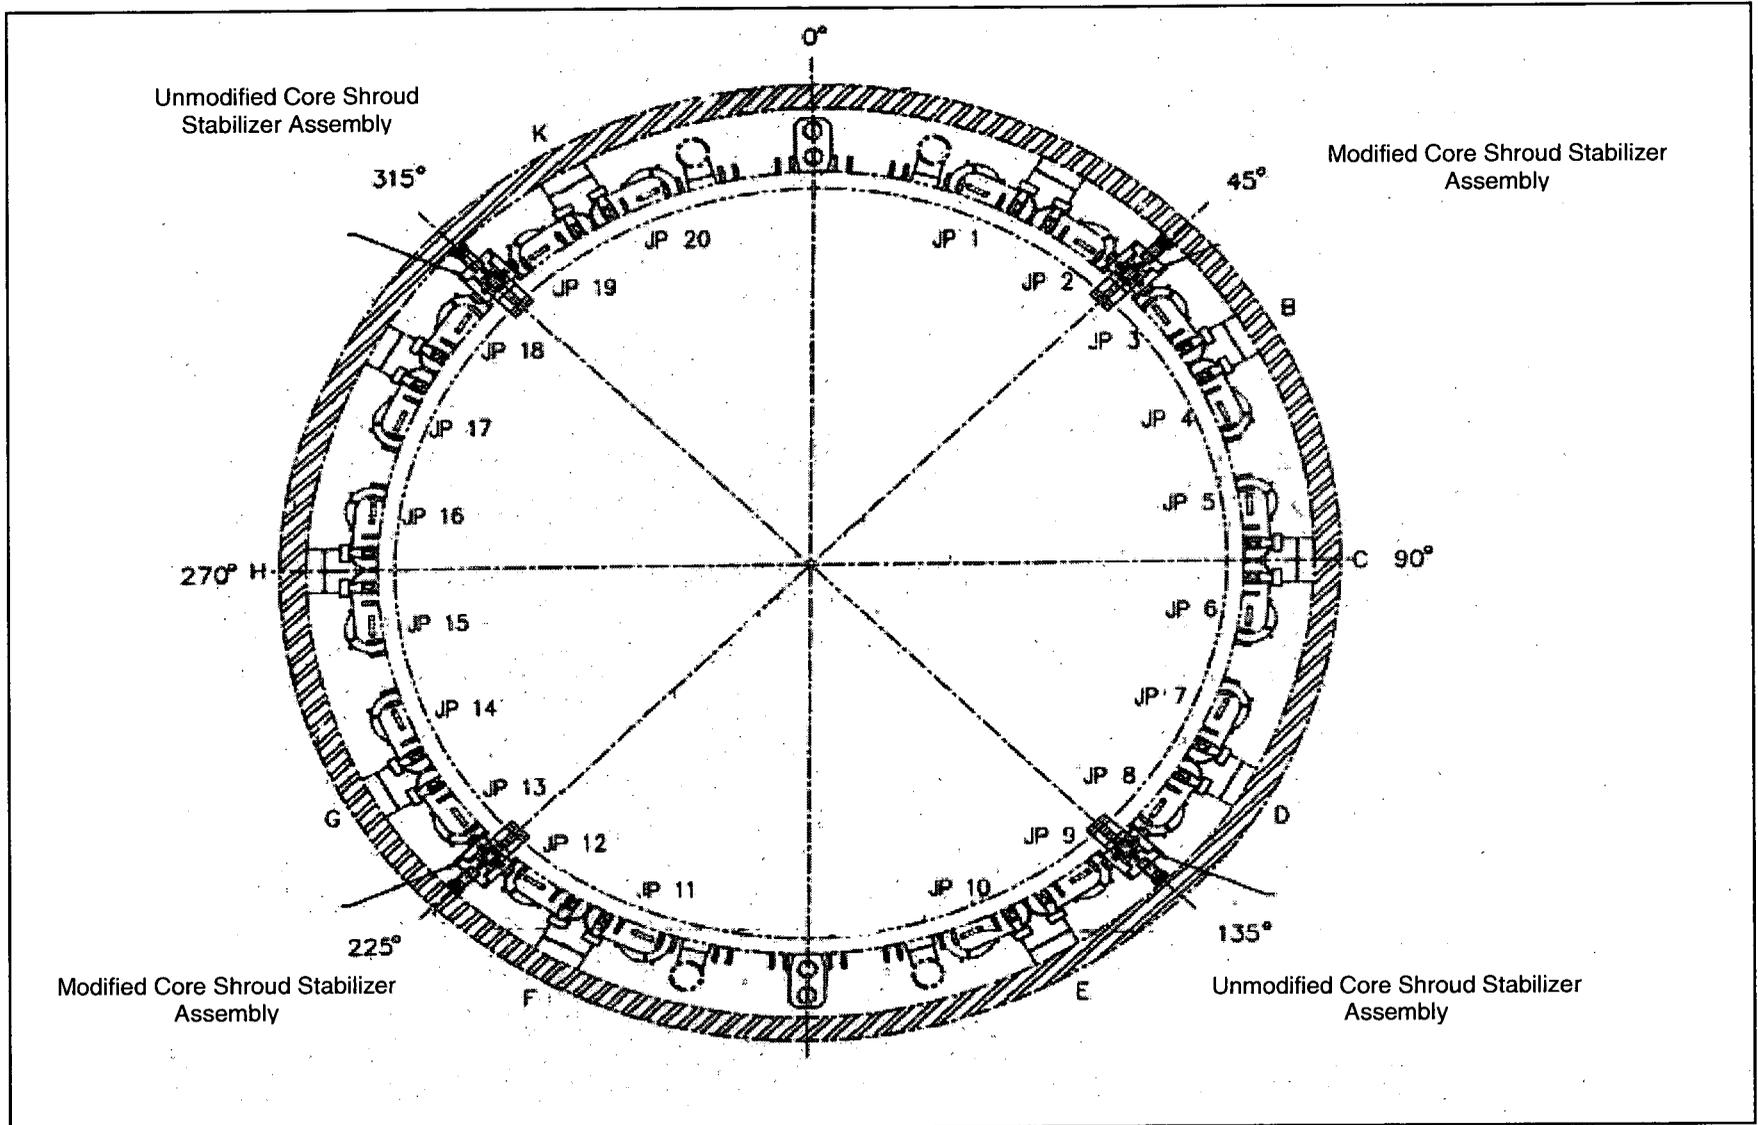
Figure 1: Locations of Core Shroud Stabilizer Assemblies

During RFO-16 Entergy replaced the upper supports and the torsion arm clamps on the 45° and 225° azimuthally located core shroud stabilizer assemblies. However, the upper supports of the 135° and 315° azimuthally located core shroud stabilizer assemblies were not replaced due to difficulties encountered with tooling. Thus, these tie rods and the upper supports of the stabilizer assemblies remain in the configuration reviewed and accepted by the NRC in Reference 5. Figure 1 provides the locations of the core shroud stabilizer assemblies.
