SUBJECT: Entergy Nuclear Operations, Inc.
Pilgrim Nuclear Power Station
Docket No. 50-293
License No. DPR-35

Additional Information Concerning Revised Request for Authorization
under the Provision of 10 CFR 50.55a(a)(3)(i) for Modification of Core
Shroud Stabilizer Assemblies (TAC NO. MD4918)

LETTER NUMBER: 2.07.045

Additional Information In Support of Proposed Core Shroud Stabilizer Assembly Configuration

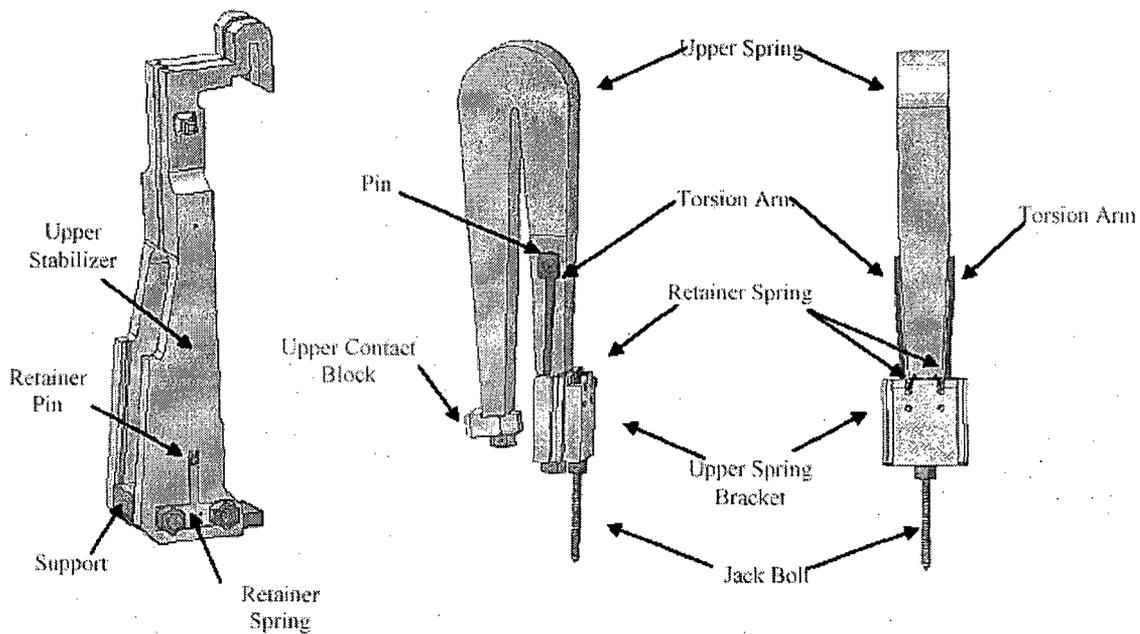
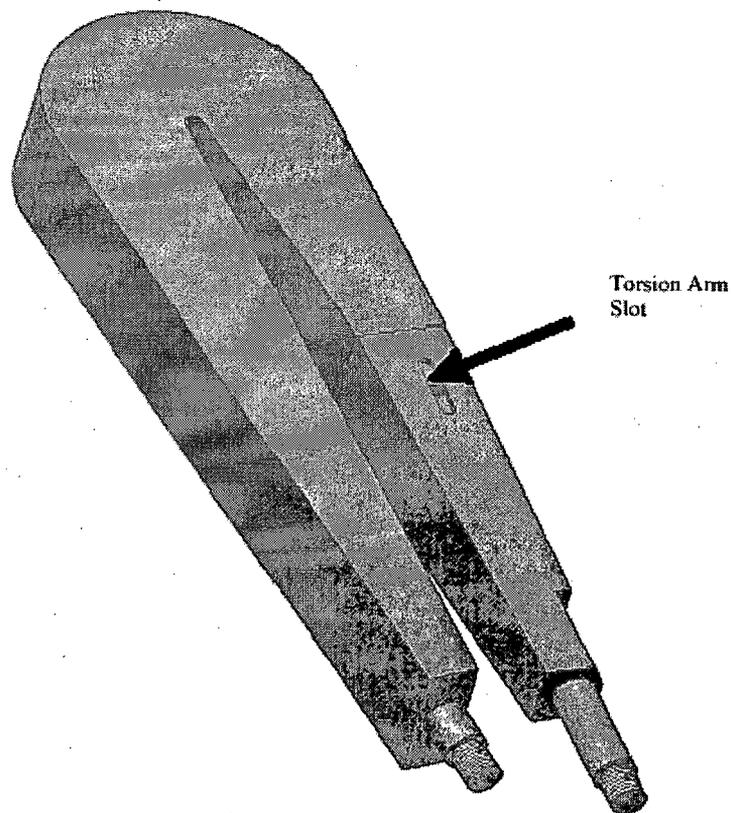
Figure 2

Upper Spring
