SUBJECT: Entergy Nuclear Operations, Inc.
Pilgrim Nuclear Power Station
Docket No. 50-293
License No. DPR-35

Additional Information Concerning Revised Request for Authorization
under the Provision of 10 CFR 50.55a(a)(3)(i) for Modification of Core
Shroud Stabilizer Assemblies (TAC NO. MD4918)

Additional Information In Support of Proposed Core Shroud Stabilizer Assembly Configuration

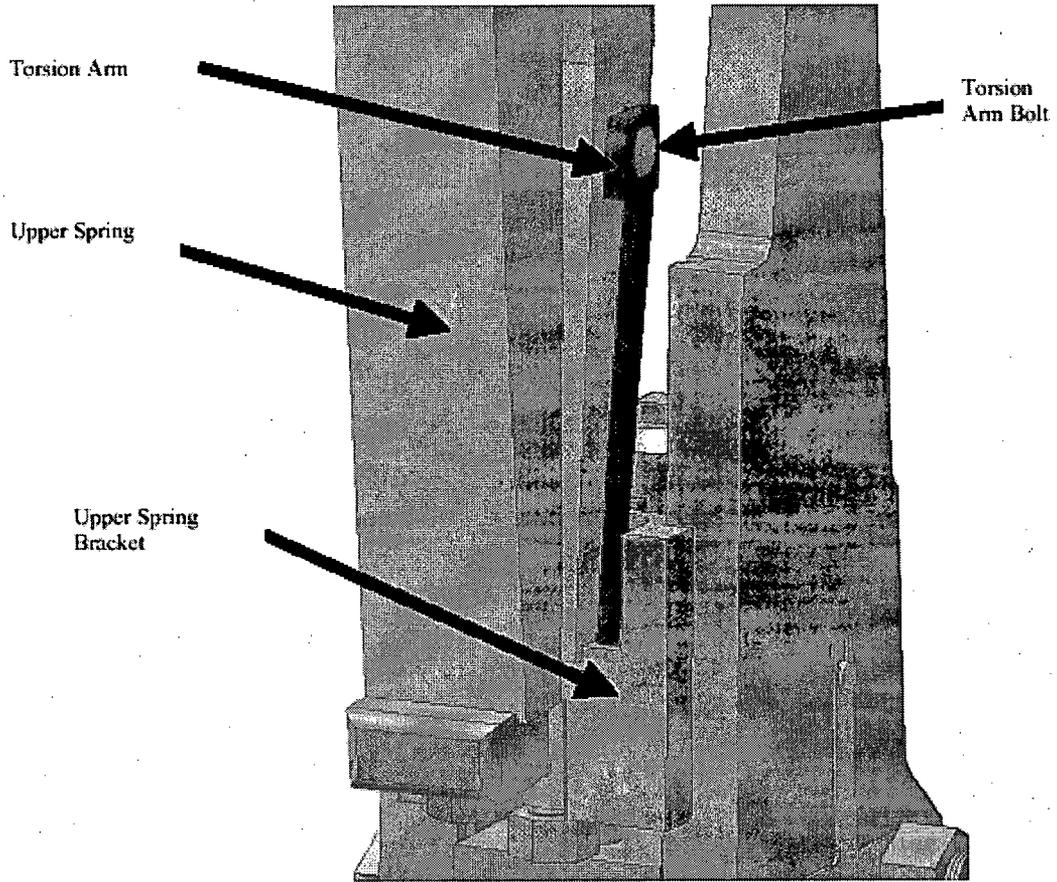
Figure 1

The torsion arm assembly and torsion arm clamp are shown in Figures 1, 2, 3, and 4.

The nominal rotation is 4.2°. Considering the tolerances, the maximum rotation is 5° in each direction

Upper Spring to Upper Spring Bracket Connection

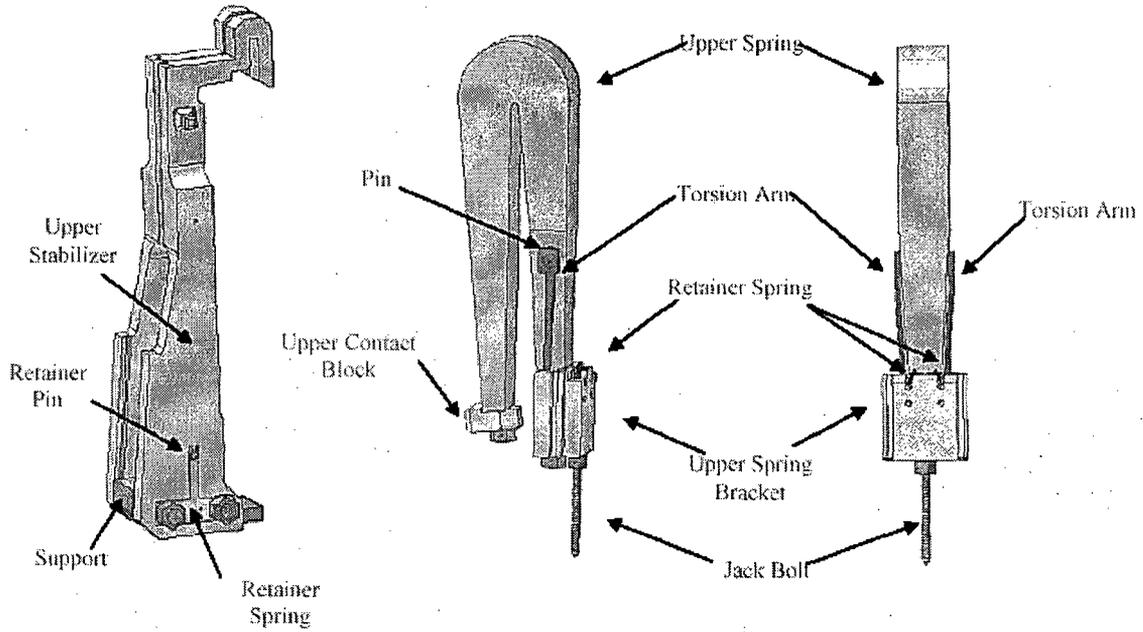
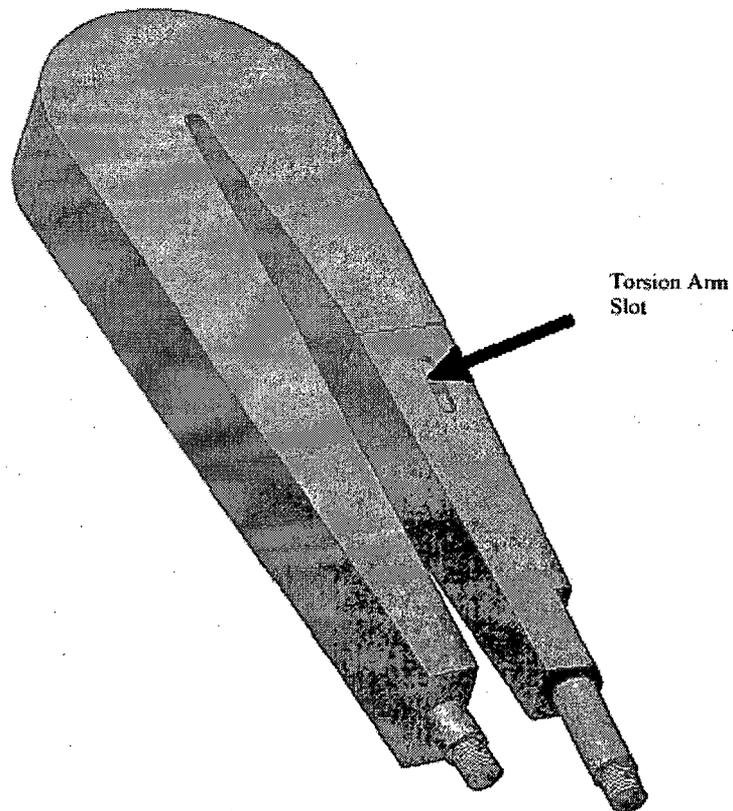
Figure 2

Upper Spring

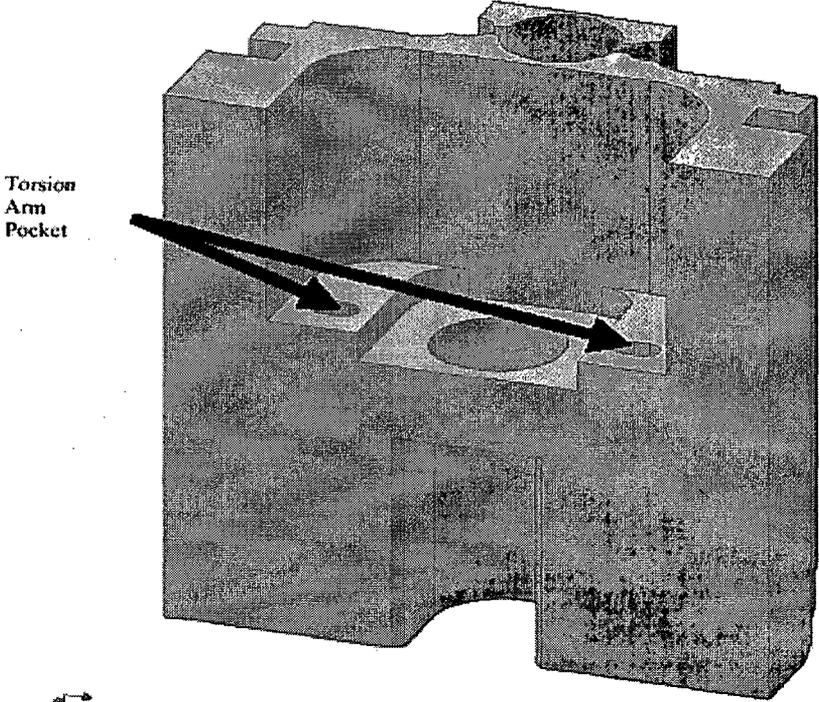
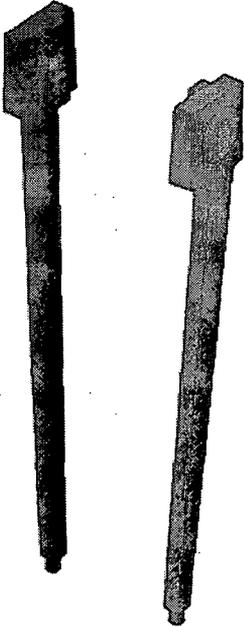
Torsion Arms
Figure 3

Upper Spring Bracket
