SUBJECT: FORT CALHOUN STATION - NRC SPECIAL INSPECTION
REPORT 05000285/2007006

IR 05000285/2007006; 02/20-04/09/2007; Fort Calhoun Station, Special inspection to evaluate ABB circuit breaker failures.

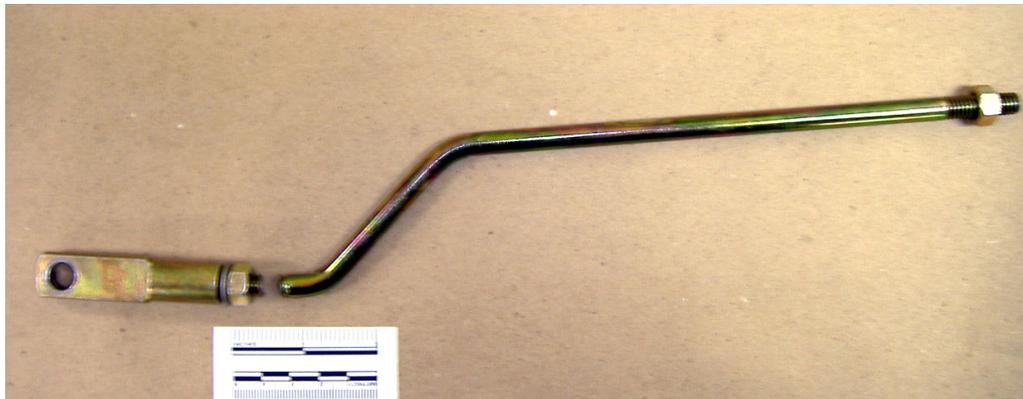
The team concluded that the January 25 and February 8, 2007, raw water pump breaker failures were due to inadequate design of the mechanism operated contact switch linkage arm used to adapt the ABB circuit breakers to the General Electric cubicles during the 1995 period. Both linkage arms failed at the same location (Figure 1) due to reverse bending fatigue. The number of operating cycles on the failed breakers were 1222 cycles, for raw water Pump AC-10B, and 1728 cycles for raw water Pump AC-10C. Replacement arms, manufactured to the same design specifications, also failed during laboratory testing due to reverse bending fatigue. The replacement arms, however, underwent additional stress cycles prior to failure. The inspectors concluded that the failure could have been predicted based on the linkage arm geometry, the static and cyclic stress induced on the component by the breaker and mechanism operated contact switch spring, and material used in the construction.

Figure 1 - Failed Mechanism Operated Contact Linkage Arm

The mechanism operated contact switch is aligned with the breaker by a mechanical linkage arm and changes position as the breaker either opens or closes. The mechanism operated contact switch is located in the breaker cubicle and is not physically part of the breaker (Figure 2). The broken linkage arms resulted in failure of the raw water pump discharge valves to open during the pump starting sequence on January 25 and February 8, 2007. The normally-closed discharge valve receives an open signal after the pump breaker closes. The valve open-signal is generated when the mechanism operated contact switch changes position. The broken linkage arm resulted in the failure to complete the circuit.

testing confirmed that the failure mechanism was reverse bending fatigue. Based on the Weibull Analysis, OPPD concluded that no linkage arm failures were likely to occur prior to 1000 breaker cycles (97.5 percent confidence).

OPPD concluded the root cause of the linkage arm failures was a less than adequate process for identification of critical interface/operating configurations when specifying the replacement breaker procurement requirements. Specifically, OPPD failed to identify the usage of the "test flag" as a critical constraint during the 1994 breaker modification procurement. The OPPD purchase contract for the breaker modifications required "the circuit breakers, with interrupter, are otherwise identical to and interchangeable with the existing General Electric Magna-Blast air-magnetic circuit breakers." The purchase specification did not include use of the "test flag" or a requirement to perform production testing with the "test flag." Use of the "test flag" increased the linkage arm stress, aggravating the reverse bending fatigue.

- Evaluation of material change for mechanism operated contact switch linkage arms to obtain reliable operation
- Develop replacement schedule or strategy to address rod replacement needs
- Revise procedure for "test flag" installation
- Provide administrative control for tracking mechanism operated contact switch linkage arms

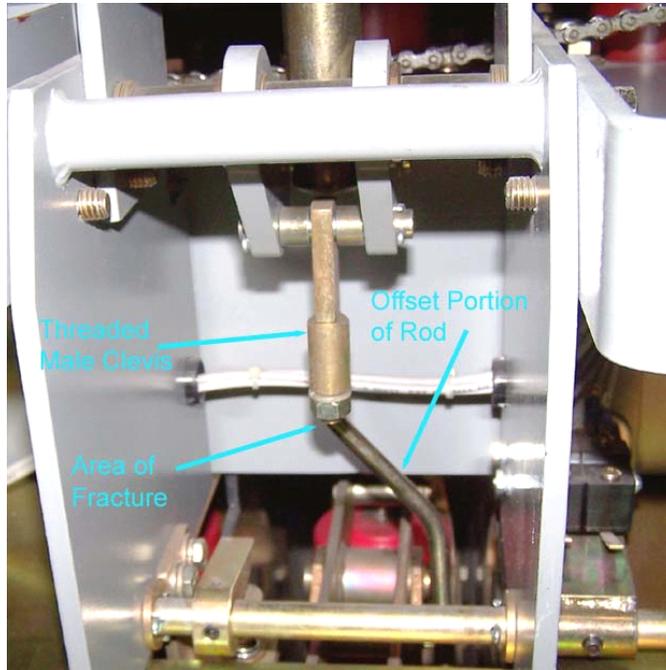
Figure 2 - Linkage Arm Installed in Modified 4160 Volt Breaker
