RF-16 Emergent Activities

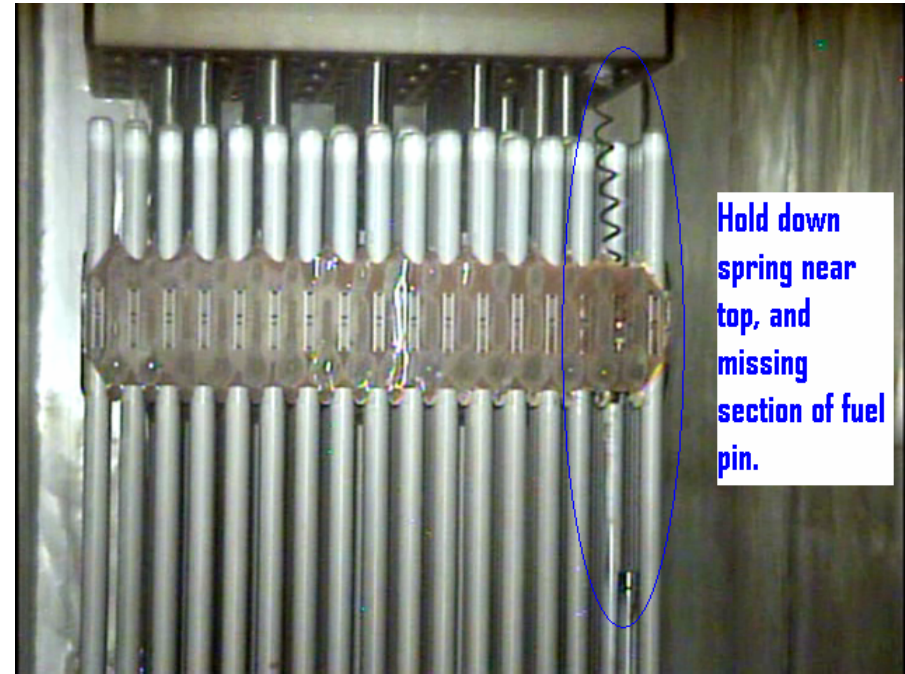
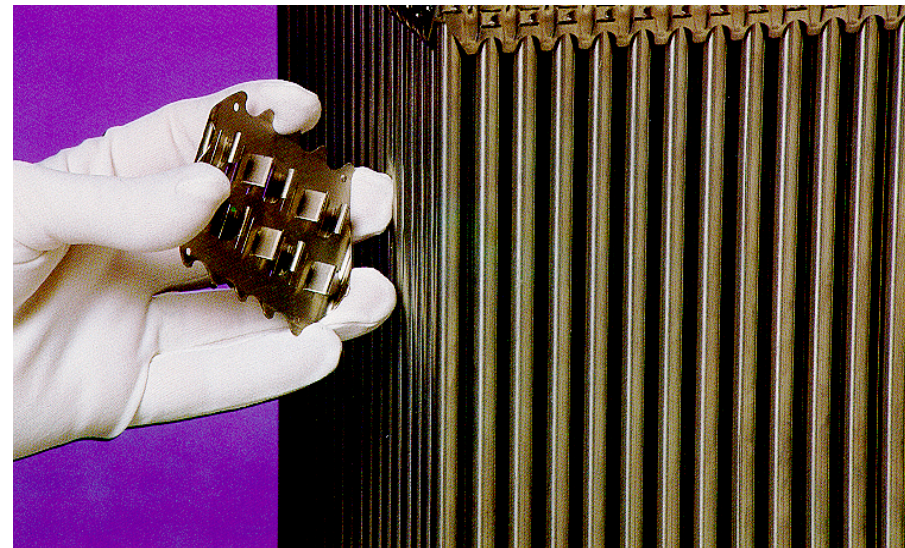
Failed Fuel:

- *Identified Assembly via In Mast Sipping and Visual Inspection*
- *Cause Determined to be Baffle Jetting*
- *Installed Clips to Prevent Recurrence*
- *Perform Upflow Modification in RF-18*
