Subject: Sequoyah Fuels Corporation, Docket – 40-8027
Response to OIs on the Final Safety Evaluation Report –
Reclamation Plan (TAC L52511)

REPORT
FOR
SEQUOYAH FUELS CORPORATION
DISPOSAL CELL PROJECT

SOUTER QUARRY
RIP RAP SUITABILITY STUDY

PREPARED BY
KENNETH SCHLAG, P.G.
CONSULTING GEOLOGIST
April 22, 2007

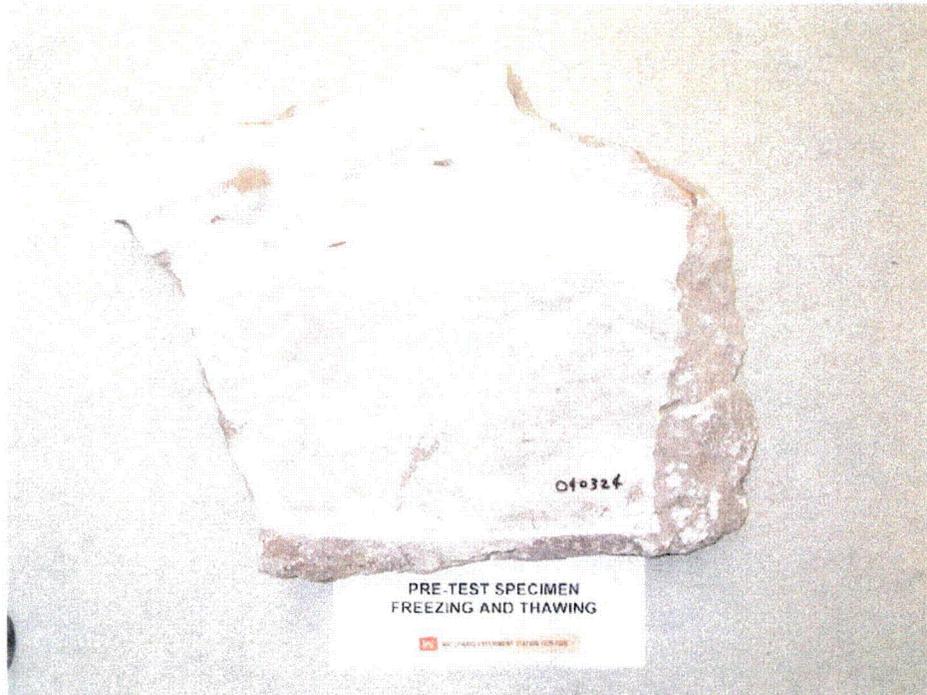
Photograph 1. Stone 040324a before subjected to 20 cycles of freezing and thawing.

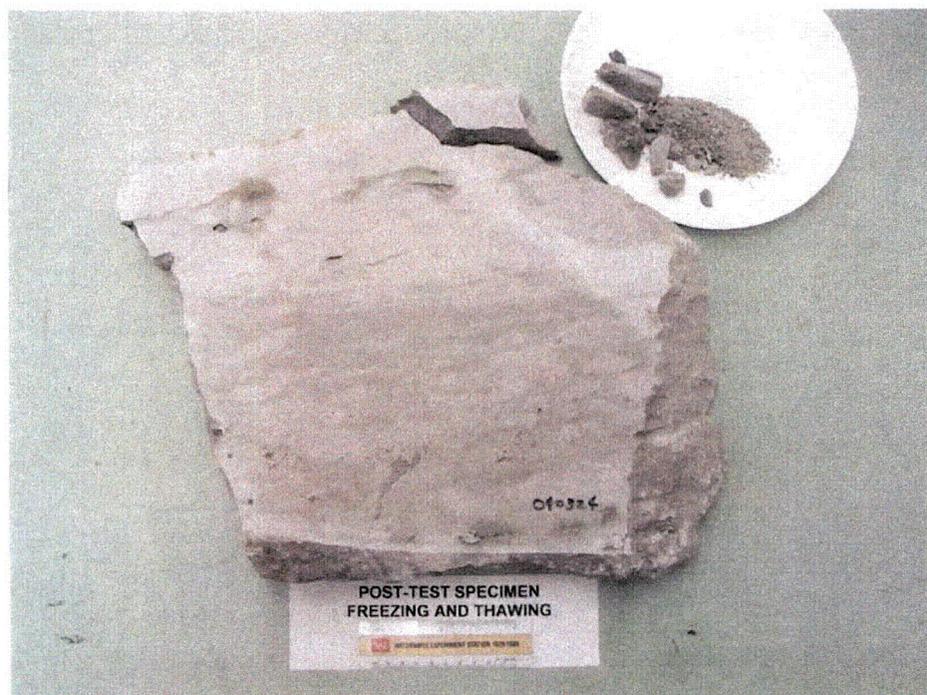
The results of the resistance to cycles of freezing and thawing test, CRD-C 144, indicated the stones exhibited a loss of only 2.6% following 20 cycles of freezing and thawing. Photographs of the pre-test condition and post-test condition of each test slab are enclosed in Appendix B.

Photograph 2. Stone 040324a after exposed to 20 cycles of freezing and thawing. Results are based upon largest remaining piece.

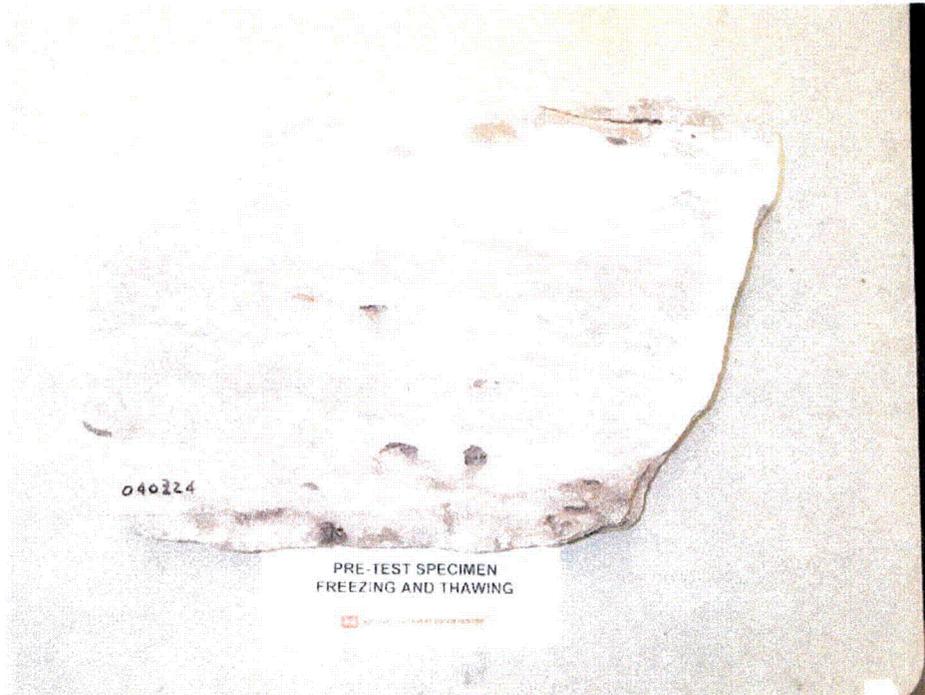
Photograph 3. Stone 040324b before subjected to 20 cycles of freezing and thawing.

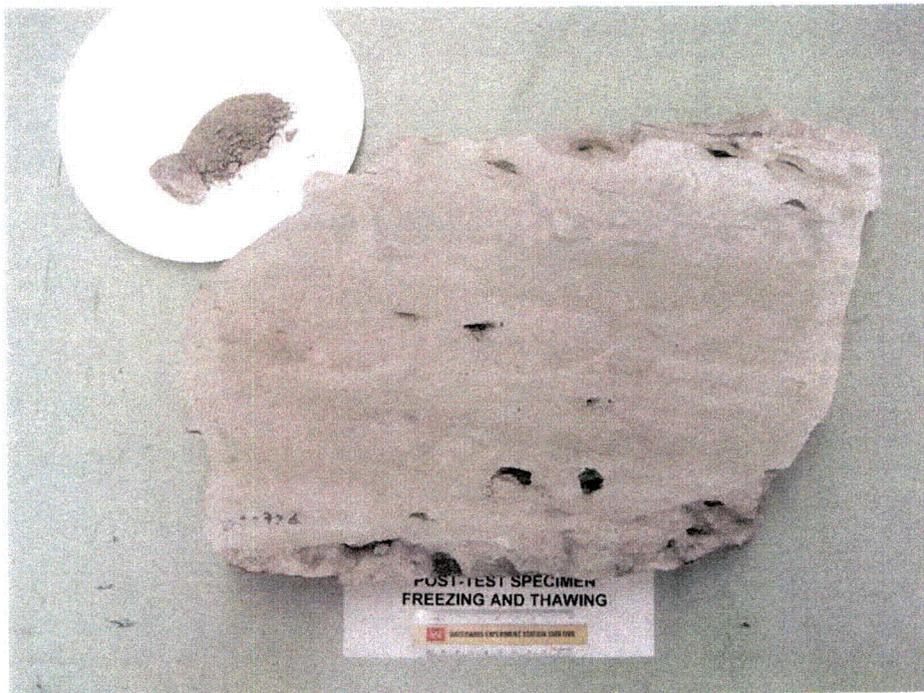
Photograph 4. Stone 040324b after exposed to 20 cycles of freezing and thawing.

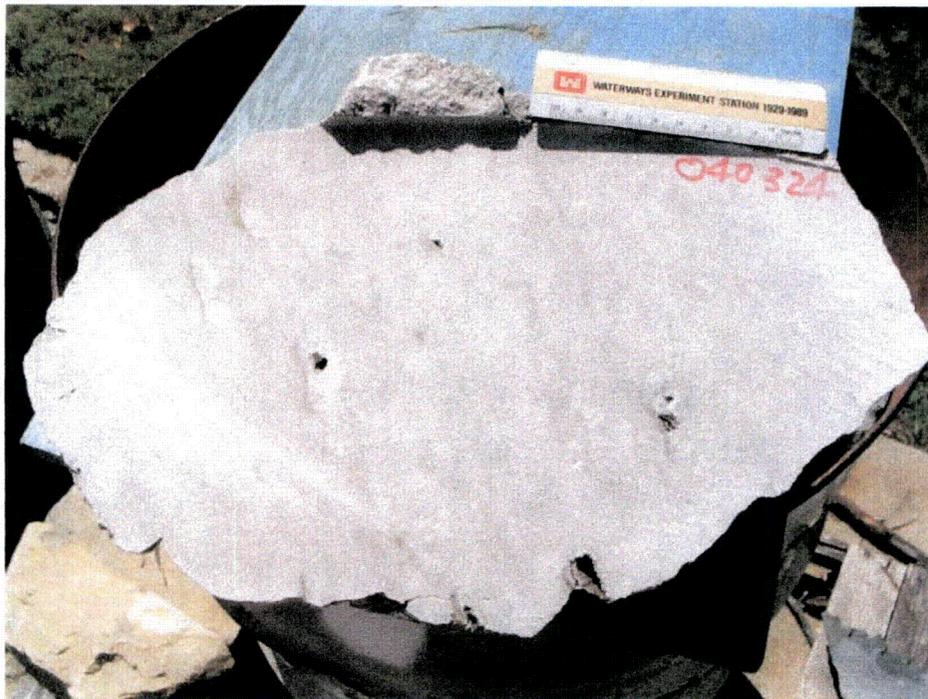
1. Sample 040324 is a large boulder-sized gray rock (Figure 1). The rock appeared to be a fine-grained fossiliferous limestone with a few vuggy holes partially filled with more coarse-grained crystals of calcite.

Figure 1. Photograph of rock sample CMB No. 040324

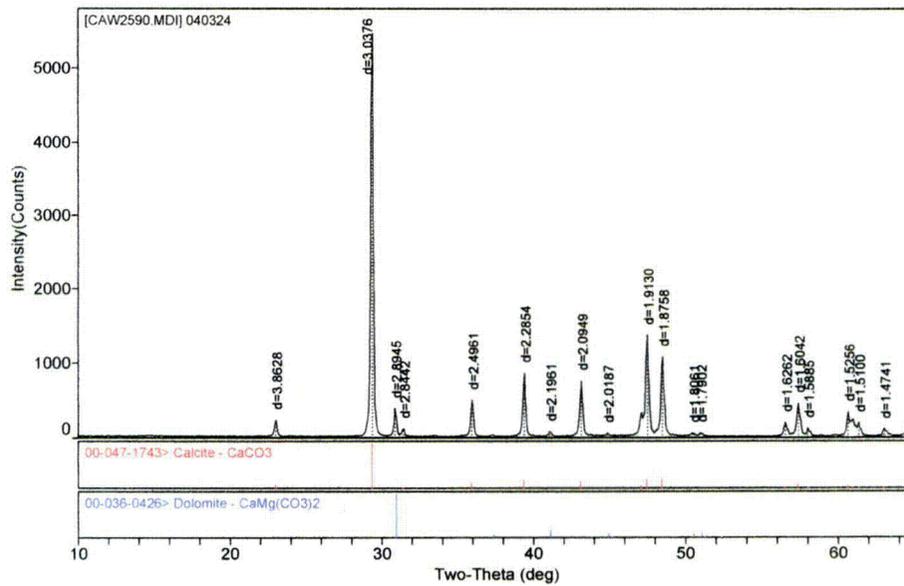
3. The XRD pattern of the sample is given in Figure 1. The sample is principally calcite with minor dolomite present. The presence of clay minerals was not observed.

Figure 1. X-ray diffraction pattern of bulk sample of sample 040324.

4. The mineralogy of the sample as determined by XRD analysis does not indicate that there would be any phases present that would cause a problem if the rock was subjected to freezing and thawing conditions.

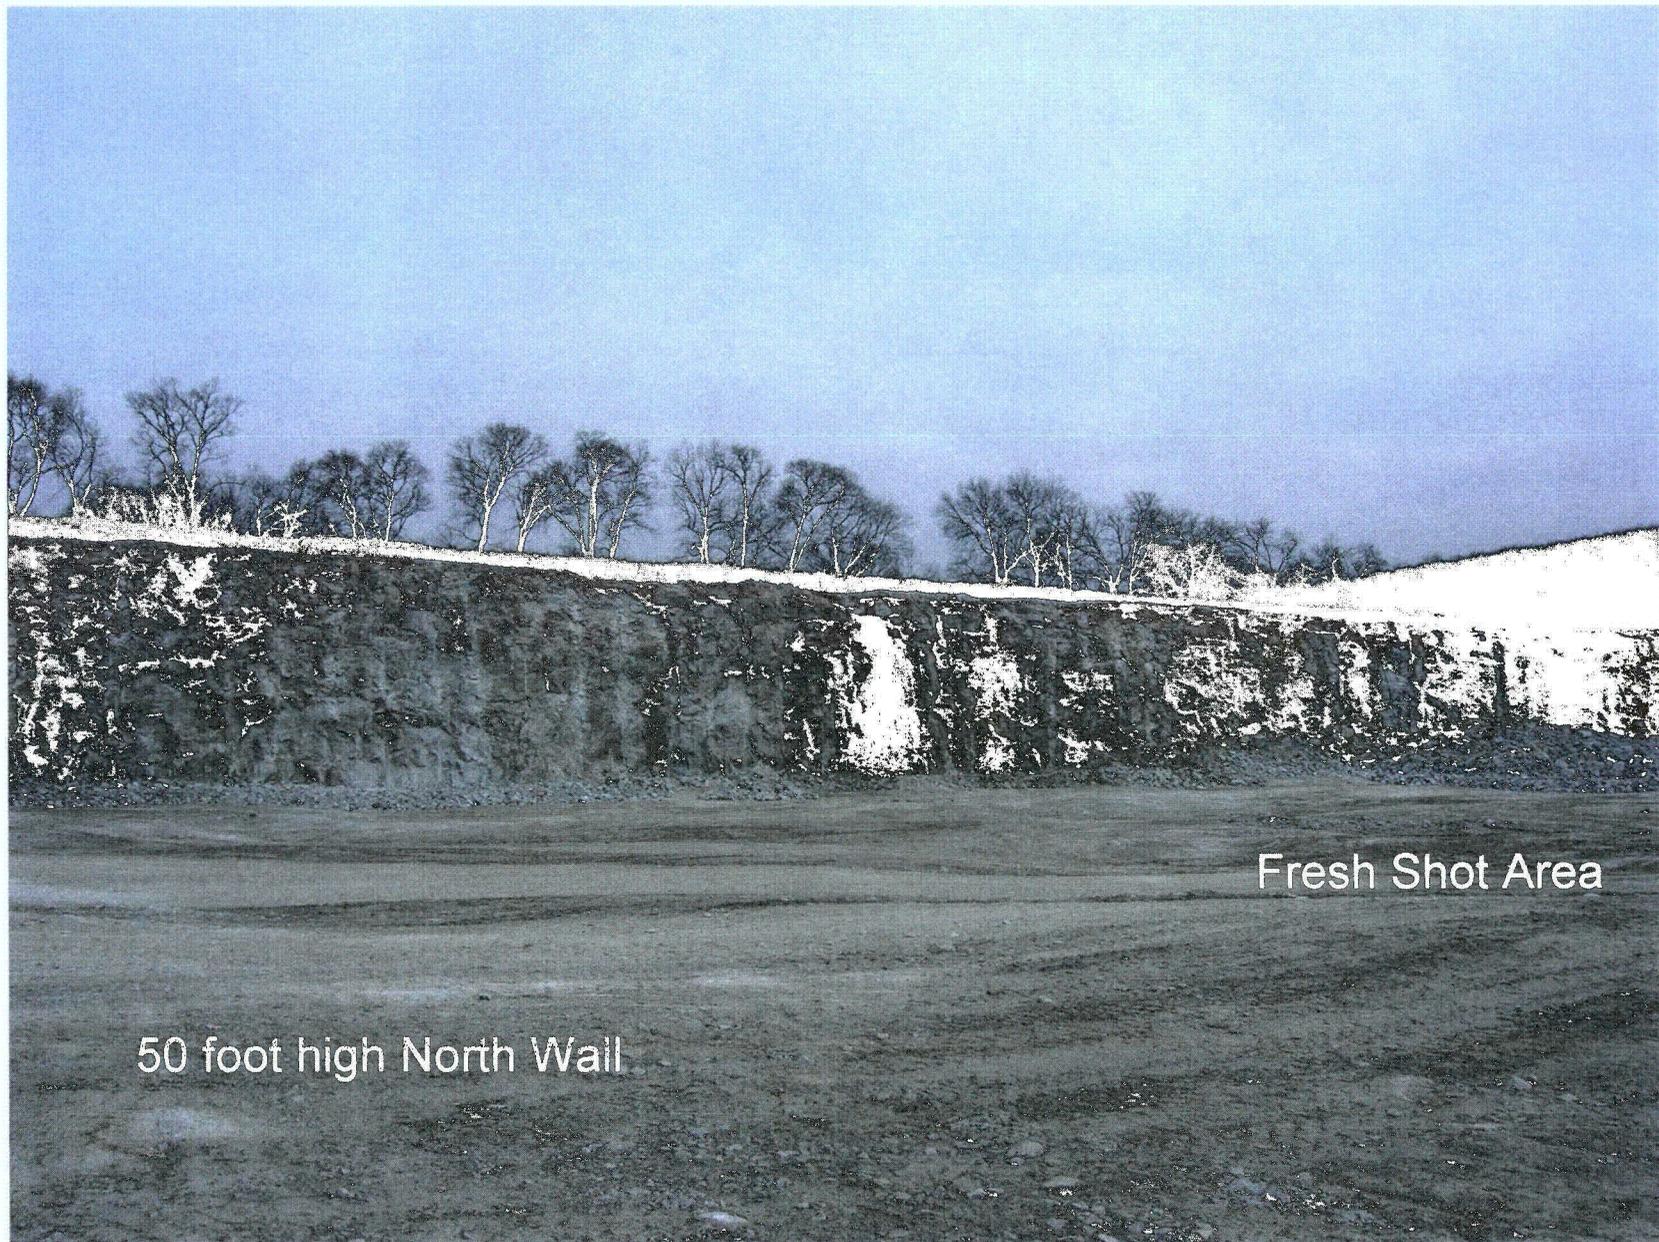
Figure C-1

50 foot high North Wall

Fresh Shot Area

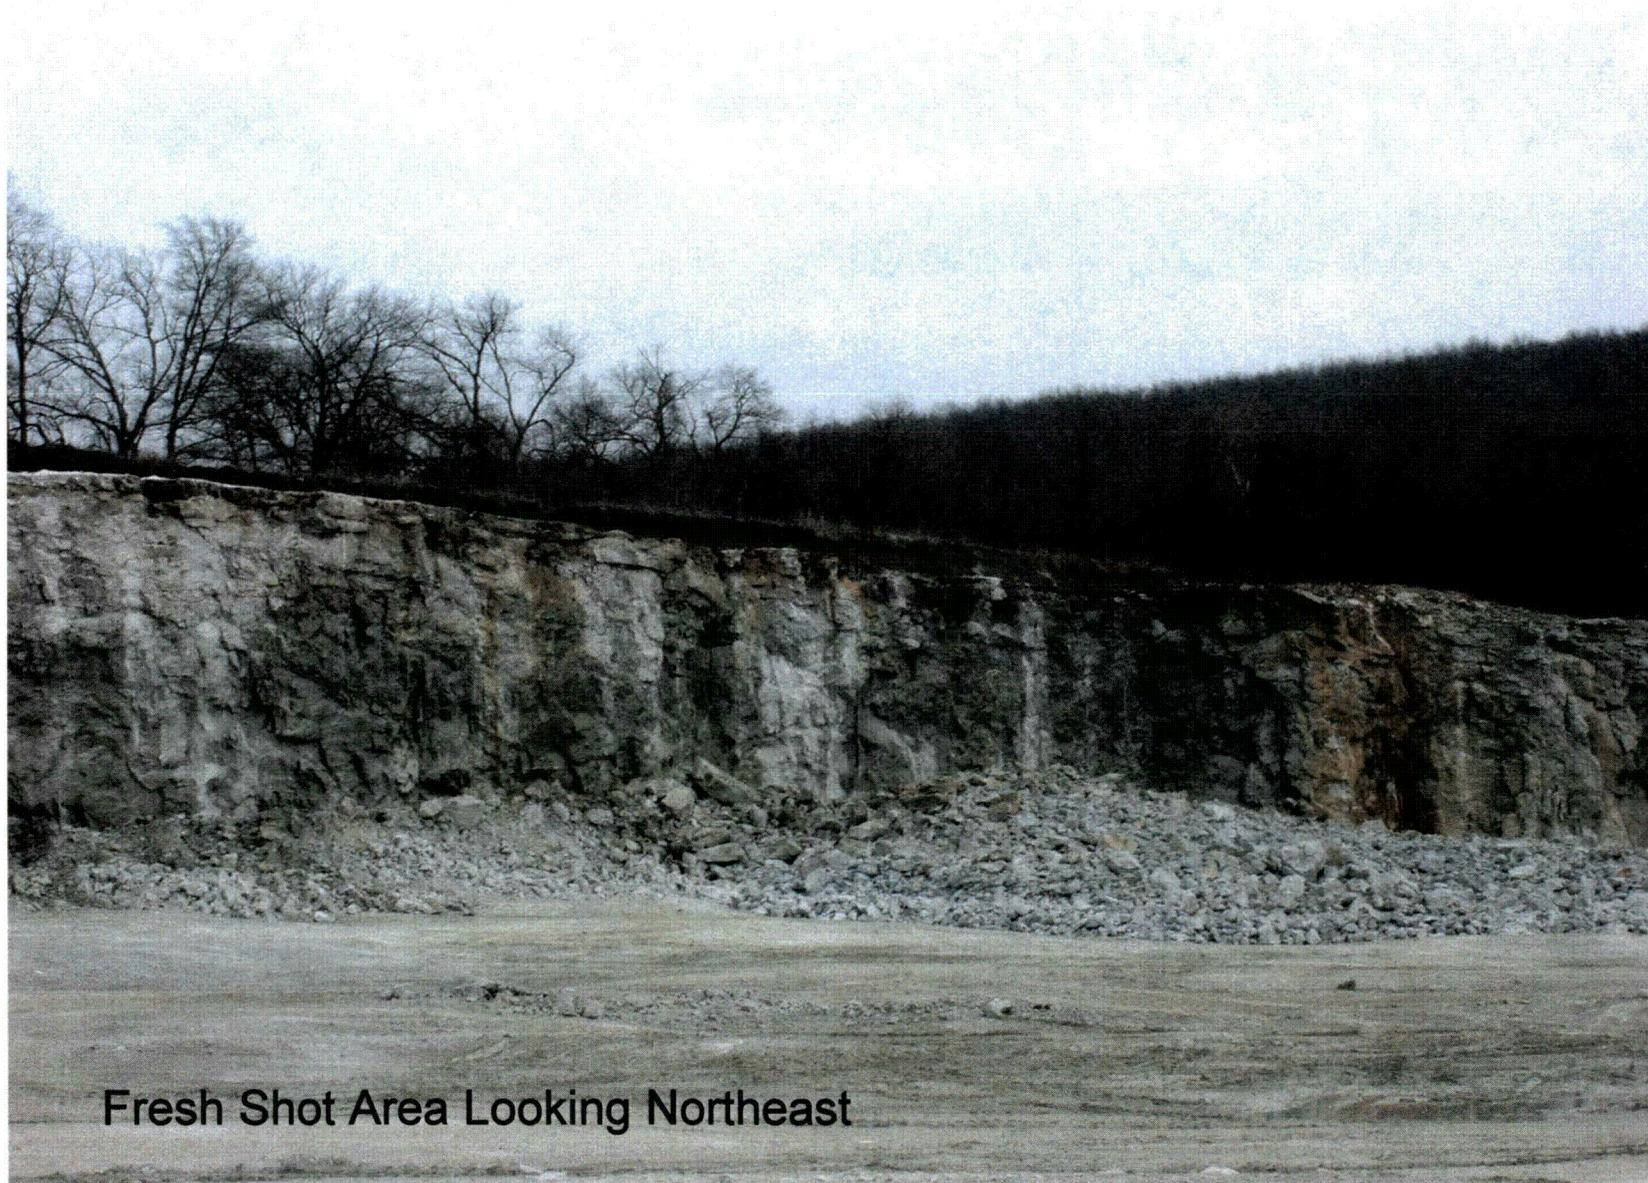
Figure C-2

Fresh Shot Area Looking Northeast

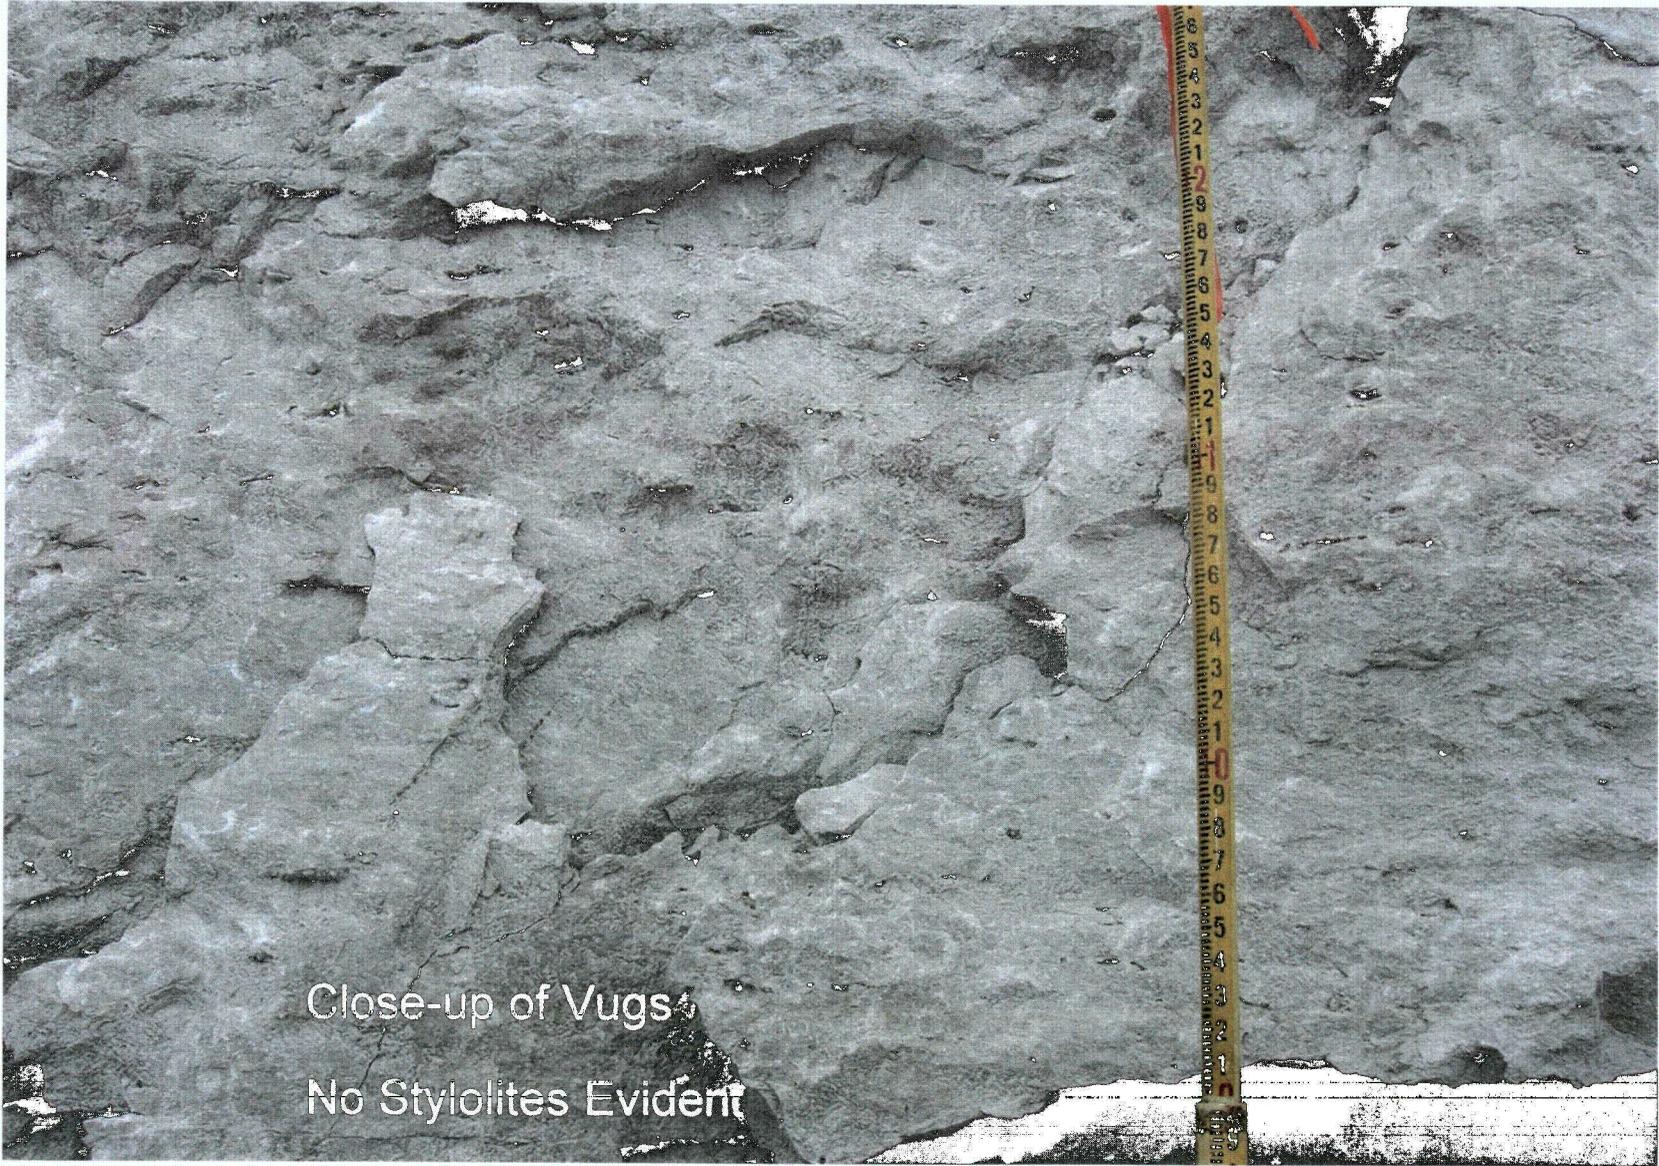
Figure C-6

Close-up of Vugs
No Stylolites Evident

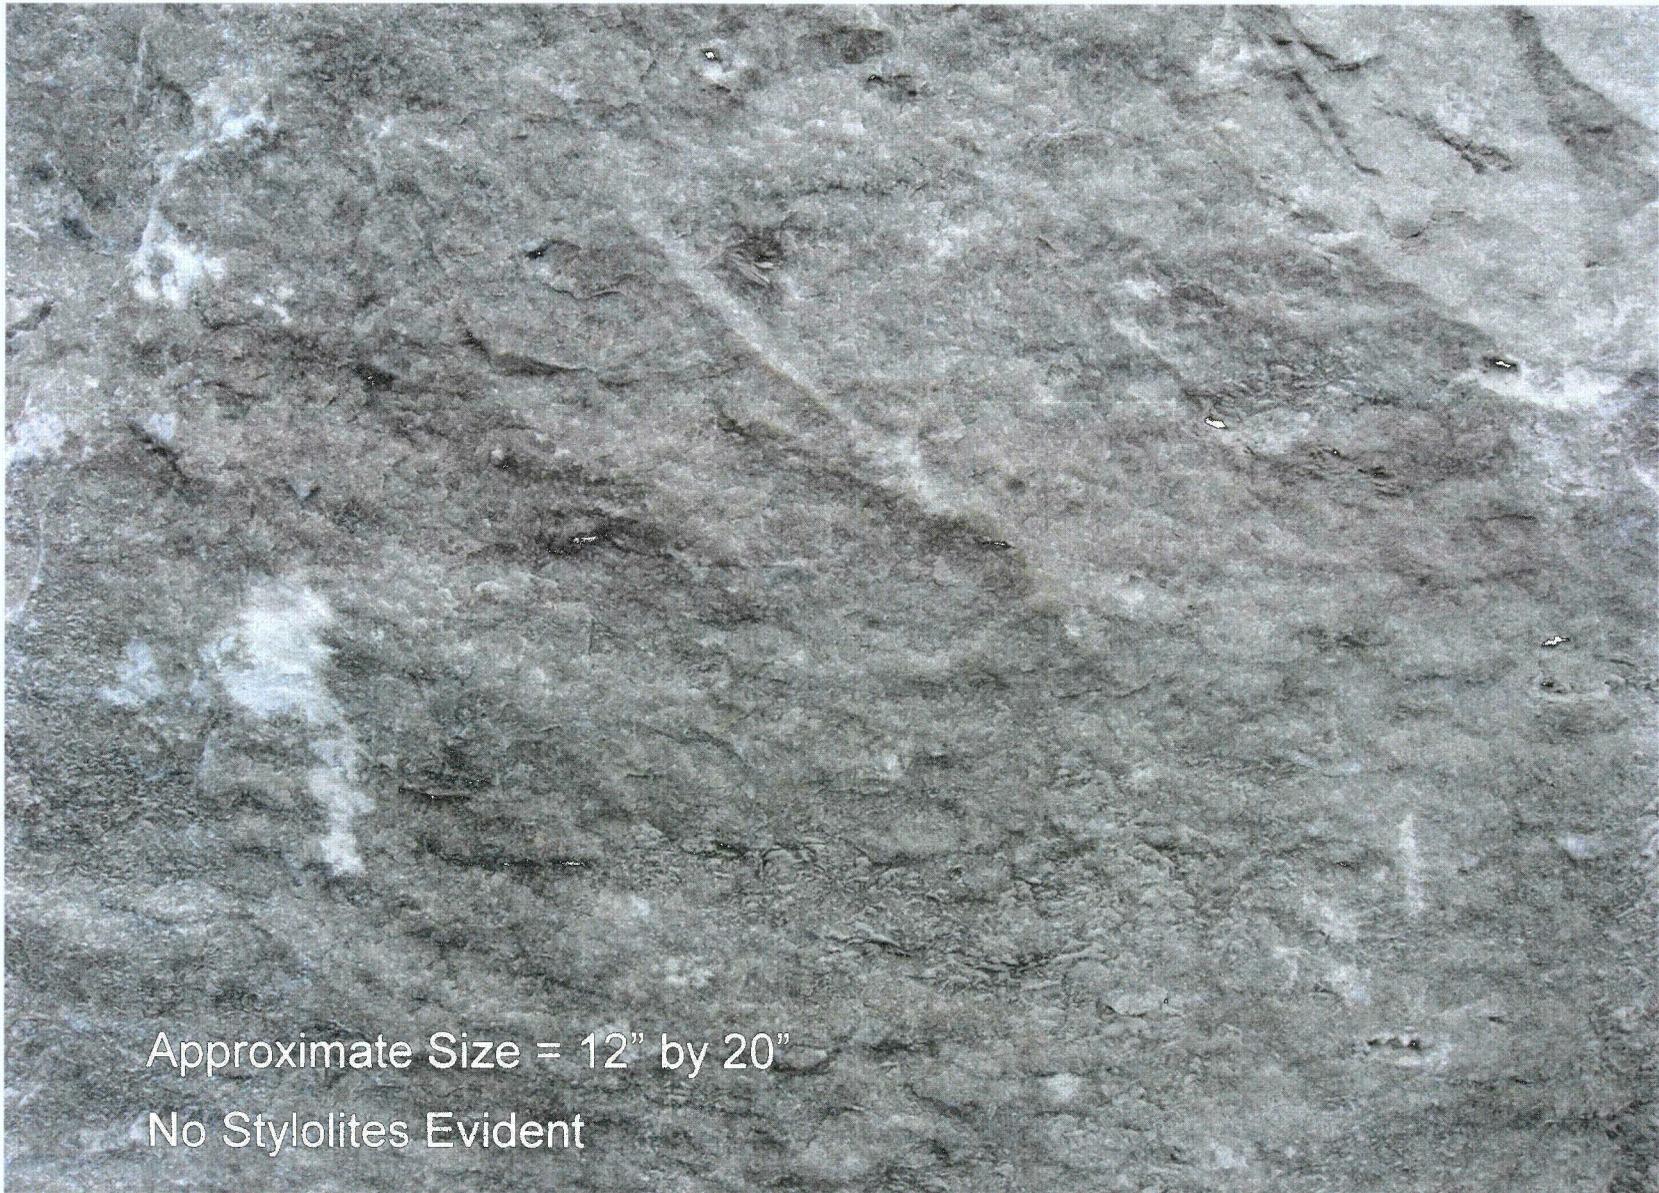
Figure C-7

Approximate Size = 12" by 20"
No Stylolites Evident

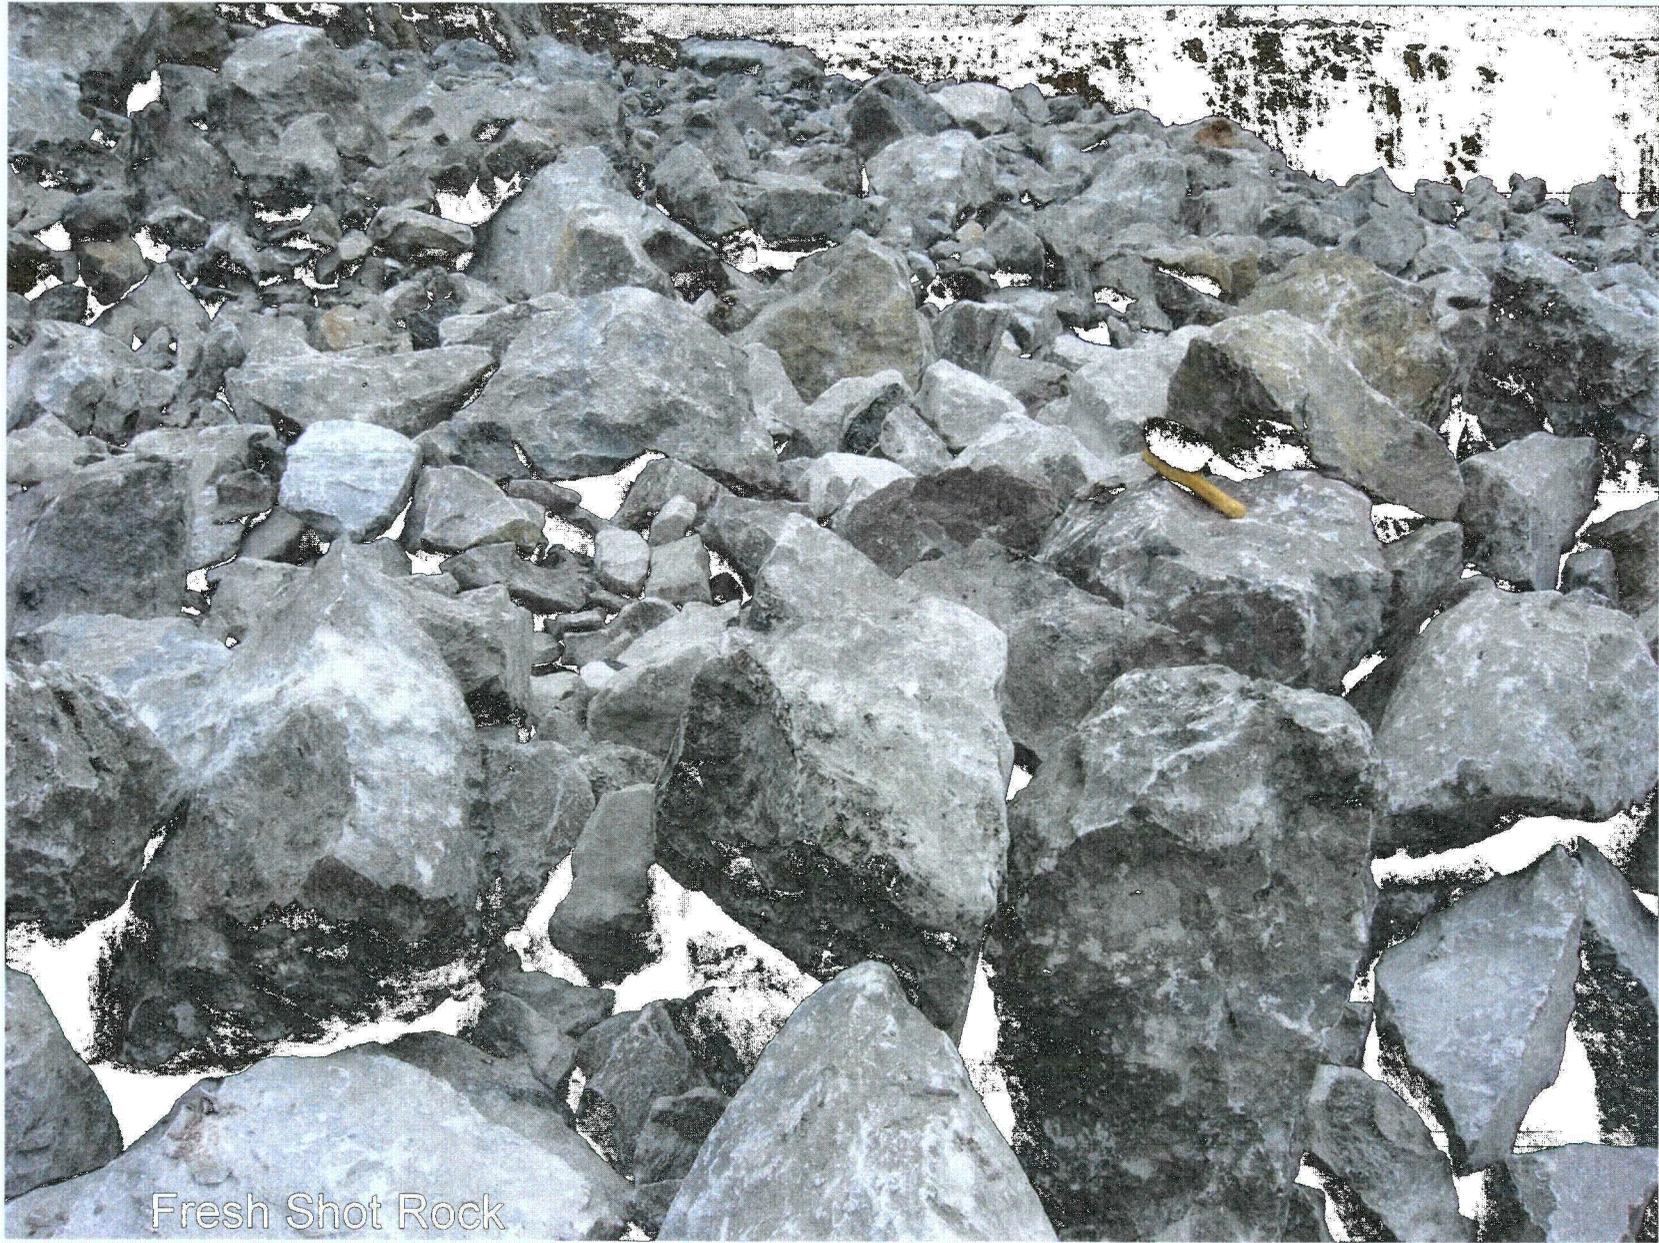
Figure D-1

Fresh Shot Rock

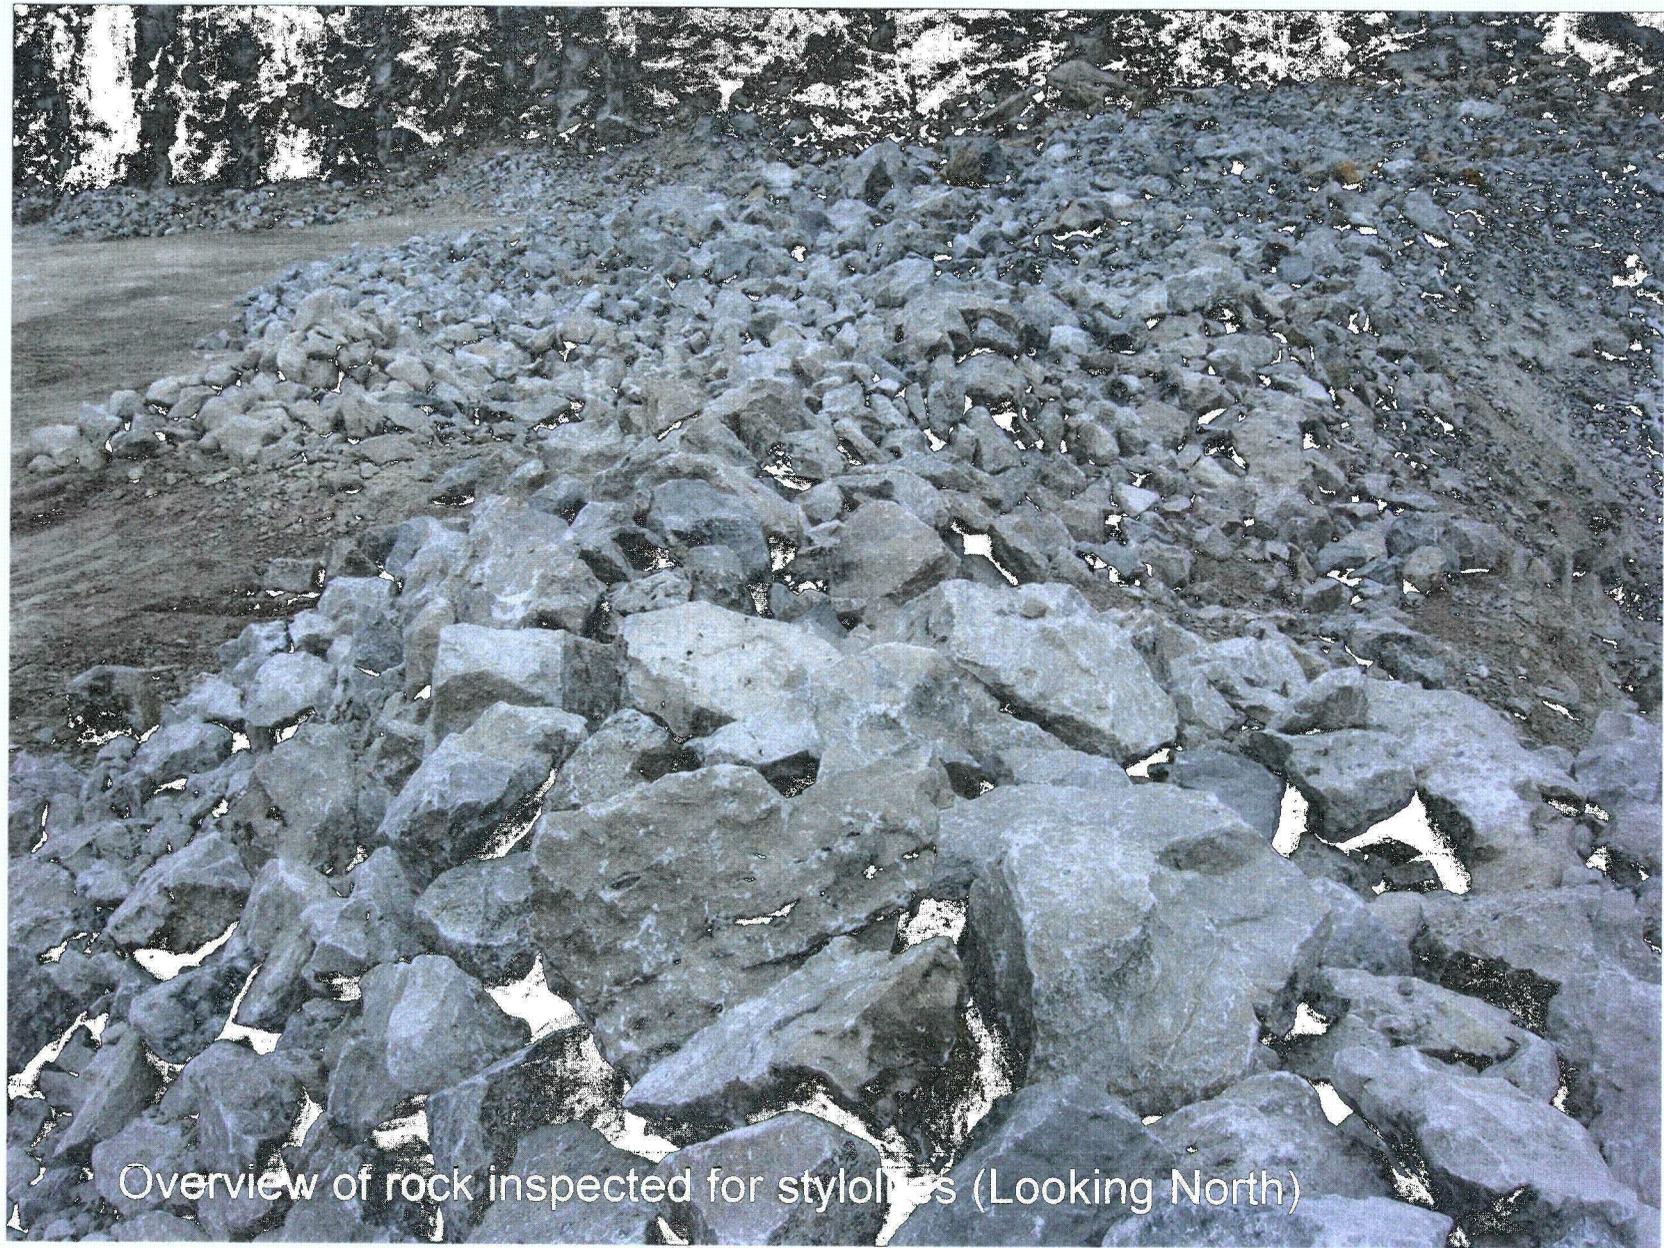
Figure D-4

Overview of rock inspected for stylolites (Looking North)

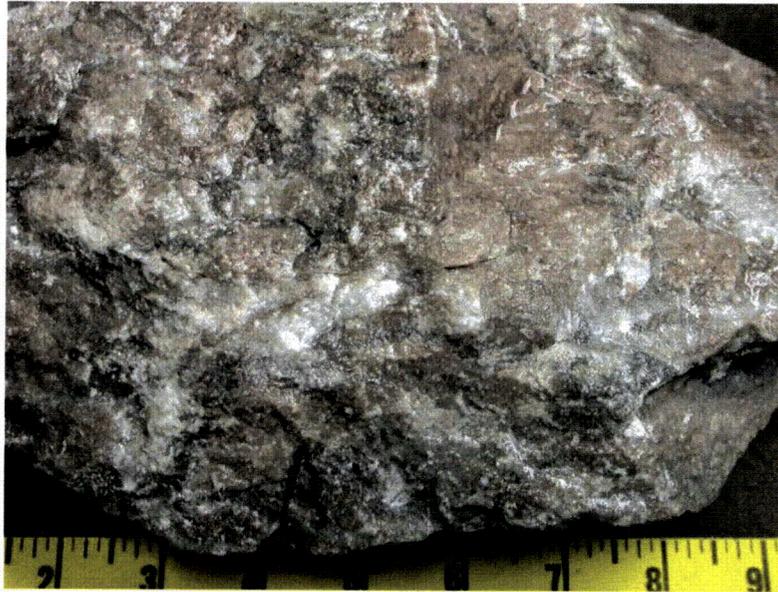
Figure 4. After washing, the Rock Fragment A is shown to be mottled pinkish-beige, gray and white.

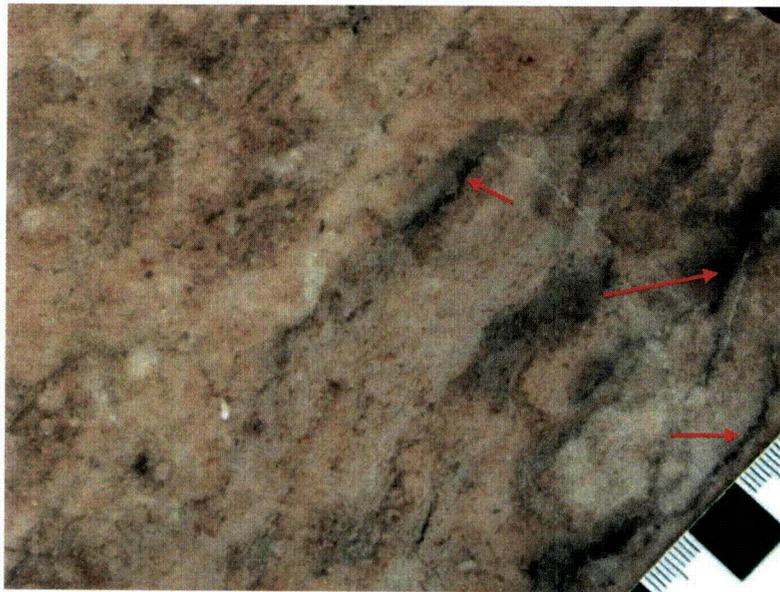
Figure 5. Banding and color variation in the limestone. Arrows show layers that resemble poorly-formed stylolites. Millimeter scale.

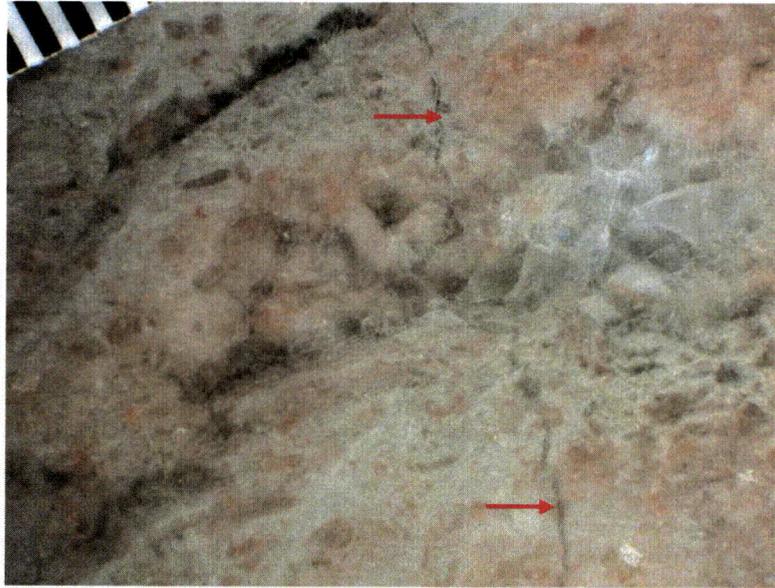
Figure 6. Fine to coarse-grained whitish-beige to pinkish-beige bands of fossiliferous limestone. Arrows show a calcite-filled fracture. Millimeter scale.

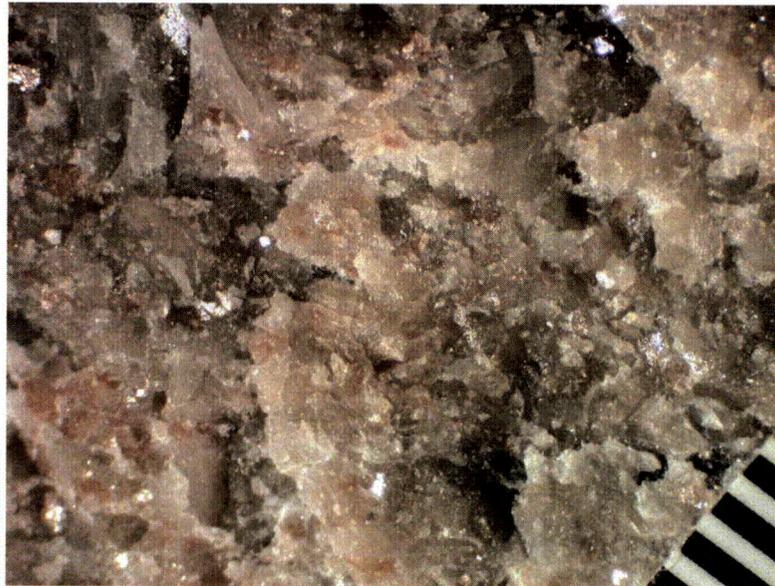
Figure 7. The pinkish-beige portions consist of medium to coarse-grained calcite that contains inclusions of hematite 'dust.' Millimeter scale.

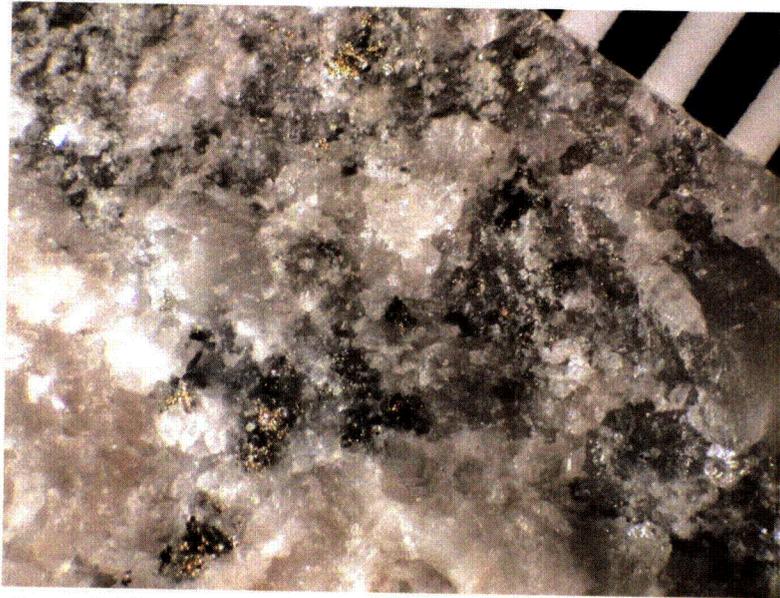
Figure 8. The limestone contains disseminated crystals of brassy pyrite. Millimeter scale.

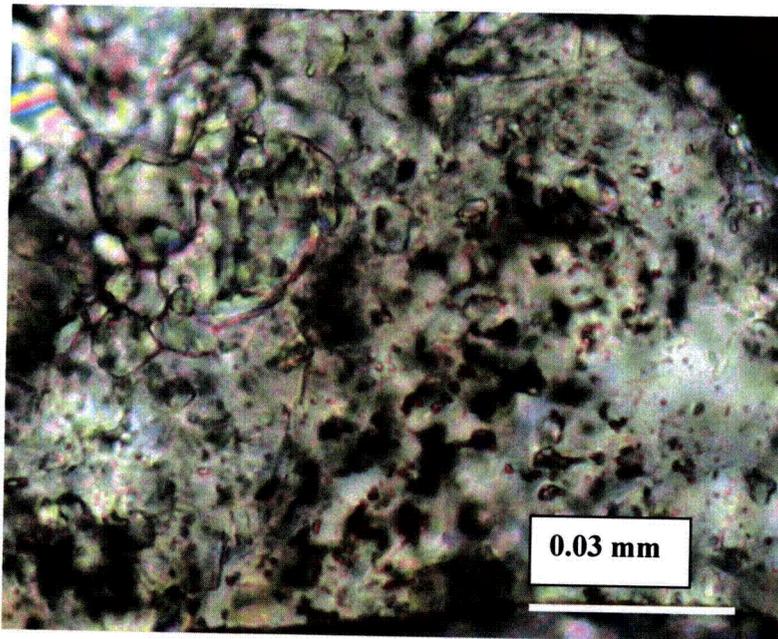
Figure 9. Cross-polarized light image showing small, red, hematite inclusions in calcite.

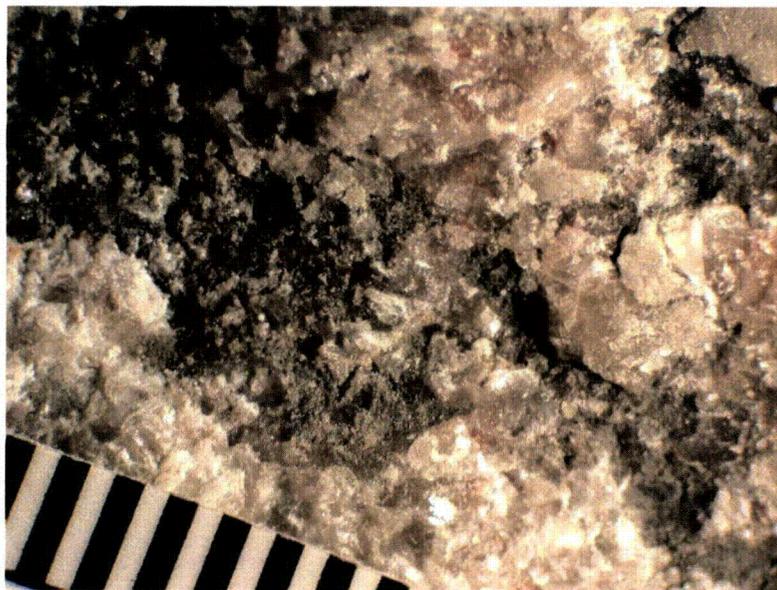
Fresh fractures passing through the pinkish-beige portions of the rock are hard and firm. Only the infrequent, narrow, dark gray bands constitute planes of weakness in the rock. Fracture surfaces through these regions are soft. The healed fractures are not planes of weakness.

Figure 10. Gray portions of the limestone are soft clay or clay-size minerals. Millimeter scale.

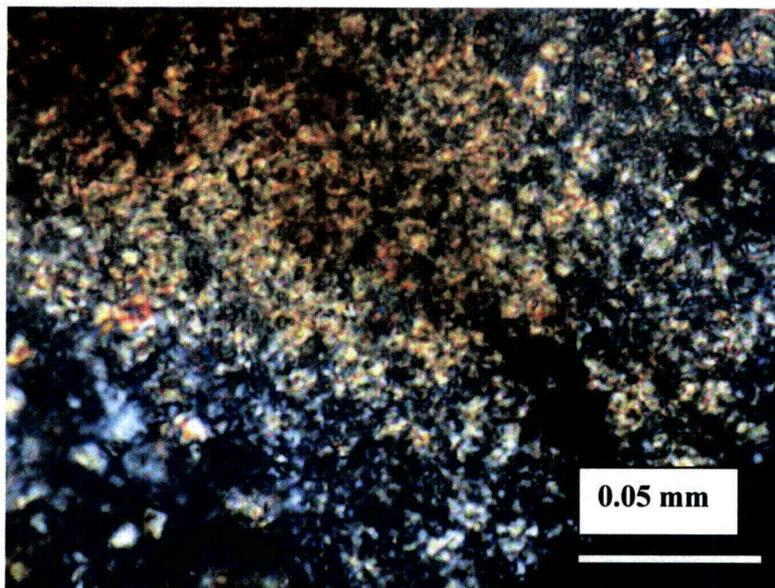
Figure 11. Cross-polarized light image of the soft, very fine-grained, clay-like siliceous material.

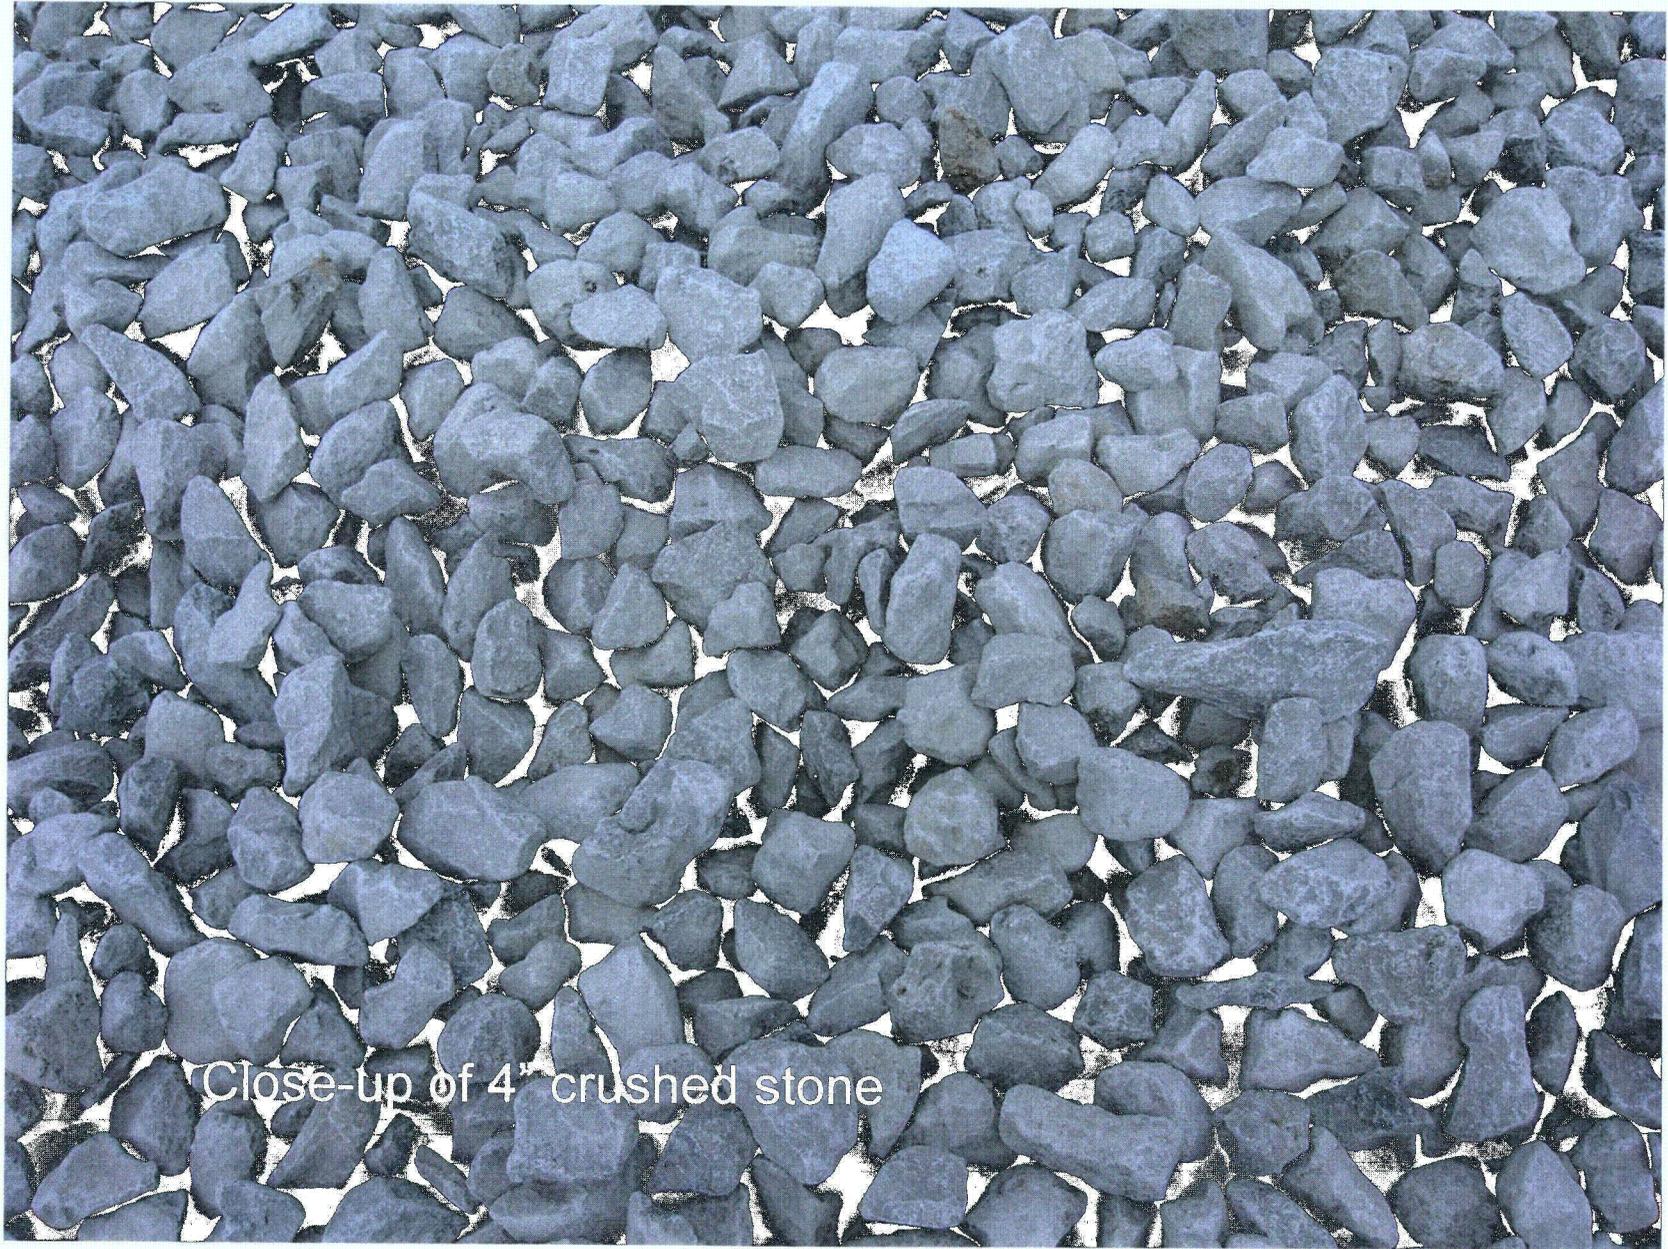
Figure F-2

Close-up of 4" crushed stone
