Subject: Sequoyah Fuels Corporation, Docket – 40-8027
Response to OIs on the Final Safety Evaluation Report –
Reclamation Plan (TAC L52511)

REPORT
FOR
SEQUOYAH FUELS CORPORATION
DISPOSAL CELL PROJECT

SOUTER QUARRY
RIP RAP SUITABILITY STUDY

PREPARED BY
KENNETH SCHLAG, P.G.
CONSULTING GEOLOGIST
April 22, 2007

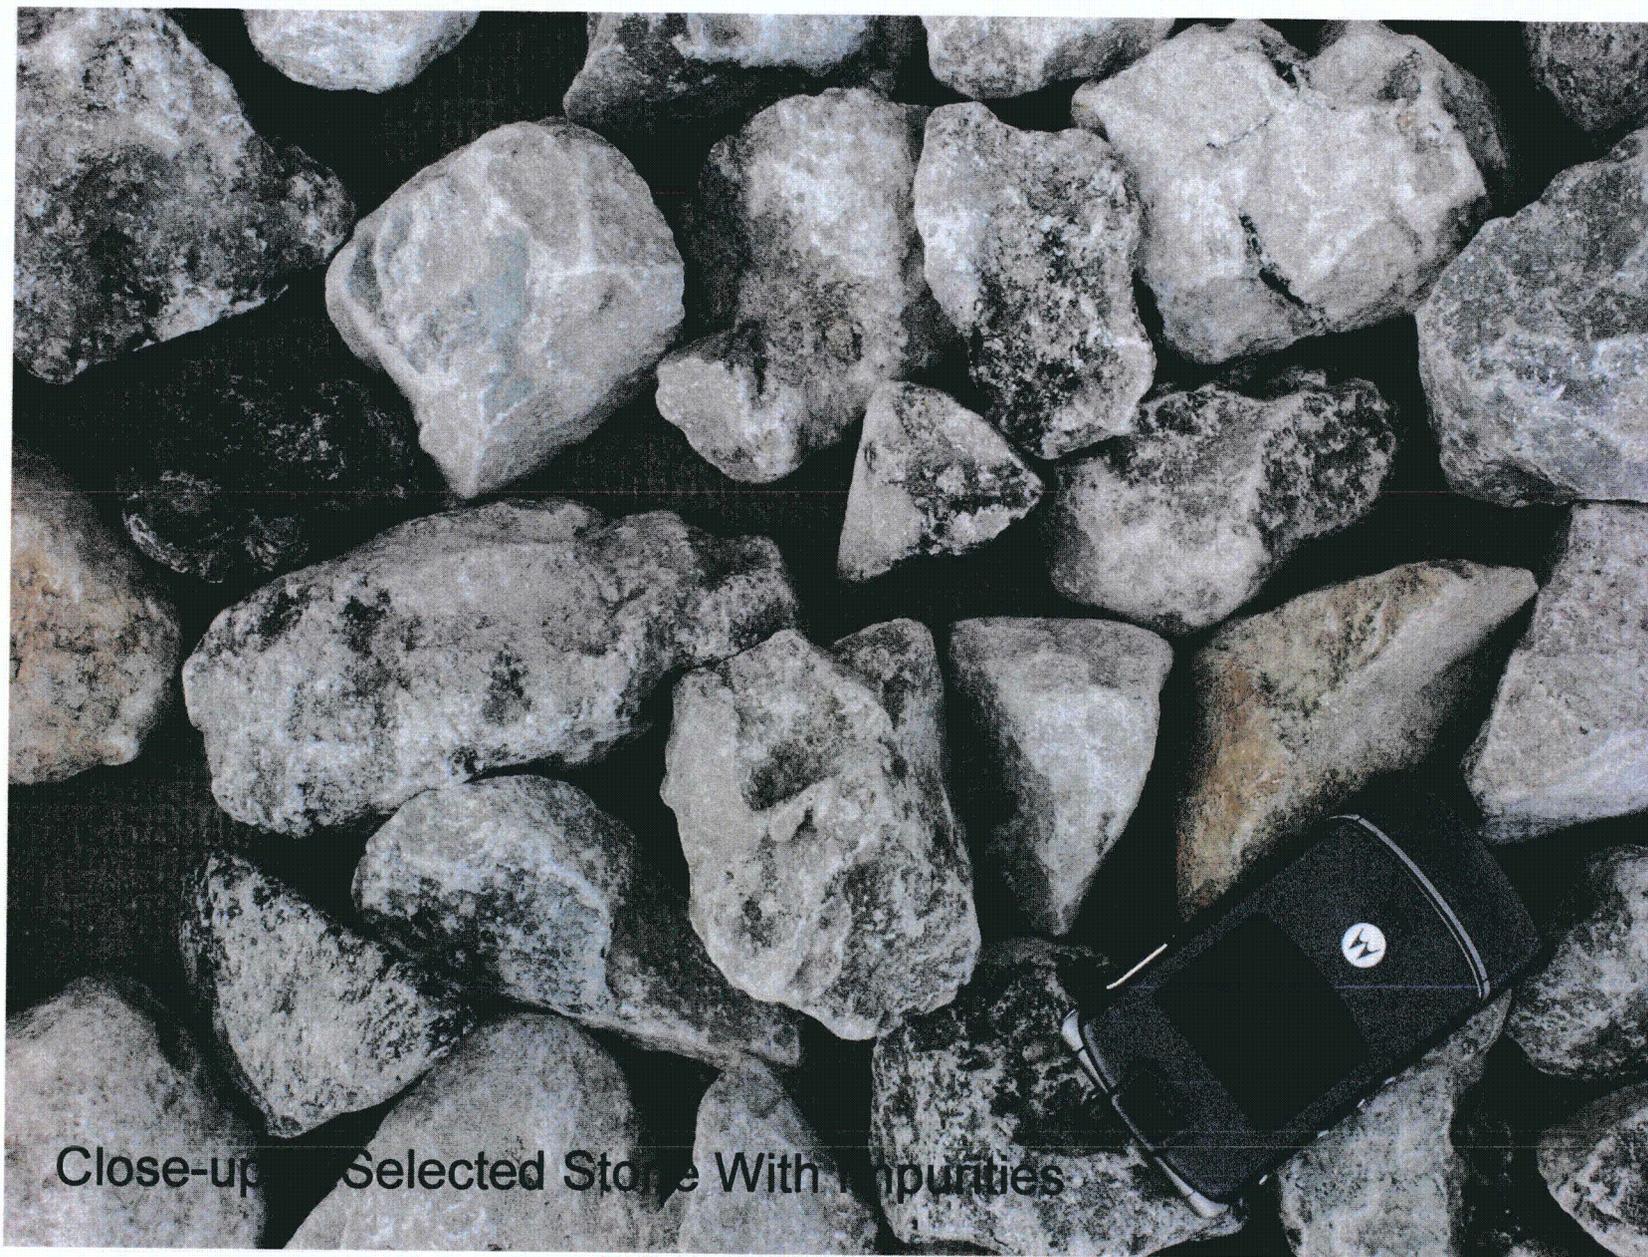
Figure F-3

Close-up Selected Stone With Impurities

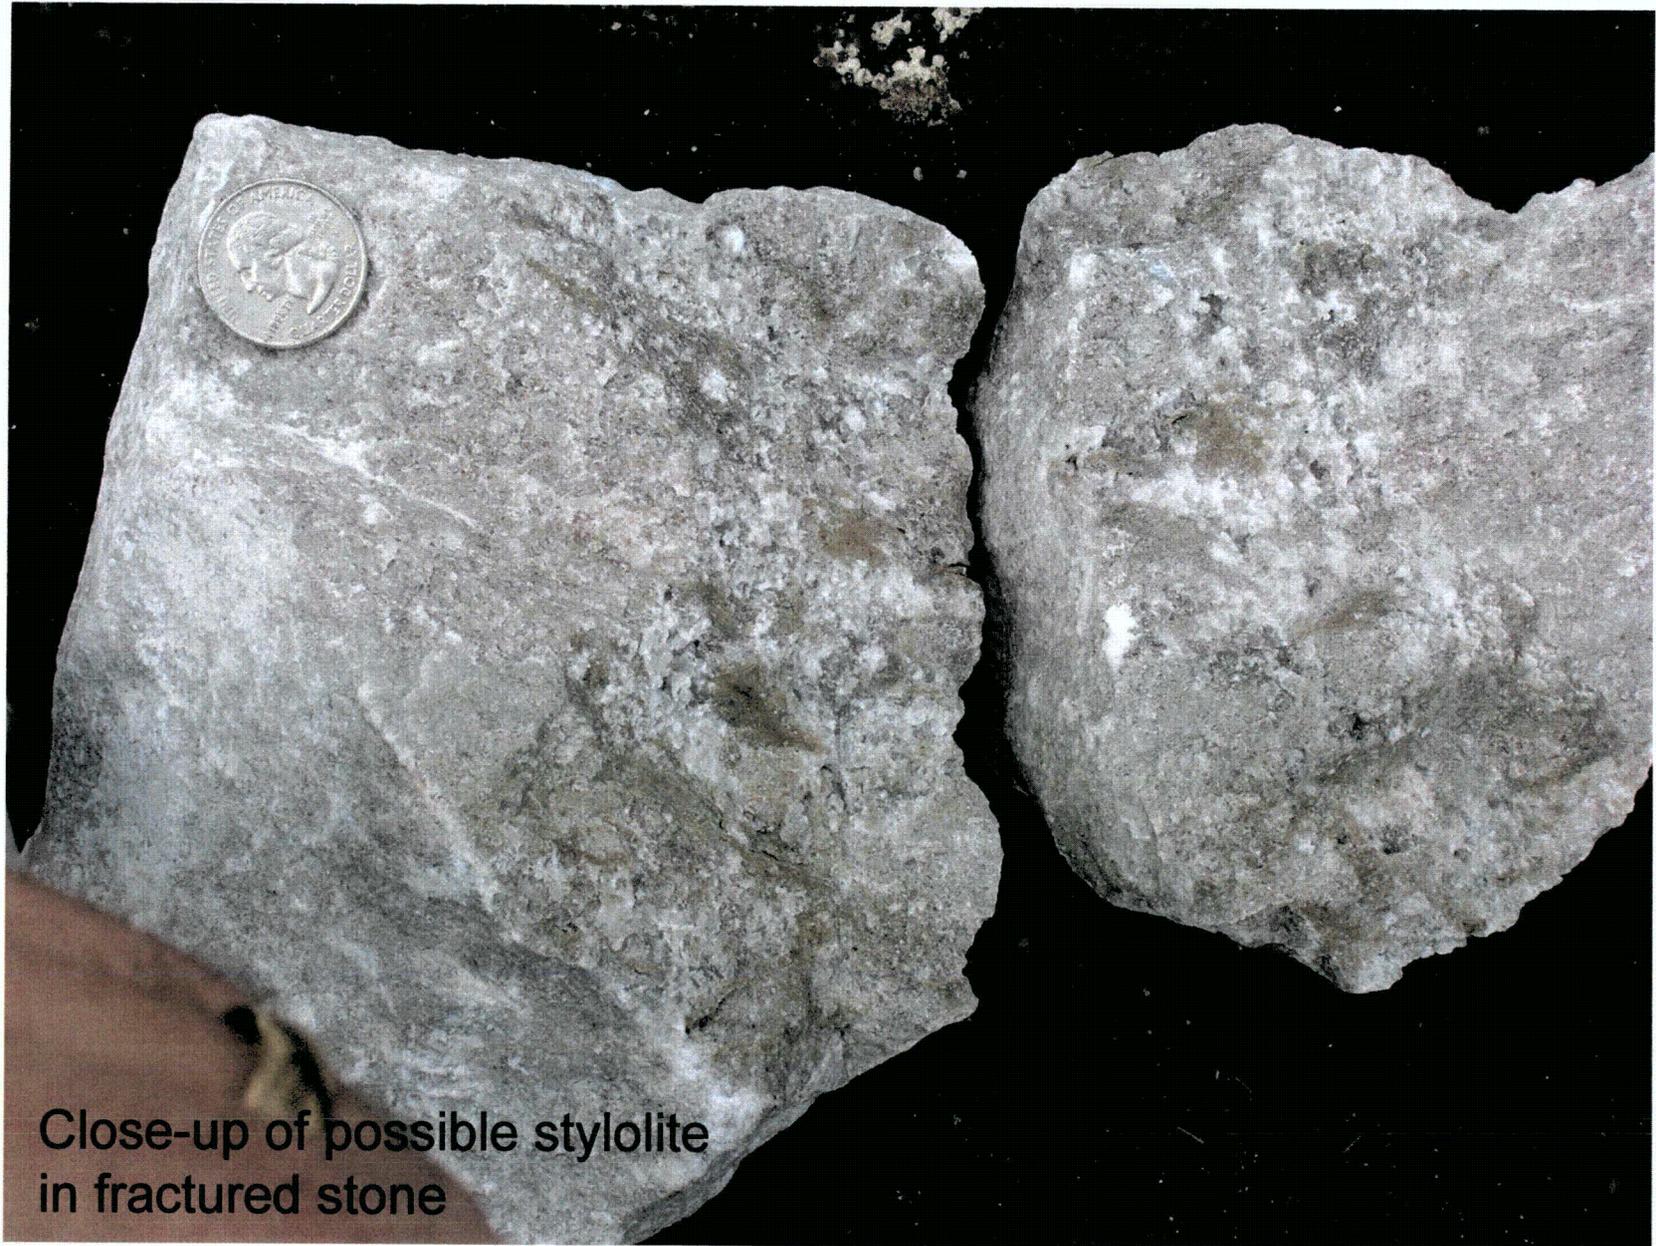
Figure F-4

Close-up of possible stylolite
in fractured stone
