AREVA CALCULATION

AREVA DOCUMENT 51-5049676-002, "PALISADES VENT LINE NOZZLE REPAIR ANALYSIS SUMMARY," DATED APRIL 2007

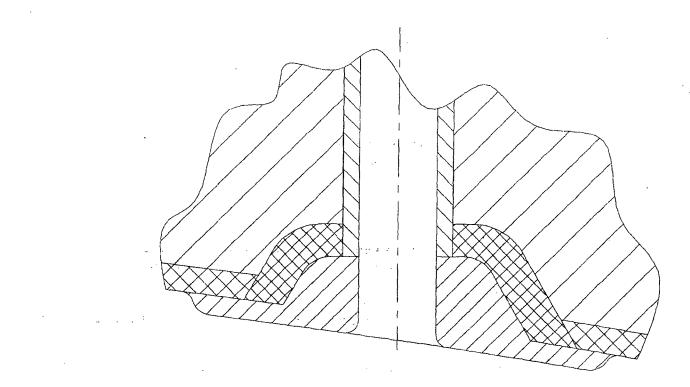
Figure 1. Vent Line Nozzle Weld Repair

Due to the susceptibility of Alloy 600 reactor vessel head partial penetration nozzles to primary water stress corrosion cracking (PWSCC), a weld repair procedure has been developed for the Palisades reactor vessel head vent line nozzle wherein degraded Alloy 182 J-groove weld material is removed and Alloy 52/52M/152 weld metal is used to fill the cavity, leaving an embedded flaw between the low alloy steel head and the new weld, as shown in Figure 1. The repair is more fully described by the design drawing [1] and the technical requirements document [2].
