Subject: Duke Power Company LLC d.b.a.
Duke Energy Carolinas, LLC
McGuire Nuclear Station, Unit 1
Docket No. 50-369

Emergency License Amendment Request for One-Time Limited
Duration Extension of Allowed Outage Time for the Unit 1A
Emergency Diesel, Request for Additional Information

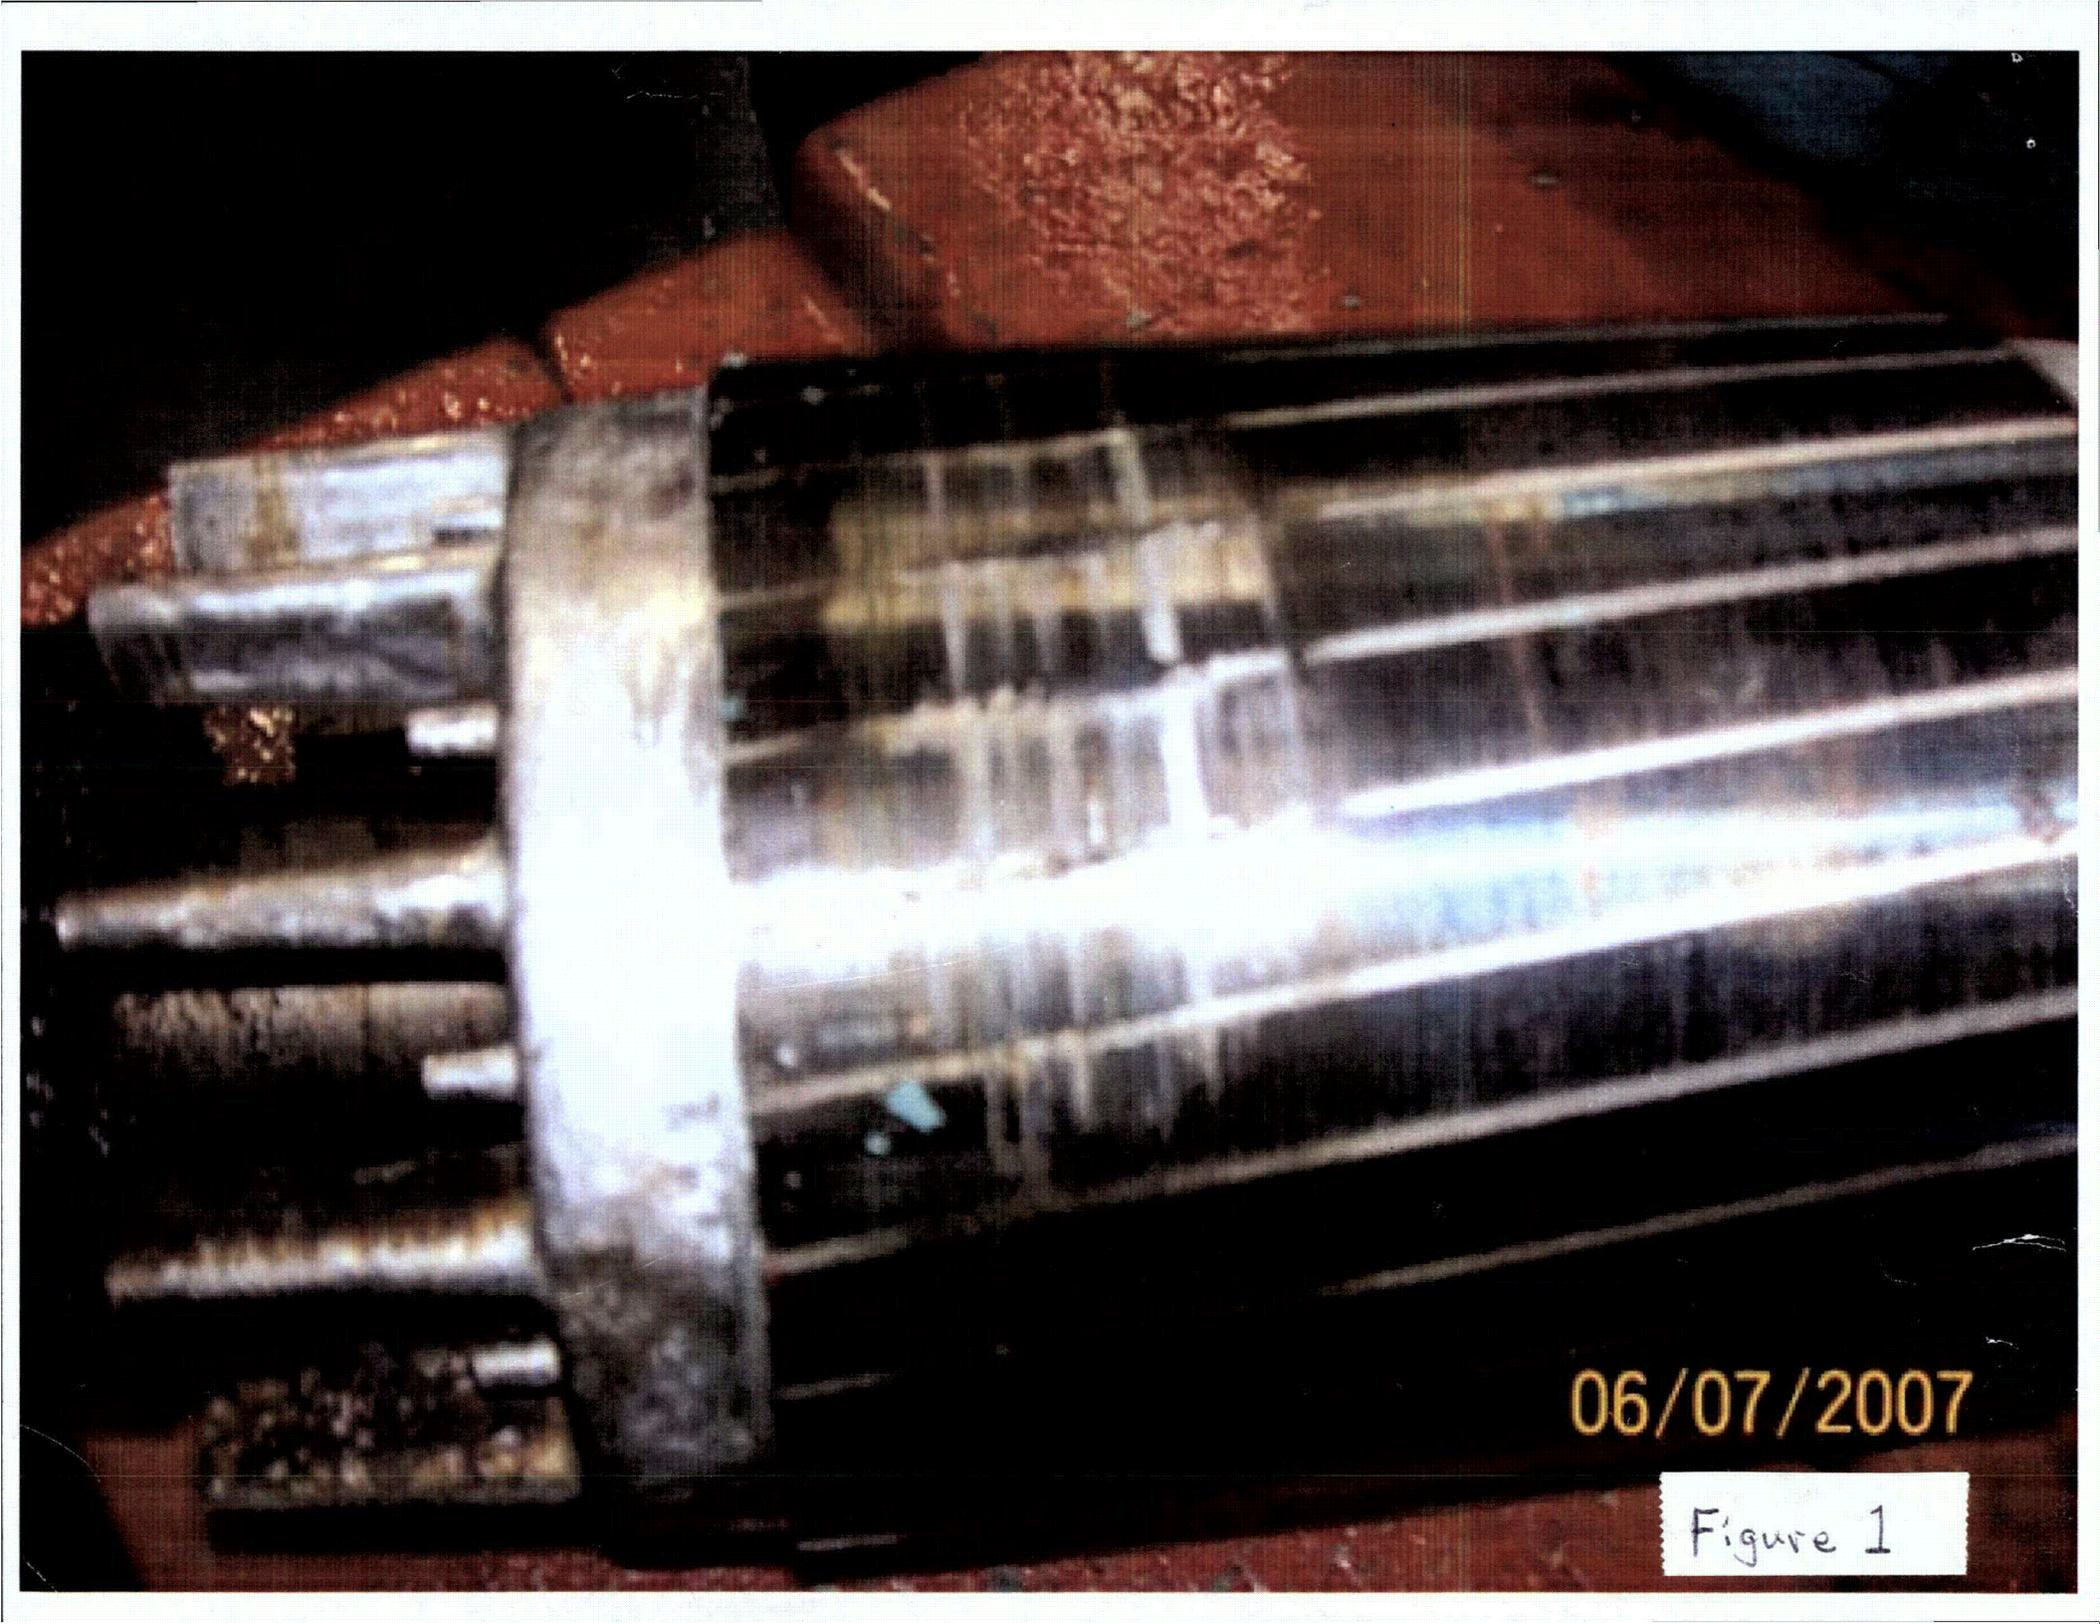
Figure 1

The vendor disassembled the motor and provided photographs of an apparent hard rub between the stator and rotor (Figure 1, 2, and 3). There were also numerous pieces of metal particles inside the end-bell and in the end turn windings of the stator (Figure 2, 3, and 4). Since an apparent rub was in several places around the circumference of the stator winding, the initial cause investigation (based on vendor supplied photos only) suggested a bearing failure. However, this was later refuted as discussed below.

Again, based on pictures provided by Shultz Electric earlier on 6/7/07 of the disassembled motor, there appeared to be an indication of a hard rub between the rotor and the stator. However, the apparent rub was actually aluminum that flowed out of the rotor due to heat, that smeared onto the stator. Given that the bearings did not indicate degraded condition, this supports the conclusion that the rotor did not come into contact with the stator.

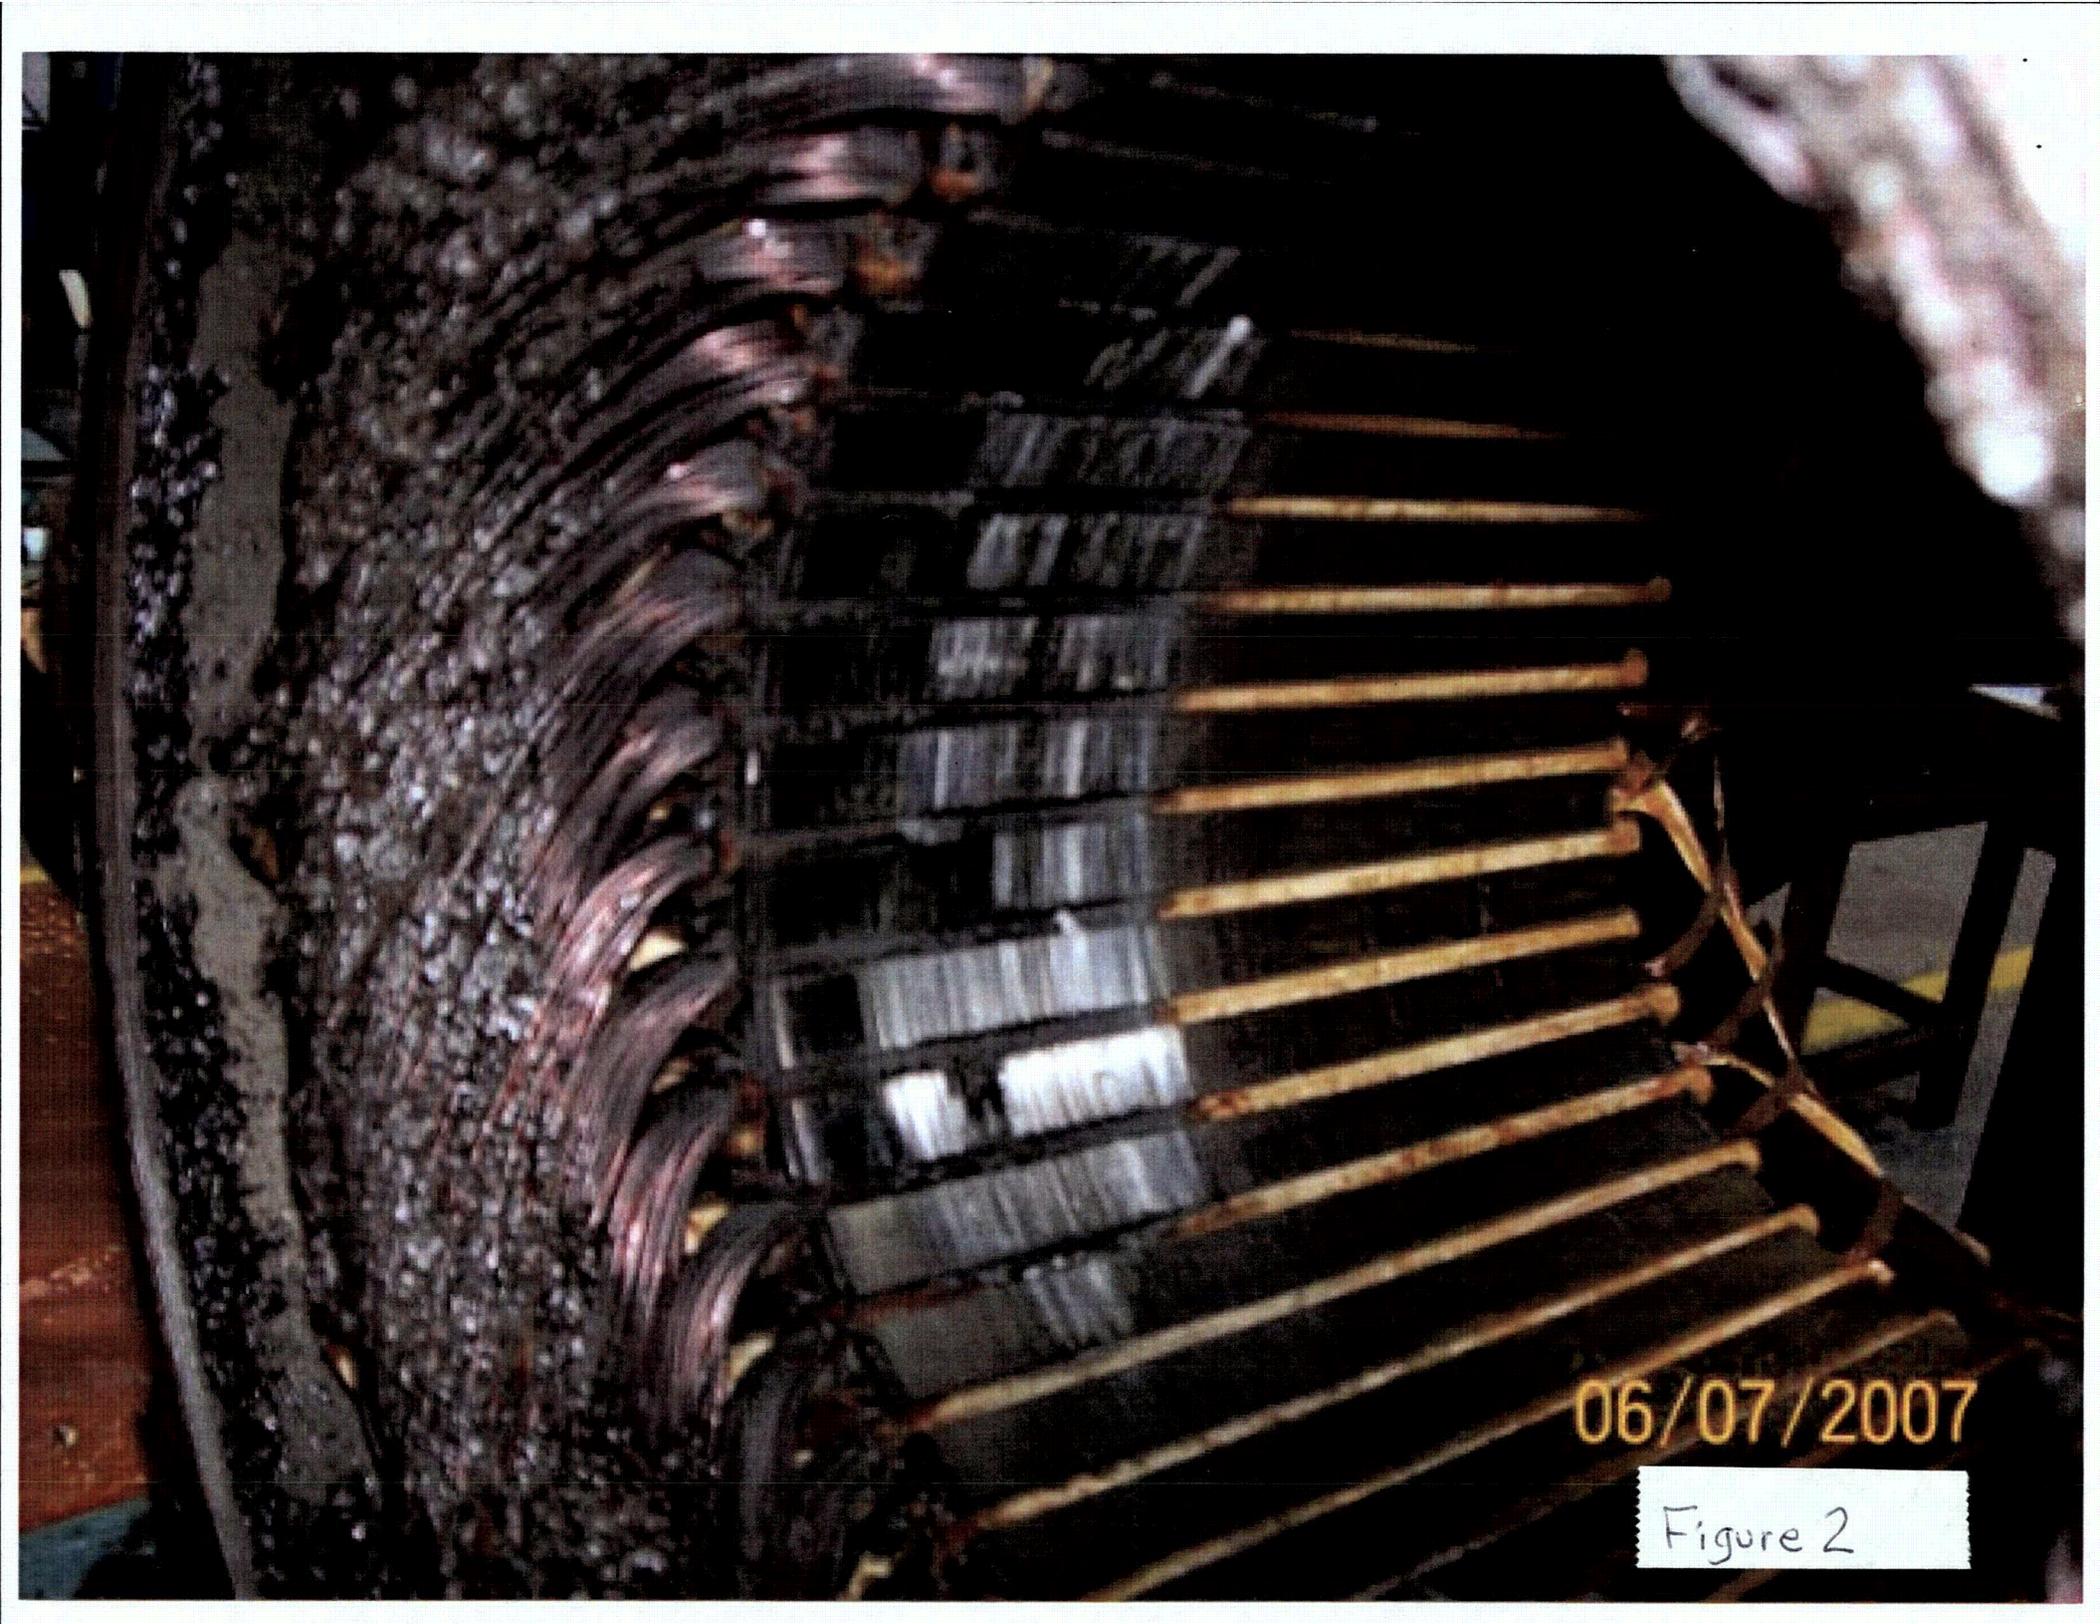
Figure 2

The pictures, specifically of the bracket, show loose aluminum particles. Any aluminum imbedded in the windings or the slot can provide a tracking path to ground, resulting in degraded indications from the DC HI-POT test and surge test performed at McGuire prior to shipping the motor to the repair facility. The degraded core due to the melted aluminum would lead to higher current draw, causing the overload alarm that was received, and would be expected for this condition.
