**Paducah Gaseous Diffusion Plant (PGDP)**  
**Docket No. 70-7001, Certificate No. GDP-1**  
**Event Report ER-07-02**

Pursuant to 10 CFR 76.120 (d)(2), enclosed is the final written event report pertaining to the rupture of the C-337 High Pressure Fire Water system C-12 on April 16, 2007. The Nuclear Regulatory Commission was verbally notified on April 16, 2007 at 1036 hours.

**EVENT REPORT**  
**ER-07-02**

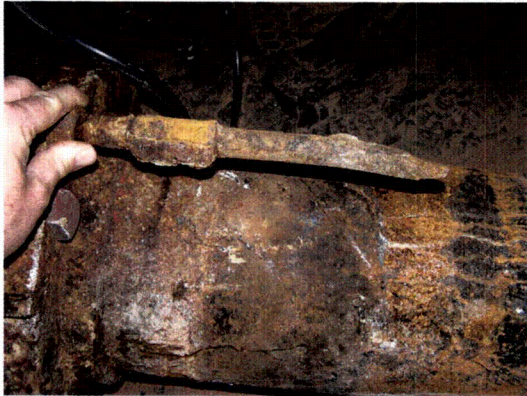
The root cause was determined to be improper installation (during original HPFW construction in 1958) of the C-12 cast iron piping. The gland sealed mechanical joint just below the concrete floor was misaligned beyond the maximum allowed by design, preventing adequate crush to the gasket, and allowing slow HPFW (approximately 130 psig system) leakage past the rubber seal. This eventually compromised the integrity of the joint and both carbon steel restraining rods holding the joint together (one shown in Figure 1 on page 4). The restraining rods failed and a crack, initiated at the joint, propagated into the 8-inch pipe that ruptured.

Figure 1 – Restraint rod failure and degradation of the piping at the joint caused by leaking joint.

1. By May 2, 2007, all other HPFW systems were inspected for hanger integrity, standing water (and source), and pipe restraint rod condition. Corrective actions were completed where needed.
2. By May 4, 2007, the four systems that were discovered with restraint rods severed were repaired. All four systems were declared inoperable until repairs to the restraint rods were made.
3. On May 11, 2007, the C-10, C-11, and C-12 systems were returned to service. The systems were repaired and tested prior to operability.

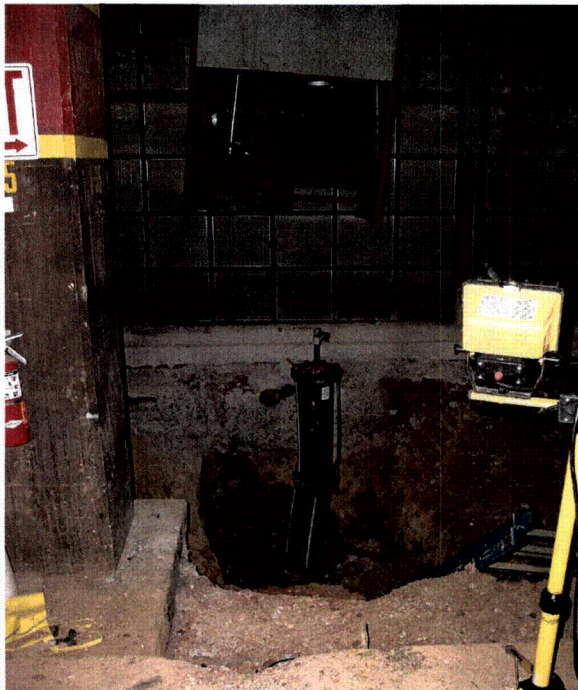
Further excavation revealed that misalignment of the failed mechanical joint was itself caused by misalignment of the next upstream mechanical joint, a 90 degree elbow fixed in a concrete thrust block. When the concrete thrust block was poured during initial installation, the 90 degree elbow was slightly tipped. This caused the pipe between the elbow and the failed mechanical joint to be approximately 7 degrees off vertical.

Figure 2 demonstrates the severe bend that must have existed at the failed joint before the rupture. This picture was taken after reassembly of the system with the elbow still tipped and before repairing the elbow. After this picture was taken, the elbow and riser section was replaced. Figure 3 shows the recast elbow and repaired joint.

Figure 2 – C-12 - Original elbow in place and piping reconstructed, showing misalignment.

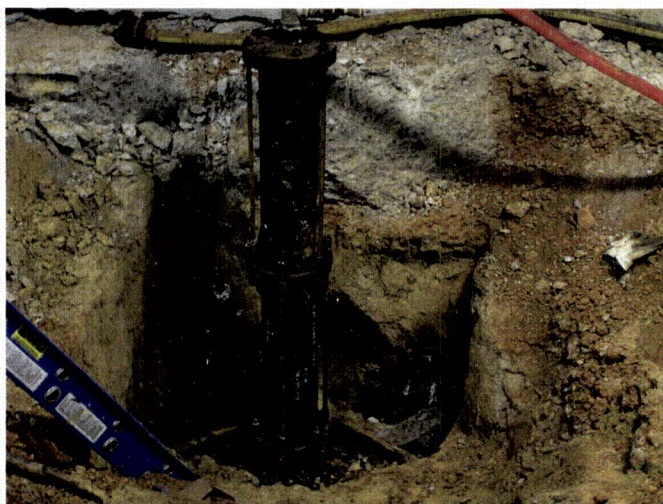
Figure 3.

Figure 3 – C-12 – Following elbow replacement and total reconstruction (final repair). The restraint rods are the threaded rods between the mechanical joint flanges.
