NUREG/CR-0596
SAND78-2238
RP

A PRELIMINARY REPORT ON
FIRE PROTECTION RESEARCH PROGRAM*
FIRE BARRIERS AND SUPPRESSION
(September 15, 1978 Test)

Sandia Laboratories
Albuquerque, NM 87185
operated by
Sandia Corporation
for the
U.S. Department of Energy

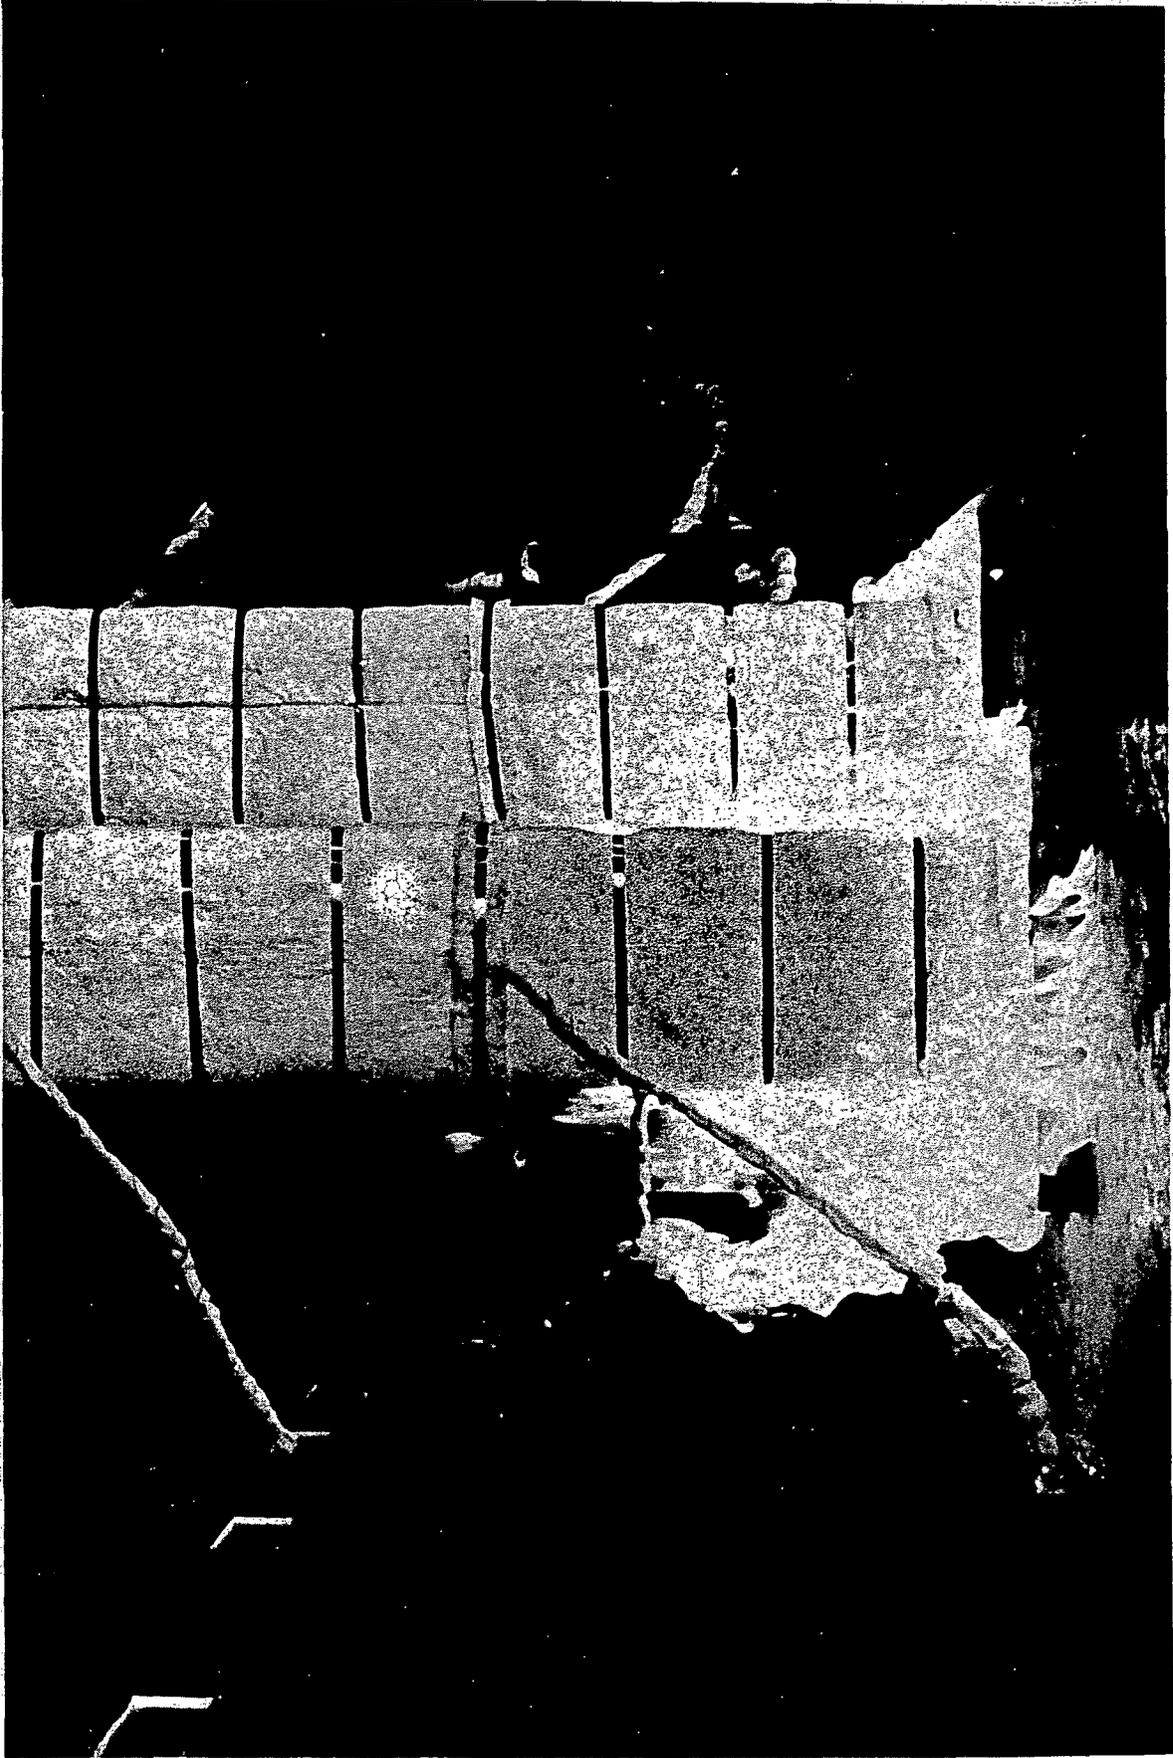
Figure 6. Test Assembly at Ten Seconds

<u>Time (Min:Sec)</u>	<u>Description</u>
0:10	Flaming appeared uniform over the entire pan area with a maximum flame height of 4 feet (1.2 m). Appearance of test assembly is shown in Figure 6.
