NUREG/CR-6095
SAND93-1803

Aging, Loss-of-Coolant Accident (LOCA), and High Potential Testing of Damaged Cables

Prepared by
R. A. Vigil/SEA
M. J. Jacobus/SNL

Sandia National Laboratories
Operated by
Sandia Corporation

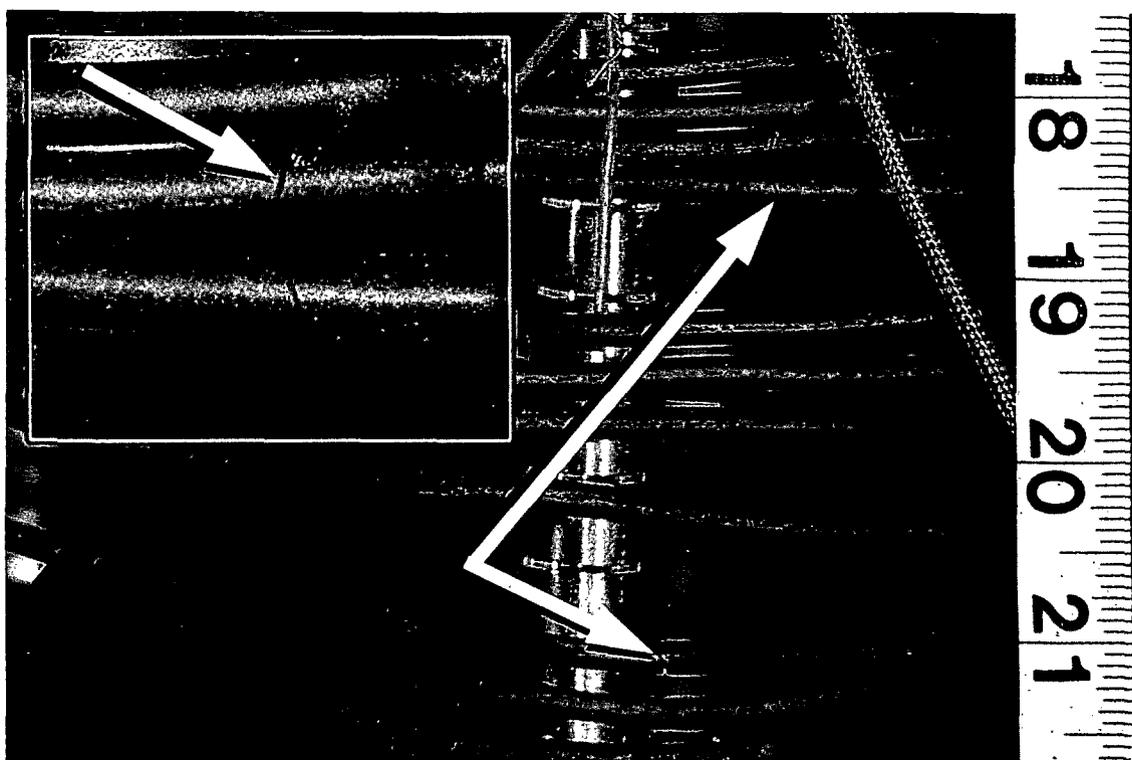
Figure 3 Cracks in Okonite Insulation After Thermal Aging

After completion of the thermal aging, a visual inspection revealed that all of the (intentionally) damaged Okonite cables had developed cracks in their insulation and/or jackets. The virgin sample did not appear to have any signs of cracks. Most of the cracks were adjacent to the damage locations, but outside the damaged area. Figure 3 is a photograph of these cracks in several of the Okonite cables. The cracks were circumferential and most were through to the conductor, although some cracks were apparent only in the CSPE jacket (especially on the cable with the least amount of damage). No cracks through to the conductor were noted on the cable with the least amount of damage. The exact cause of the cracks is unknown, but a major factor appears to be thermal aging of the bonded jacket material, followed by jacket cracking that propagated to the insulation. The bending of the cables around the test mandrel also appears to be a significant factor. The cracks were clearly not caused by sample preparation or handling during testing. Samples were carefully prepared using minimal clamping pressure and inspected after milling. There was no sample handling after aging. Because of these failures and other subsequent accident

Because of the cracks in the Okonite cables, we expected that all the damaged Okonite cables, except for the undamaged cable and the cable with the least amount of damage, would fail early in the LOCA test. In fact, the undamaged cable was one of the first cables to blow a 1 A fuse after the chamber environment became saturated steam at approximately 11 hours from the start of the LOCA exposure. (The undamaged cable blew its fuse at about 14 hours into the test as shown in Table 5.) The last surviving Okonite cable sample blew its 1 A fuse at approximately 182 hours into the LOCA simulation. Other cables that were known to have cracks through to the conductor did not blow 1 A fuses until as late as 137 hours into the LOCA test. Had chemical spray been present during the test, these cables would have almost certainly all blown fuses earlier because of the enhanced ground plane. These failures would probably have occurred soon after the chemical spray was started.

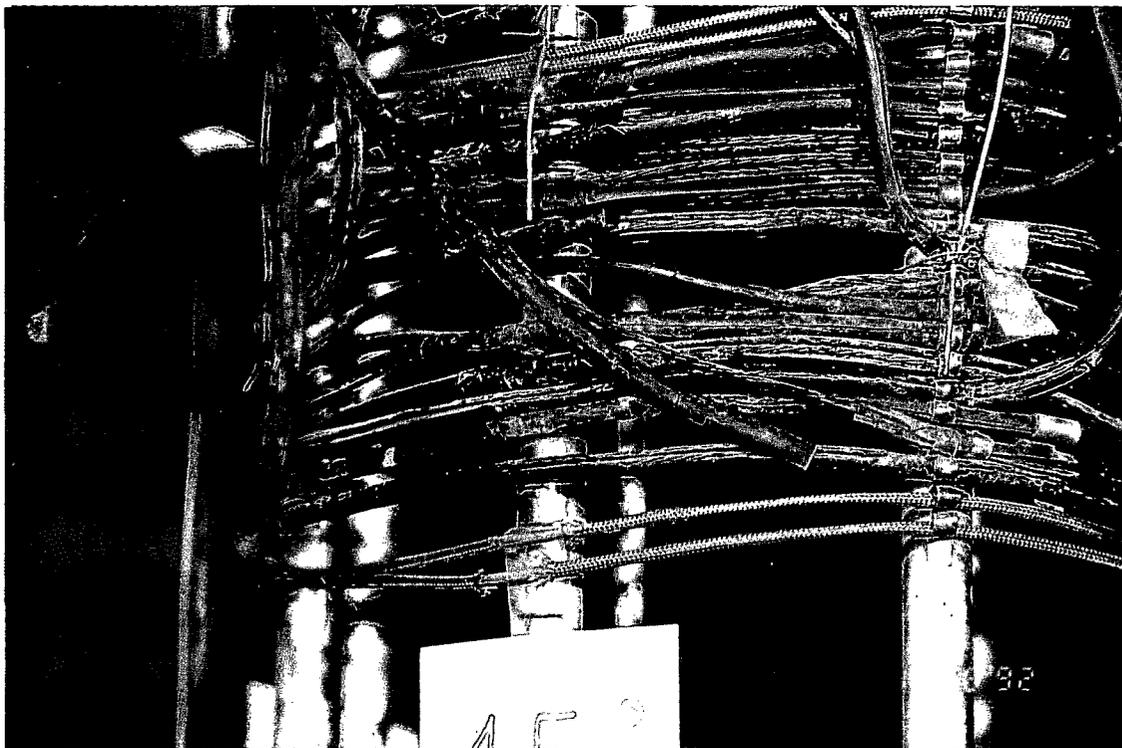
Figure 6 Okonite Cable Failures After LOCA Simulation

It was evident during the post-LOCA inspection that the Okonite cables had clearly deteriorated grossly during the LOCA exposure. All the Okonite cables had longitudinal cracks over much of their length, exposing the center conductor as shown in Figure 6. In addition, identical undamaged single conductor Okonite Okolon cables that were used as cable ties in the test chamber exhibited the same type of extensive longitudinal cracking. Because of the nature of these failures and comparison with previous testing (discussed later), we believe that the failure rate of the Okonite Okolon cables under our test conditions is essentially 100%. Because of their unexpected failures, no data for the minimum insulation thickness necessary to survive aging and accident tests can be determined for the Okonite cables. The observed failures were very similar in appearance to a failure of an Okonite cable and several failures of another cable that had bonded CSPE jackets in previous testing at Sandia [5].

Cable Number	Time of Blown Fuse (hours)	Cable Number	Time of Blown Fuse (hours)
21	102	26	90
22	137	27	122
23	50	28	97
24	11	29	182
25	81	30	14

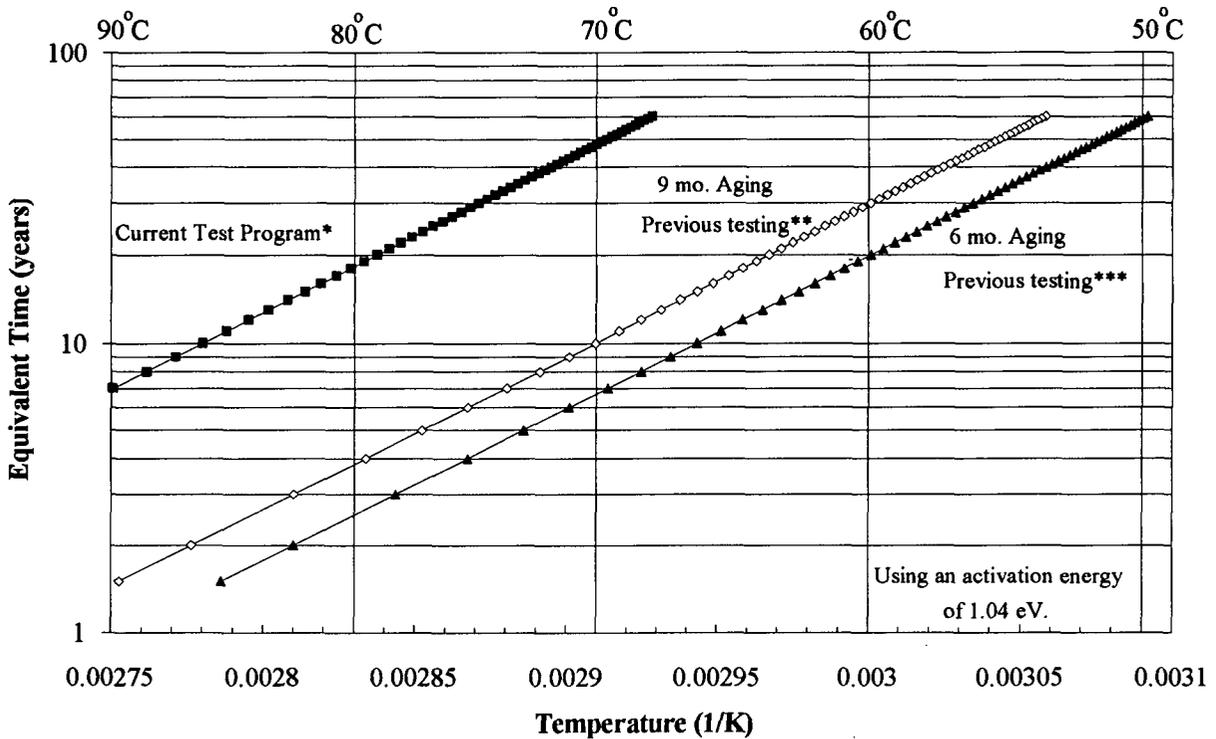
Figure 7 Equivalent Time-Temperature Corresponding to the Thermal Aging in this program and Previous Sandia Testing

of 40 years at 54°C (129°F), 0 of 3 cables failed; after the equivalent of 40 years at 57°C (135°F), 1 of 4 cables failed; and after the equivalent of 40 years at 76°C (169°F), all of the tested cables failed. Based on this data, it is reasonable to conclude that after aging at 54°C (129°F) for 40 years (and assuming an activation energy of 1.04 eV), the cables are likely to survive accident testing. Beyond 55°C (131°F) normal temperature for 40 years, the probability of failure during an accident increases and by 72°C (162°F) for 40 years, failure appears almost certain (for the radiation exposure dose and accident profile used in our testing). Appendix B includes some discussion of the effect of the radiation exposure and the approximate equivalent thermal aging if radiation had not been included.

- * All Okonite cables failed.
- ** 1 of 4 Okonite cables failed.
- *** 0 of 3 Okonite cables failed.

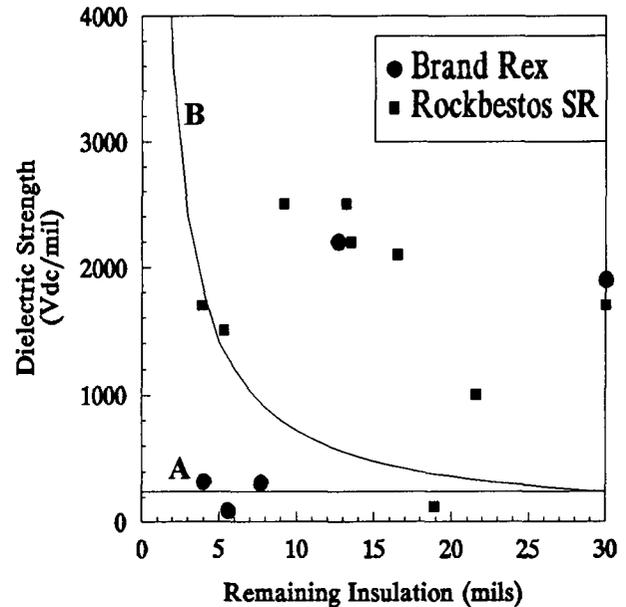
Figure 8 Dielectric Strength Based on Nominal Remaining Insulation Thickness

The results of these post-LOCA breakdown tests are given in Tables 6 and 7. Figure 8 presents the dielectric strength data in Vdc/mil of remaining insulation versus remaining insulation thickness for the Brand Rex and Rockbestos cables. Note that the two Brand Rex cables that passed the accident test with less than 7 mils of insulation remaining (samples 2 and 6) both had breakdown voltages less than the 600 Vac rating of the cable (considering 600 Vac to be equivalent to 1800 Vdc). In addition, the breakdown voltage in Vdc/mil for these two cables was much lower than the expected breakdown voltage of this material after LOCA (i.e. about 14000 kVac for an undamaged cable [6] or the equivalent of about 1800 Vdc/mil). If the cables had been energized with ac potential and/or if the applied voltage had been higher (but still within the rating of the cable), it is possible that these cables would have also failed during the accident exposure. However, unlike the cables that immediately failed the post-LOCA dielectric

tests, neither of these two cables had any indication of problems during the LOCA simulation. There appears to be a clear difference in breakdown voltage in Vdc/mil between the Brand Rex cables with less than 8 mils of insulation remaining and those with greater than 12 mils remaining. With less than 8 mils remaining, the breakdown voltage did not exceed 320 Vdc/mil, while above 12 mils the breakdown voltage was not less than 1900 Vdc/mil.

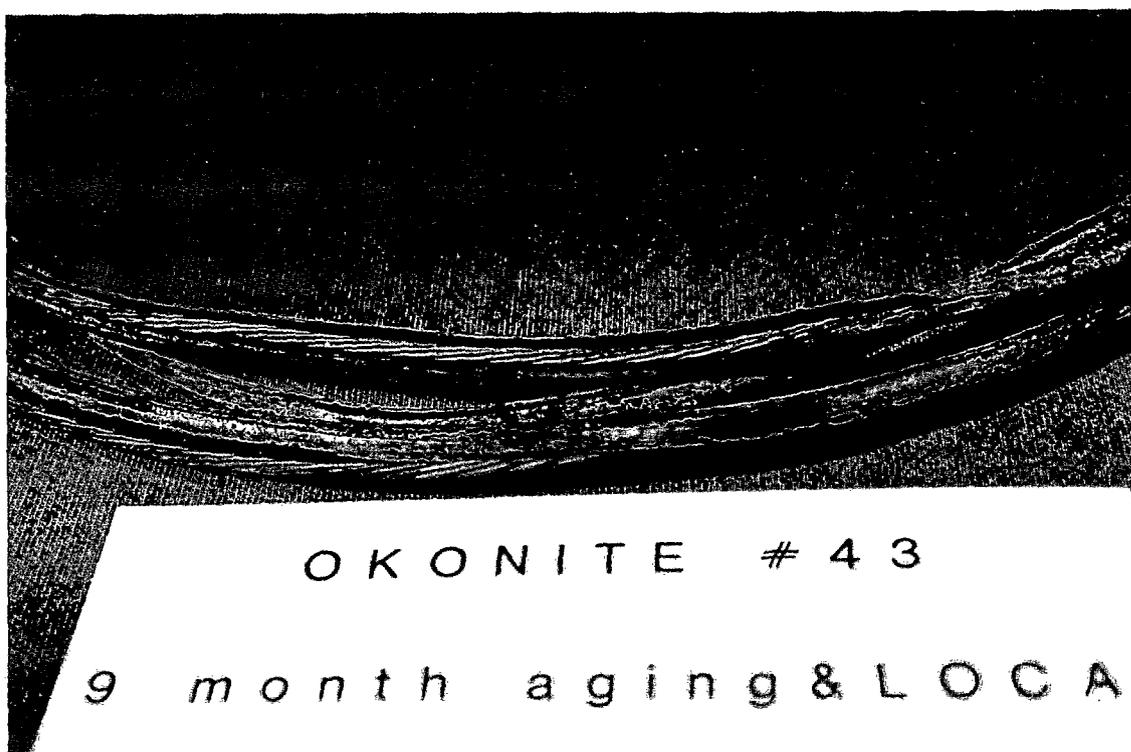
Figure B-1 Failure of Okonite Cable Sample from Reference B-1 Test Program

Because the sample that failed was aged to the maximum extent and a significant number of samples were less severely aged and did not fail, a connection with the degree of aging is strongly suggested.

Based on the analysis of equivalent thermal aging times, the fact that all of the cables had identical longitudinal cracking during the steam exposure is not very surprising. Since there is an almost certain connection between the failures and the degree of aging, we would expect the Okonite cables to fail a test where the thermal aging that was used in this test program was combined with **no radiation aging** and followed by a 110 Mrad accident exposure and the steam profile used in this test. Thus, although the application of the total radiation dose prior to thermal aging is perhaps more

severe than a different aging sequence, the evidence clearly indicates that the sequence was irrelevant in this test. However, the sequence may become important if testing at lower levels of thermal aging is conducted.
