# Final Precursor Analysis

Accident Sequence Precursor Program -- Office of Nuclear Regulatory Research

Millstone Power Station (Unit 2)	Manual Reactor Trip Due to Trip of Both Feed Pumps Following a Loss of Instrument Air	
Event Date 02/23/2006	LER 336/06-002; IR 05000336/2006-02; IR 05000336/2006-05	CCDP = $8 \times 10^{-6}$

April 11, 2007

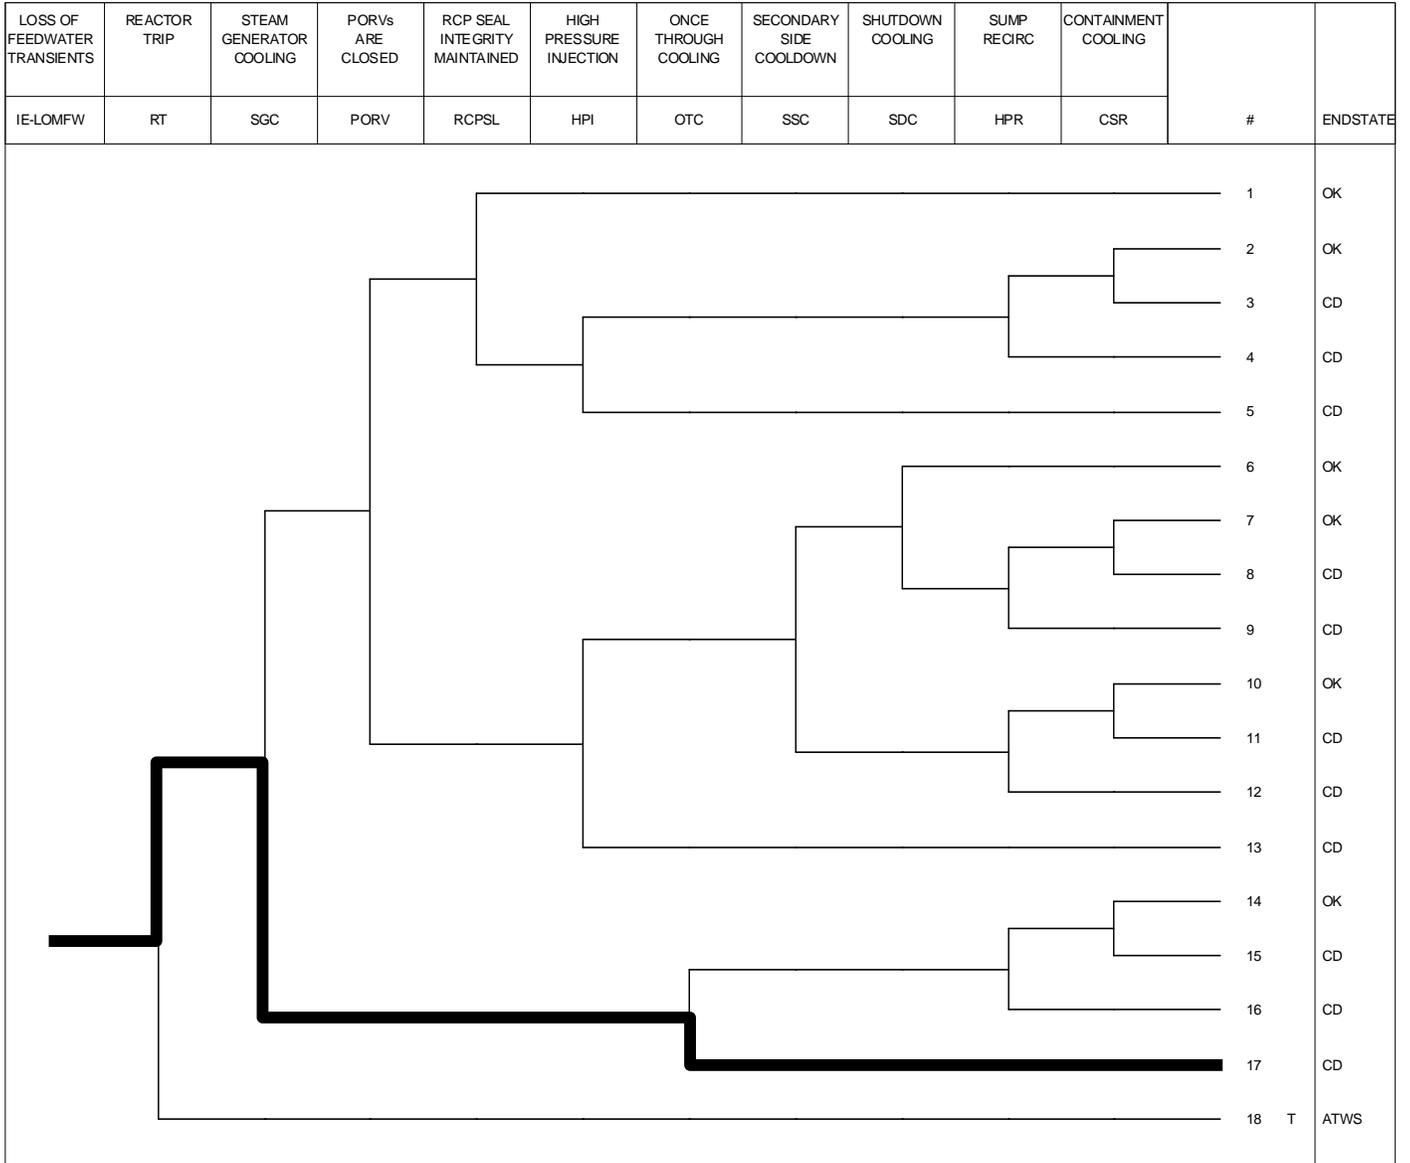
Figure 1. Millstone 2 Loss of Main Feedwater Event Tree (with dominant sequence highlighted).

The dominant core damage sequence for this event is Loss of Main Feedwater (LOMFW) Sequence 17. The events and important component failures for LOMFW Sequence 17 shown in Figure 1 (Appendix A) include:

- LOMFW initiating event,
- successful reactor trip,
- failure of steam generator cooling, and
- failure of once through cooling.

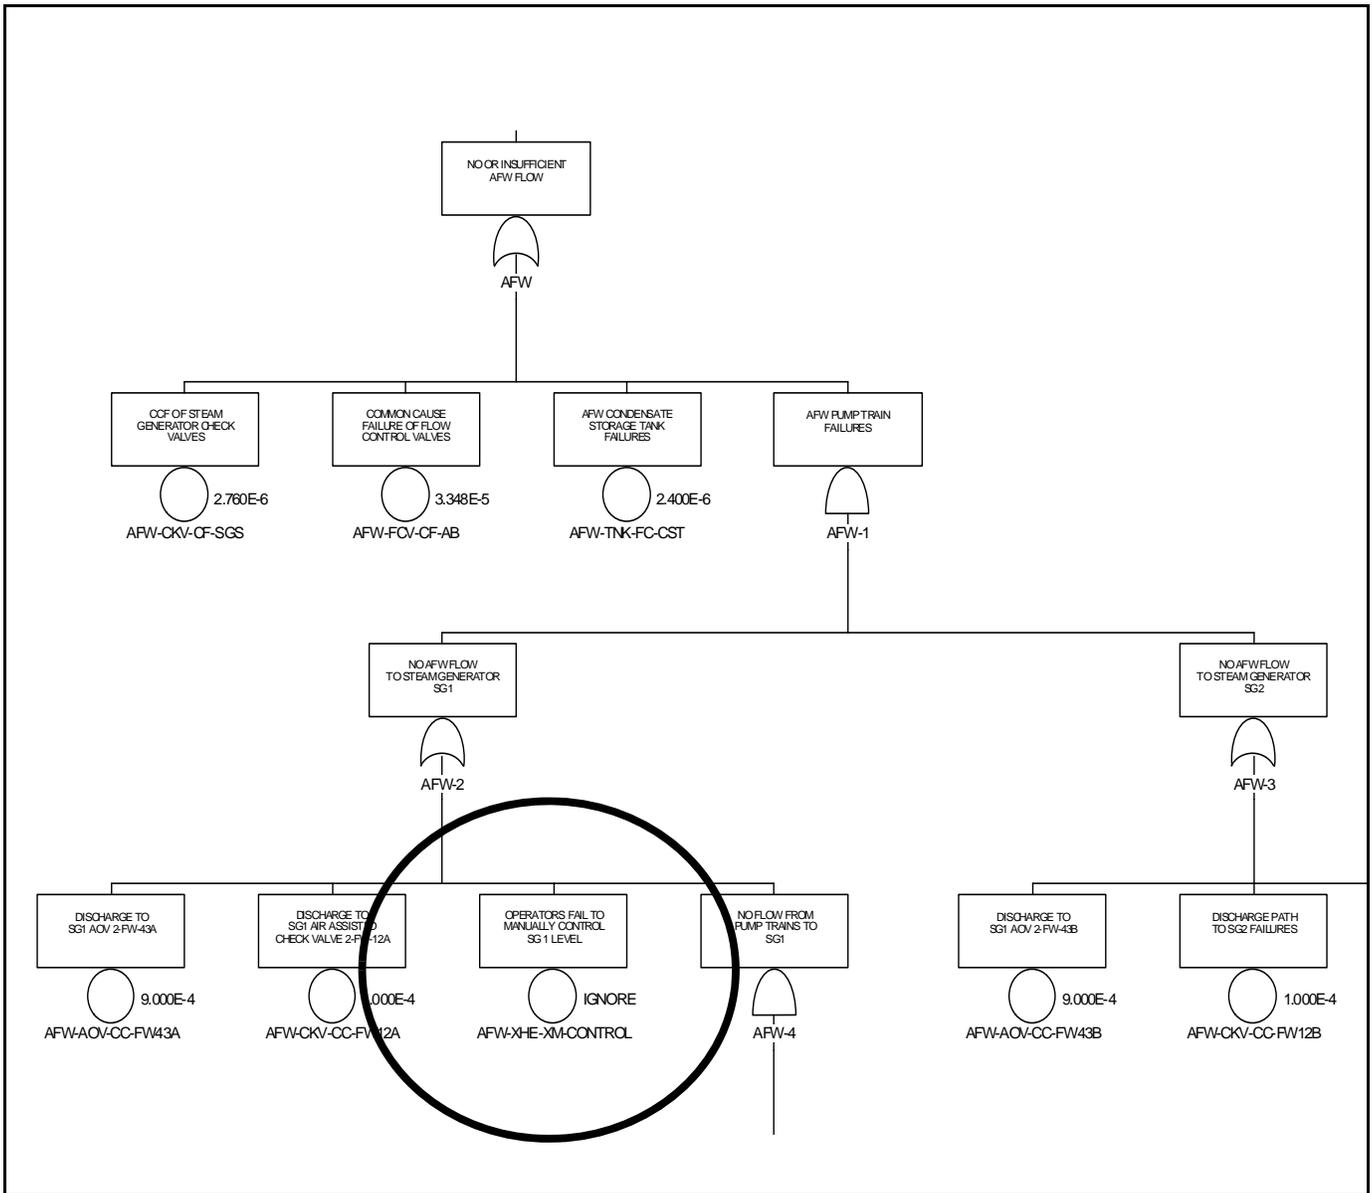
Figure 2. Modified Millstone 2 AFW Fault Tree (with added basic event circled).

- **Potential RCS Overcooling due to failure of the AFW Regulating Valve.**  
Reference 1 indicates that SG AFW Regulating Valve '1' went to its failed position (i.e., full open) allowing excessive flow to the SG '1', which contributed to a greater than expected, cool down of the RCS. The RCS temperature was restored to the normal post-trip band by dispatching an operator to take manual control of the regulating valve. The AFW system fault tree has been modified to include manual control of AFW flow to SG '1'.

- **Fault Tree Modifications**  
**AFW System Fault Tree.** The fault tree was modified to account for operators having to take manual control of AFW flow to SG '1'. Basic event, AFW-XHE-XM-CONTROL, was added under the 'AND' Gate AFW-2 (see Figure 2). For the base case, this event was set to IGNORE.

- **Basic Event Changes**
  - **AFW-XHE-XM-CONTROL.** This HEP was set to  $1.1 \times 10^{-2}$  based on evaluation using the SPAR-H Method (Reference 5). It was assumed that diagnostic activities were needed for this event, but the performance shaping factors (PSF) for the diagnosis and action portions of HEP were set to their nominal values (i.e., set to 1).
