**NRC Conference Call (5/15/07)**  
**Steam Generator Tube Inspection Discussion Points**  
**Oconee Nuclear Station, Unit 2**

Background

- This is the second in-service inspection on the Oconee Unit 2 replacement steam generators (steam generators were replaced in Spring, 2004) - operational cycle length was 1.37 EFPY

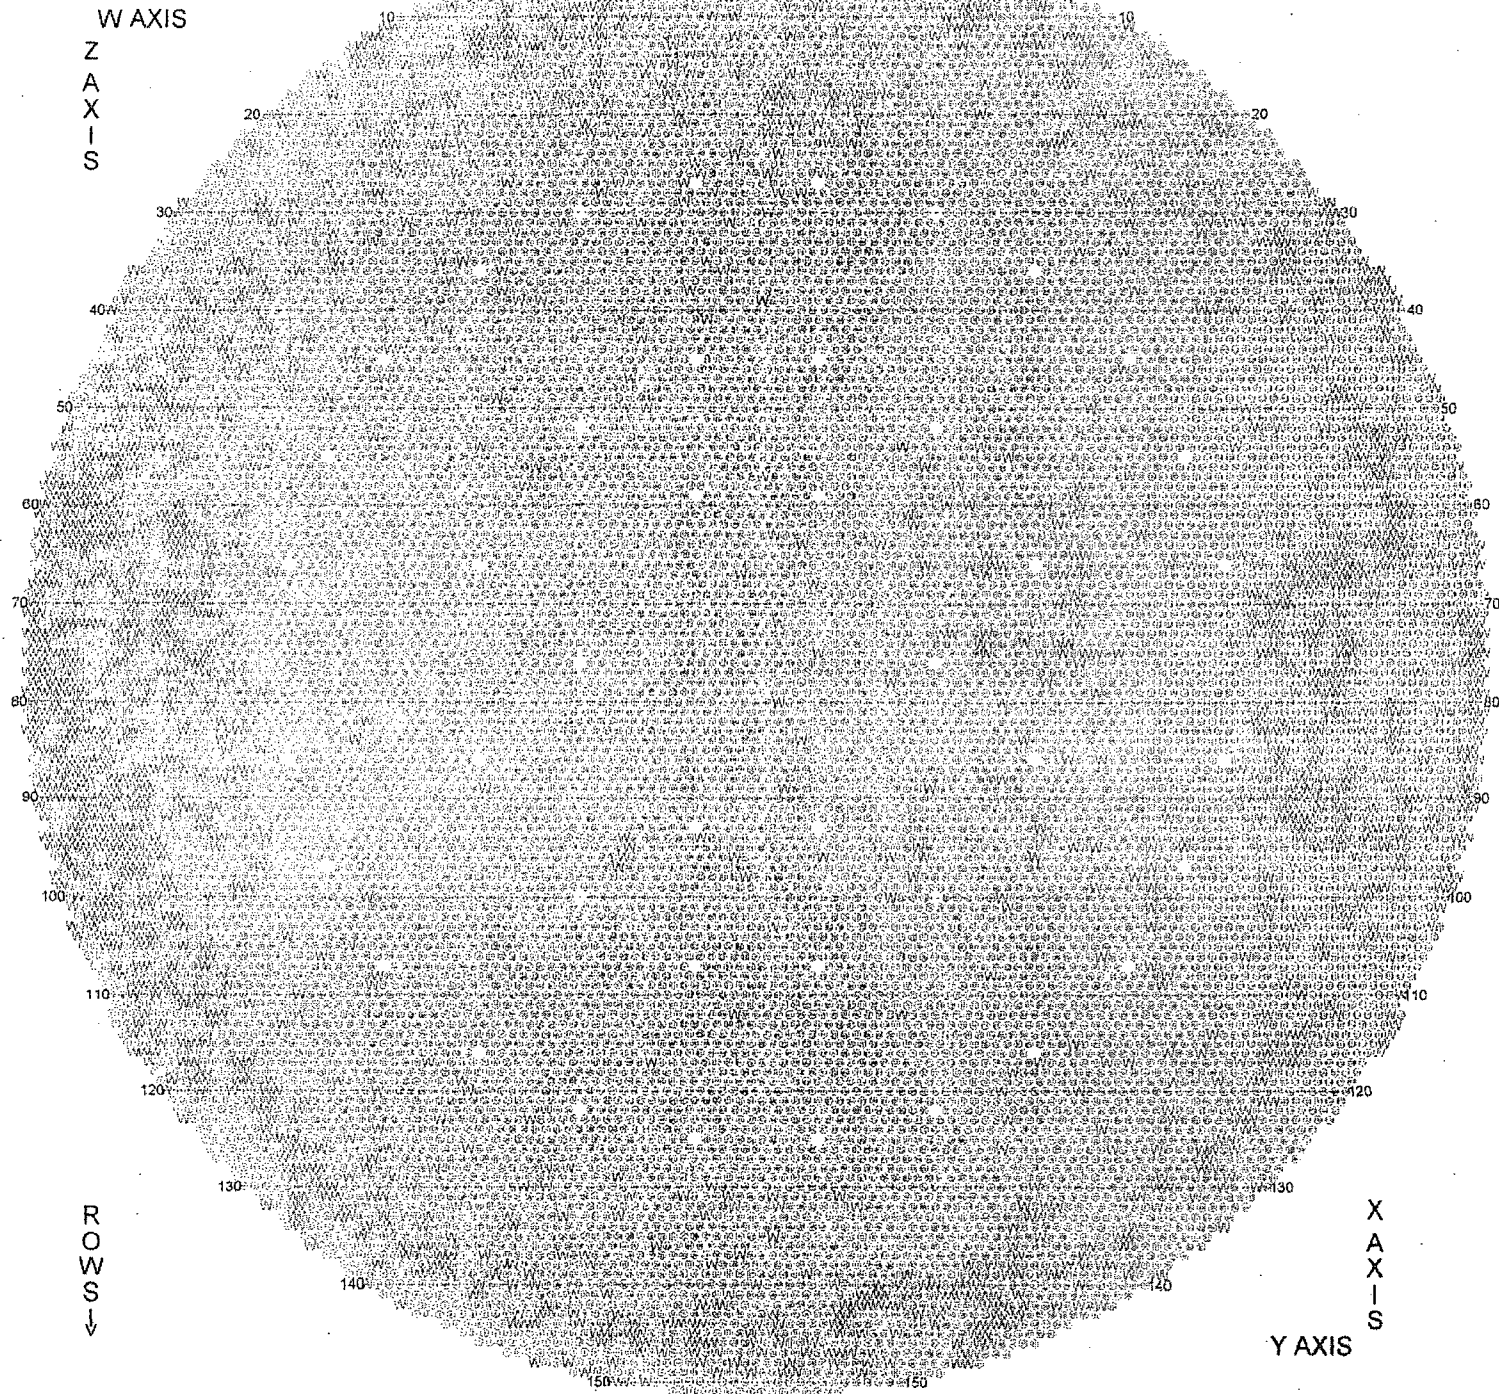
S/G B  
 PRIMARY FACE  
 INLET  
 TOTAL TUBES: 15631  
 TUBES SELECTED: 1724  
 OUT OF SERVICE (#): NA

GROUP	TUBES
Wear	1724

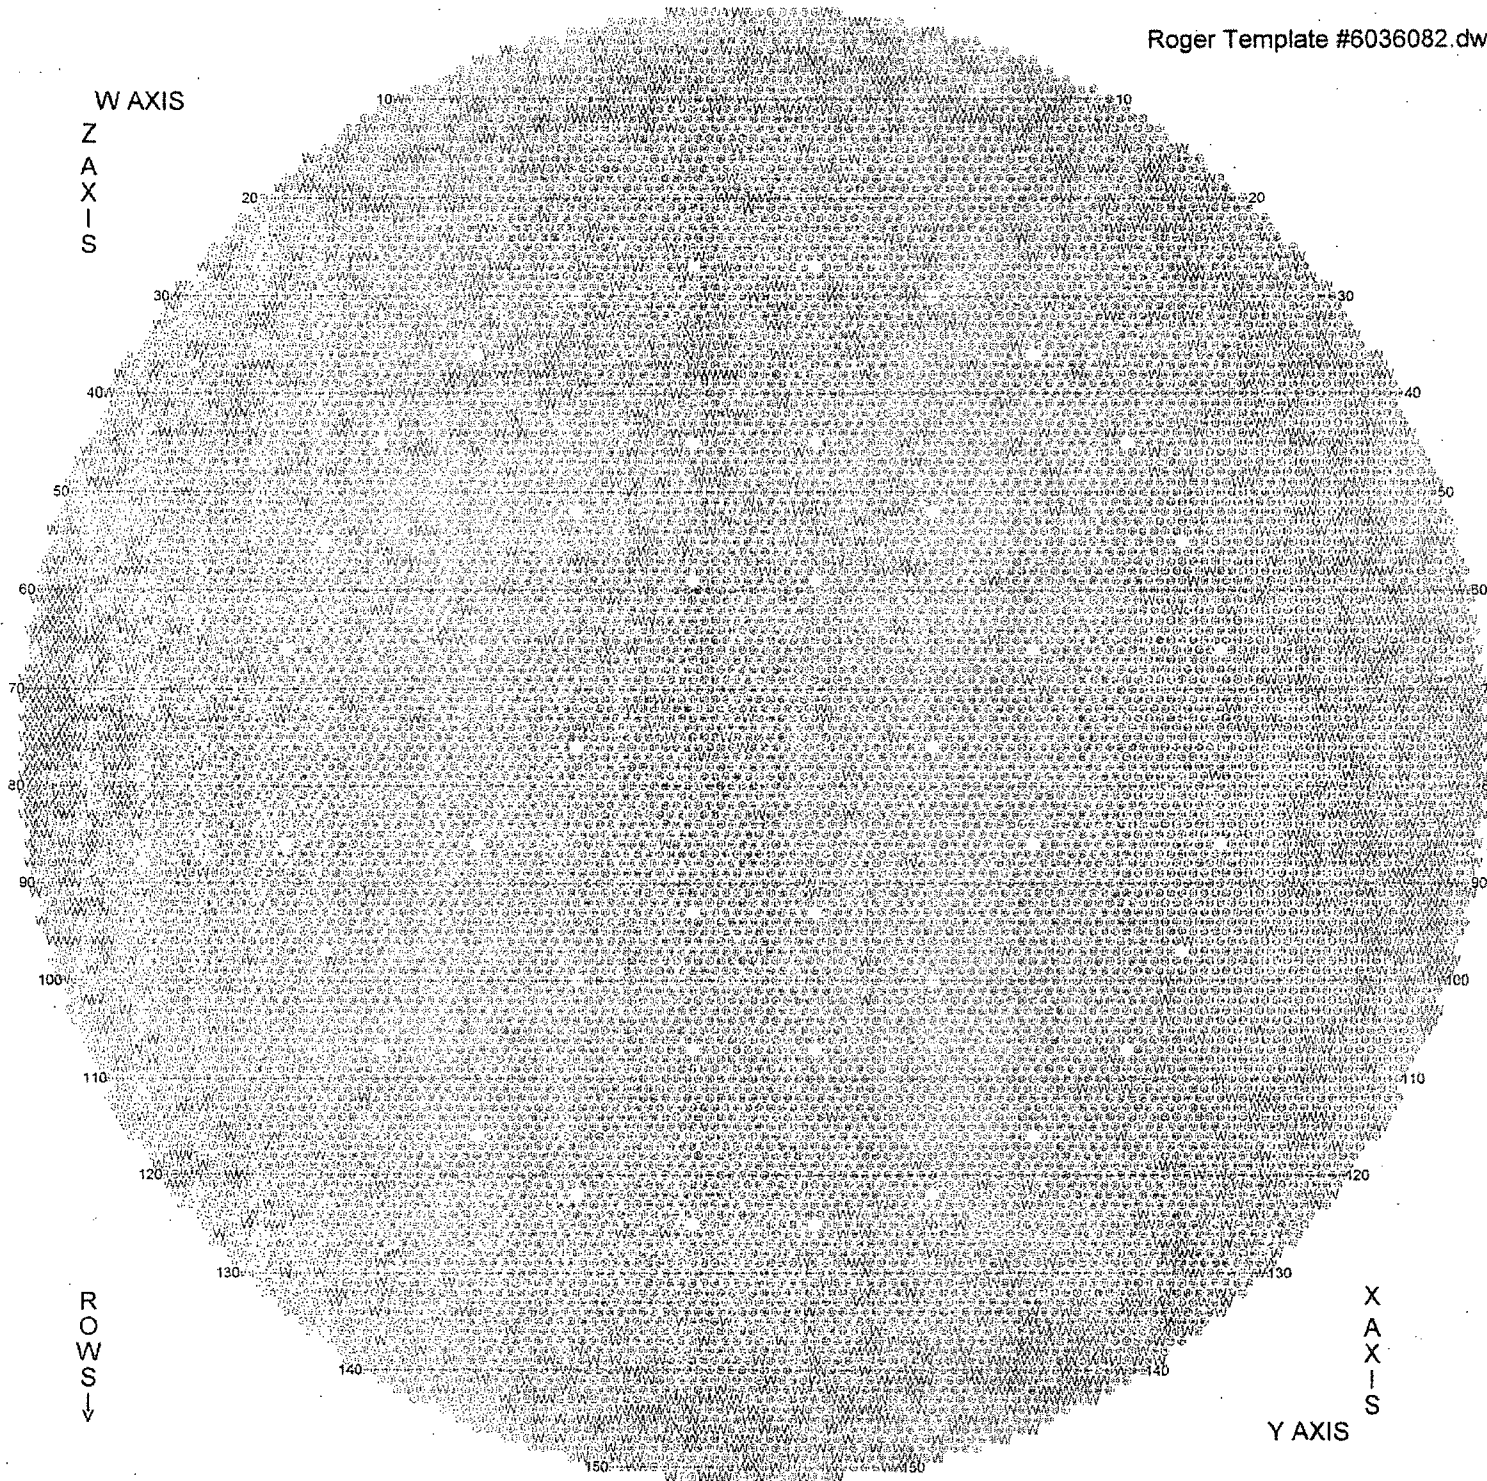
S/G A  
 PRIMARY FACE  
 INLET  
 TOTAL TUBES: 15631  
 TUBES SELECTED: 1587  
 OUT OF SERVICE (#): NA

GROUP	TUBES
Wear	1587
