PG&E Letter DCL-07-068

Docket No. 50-323, OL-DPR-82
Diablo Canyon Unit 2
PG&E Response to NRC Request for Additional Information Regarding the
Unit 2 Thirteenth Refueling Outage Steam Generator Tube Inspections

**PG&E Response to NRC Request for Additional Information (RAI) Regarding the
Unit 2 Thirteenth Refueling Outage (2R13) Steam Generator Tube Inspections**

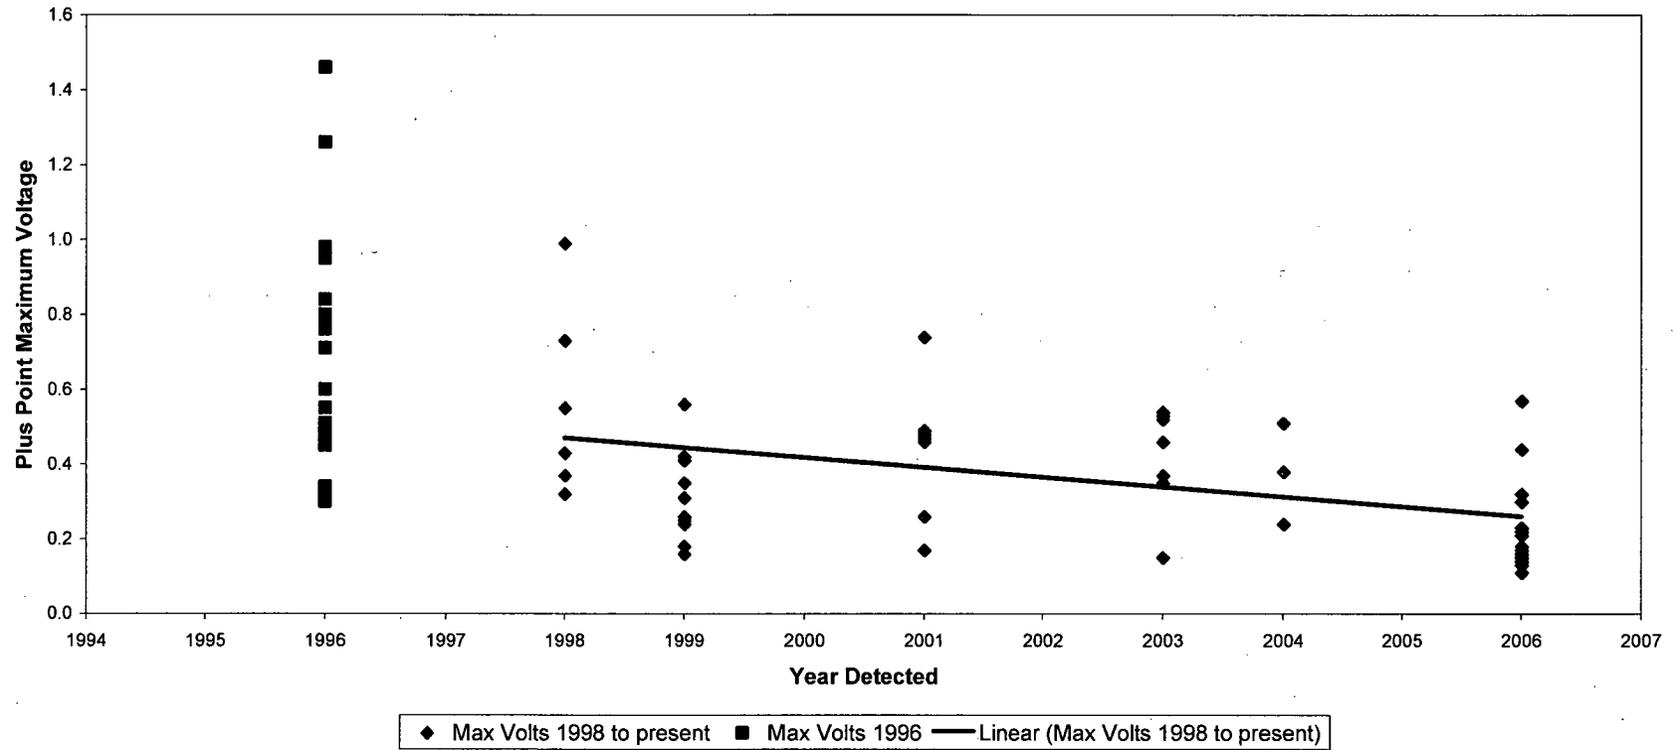
Page 2-12 of DCL-06-100 (PWSCC ARC report) notes that even though Unit 2 shows increasing recent trends in average depths of circumferential indication, there are small Plus Point voltages associated with these indications. Figure 1 of this letter plots the Plus Point voltages of all Unit 2 TSP circumferential indications, and shows a decreasing trend over time, even when the larger 1996 voltages are removed from the trend.

DCPP Unit 2 TSP Circumferential Indications Plus Point Maximum Voltage Trending
