RE: Blazosky Associates, Inc. - Troxler Nuclear Gauge #29883 Damage Incident on June 25, 2007.

Incident Response Report

Incident: Moisture/density gauge with radioactive sources damaged.

Gauge: Troxler model 3440 moisture/density gauge, S/N 29883 containing a 40 mCi ²⁴¹Am-Be neutron source S/N 47-26893 and an 8 mCi ¹³⁷Cs source S/N 750-4210.

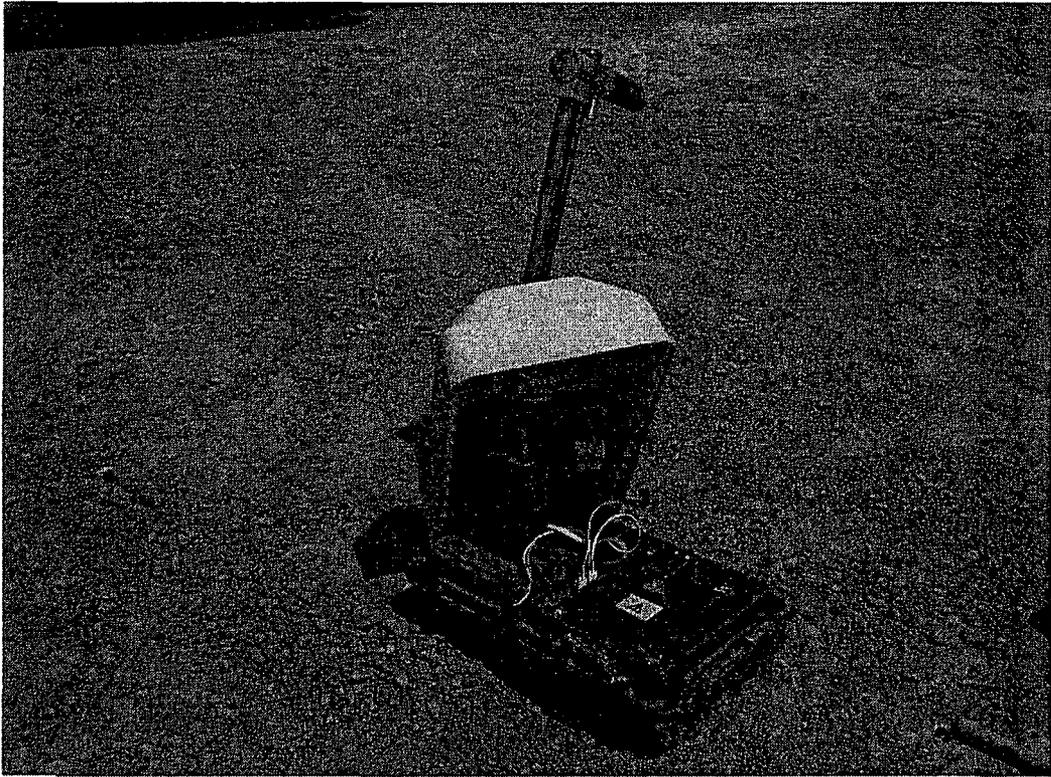
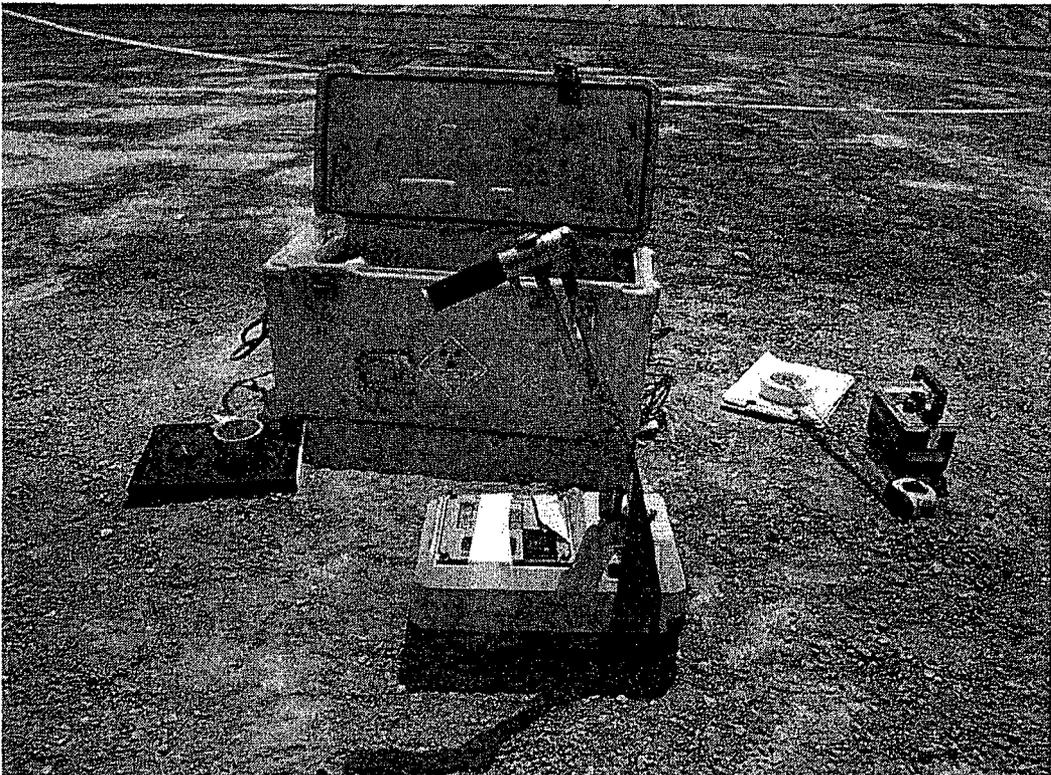
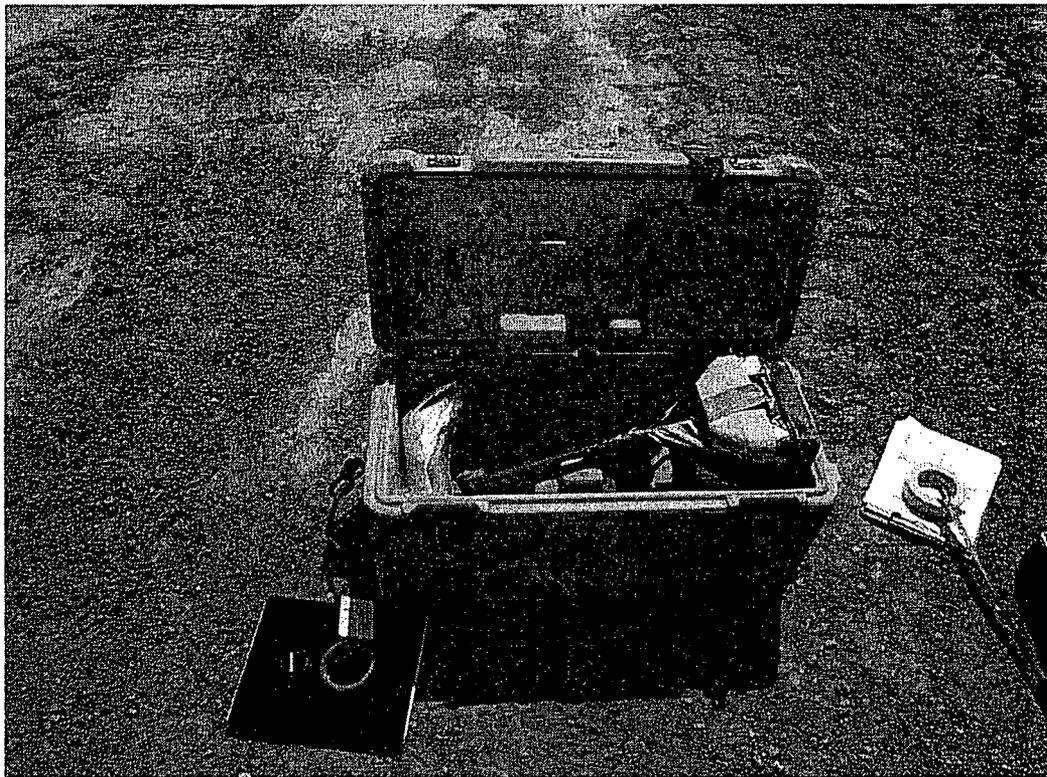
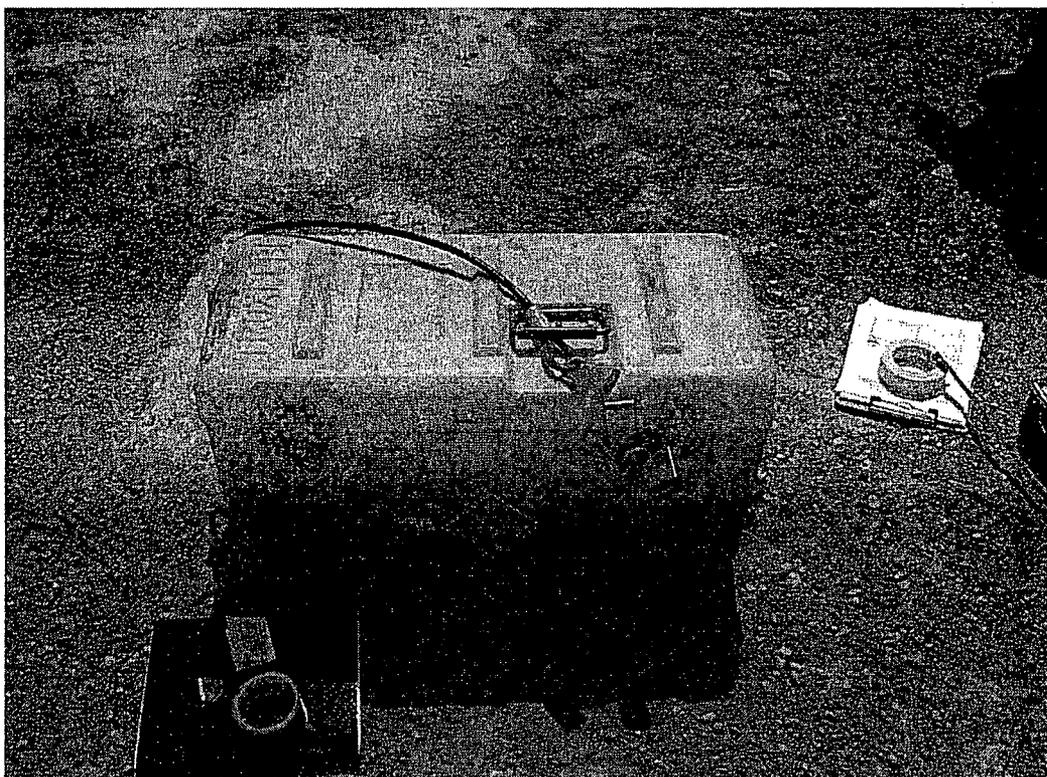
The screws holding the plastic cover on the instrument were torn from the anchors in the cover. The cover was loose and could not be secured to the base, but was not broken, except for the screw sockets. The ¹³⁷Cs source rod was withdrawn into the shield and the rod was bent at about a 15-degree angle at the top of the instrument. The support rod for the ¹³⁷Cs source rod was broken in two places, so the source rod was free to turn and could be removed from the shield. There was no apparent damage to the lead shield for the sources or to the tungsten shield block for the ¹³⁷Cs source.

Copies of the survey forms and photos of the instrument and shipping container are attached.

Recovery: The ¹³⁷Cs source rod was secured so that it could not be removed from the shield with duct tape and the instrument was placed in the Troxler shipping/storage container. The source rod is further secured against moving out of the shield by the partitions in the shipping container. It is recommended that the source rod be secured with a wire or cable to replace the duct tape for shipping the gauge to Troxler for repair. The shipping container was closed and gamma radiation measurements were made on the
