PG&E Letter DCL-07-073

Licensee Event Report 1-2007-002-00

Manual Reactor Trips During Mode 3 Rod Testing Due to Crud Related Rod  
Slippage

**4. TITLE**  
Manual Reactor Trip In Mode 3 During Control Rod Testing

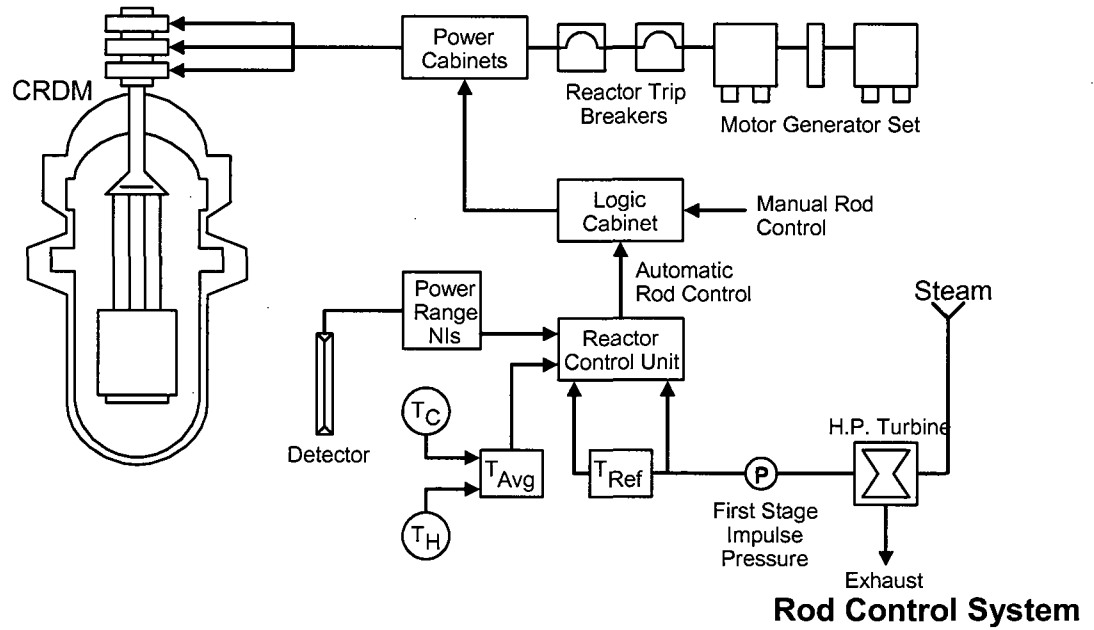
With reference to the figure below, the Rod Control System uses a magnetic stepping mechanism that withdraws, holds, or inserts control rod assemblies in fixed increments. The elements of the system include: control room switches and indicators; logic and power cabinets external to containment; and coils, connectors, and stepping mechanisms inside containment. The stepping mechanism or Control Rod Drive Mechanism (CRDM) uses mechanical components including springs and levers that concentrate and react to pulsed electromagnetic fields passed into the Reactor Coolant System (RCS) pressure boundary from exterior coils. If the RTS initiates a reactor trip, electrical power to these coils is interrupted, the magnetic field collapses, springs open the latches, and the rods are allowed to respond to gravity, falling into the core.

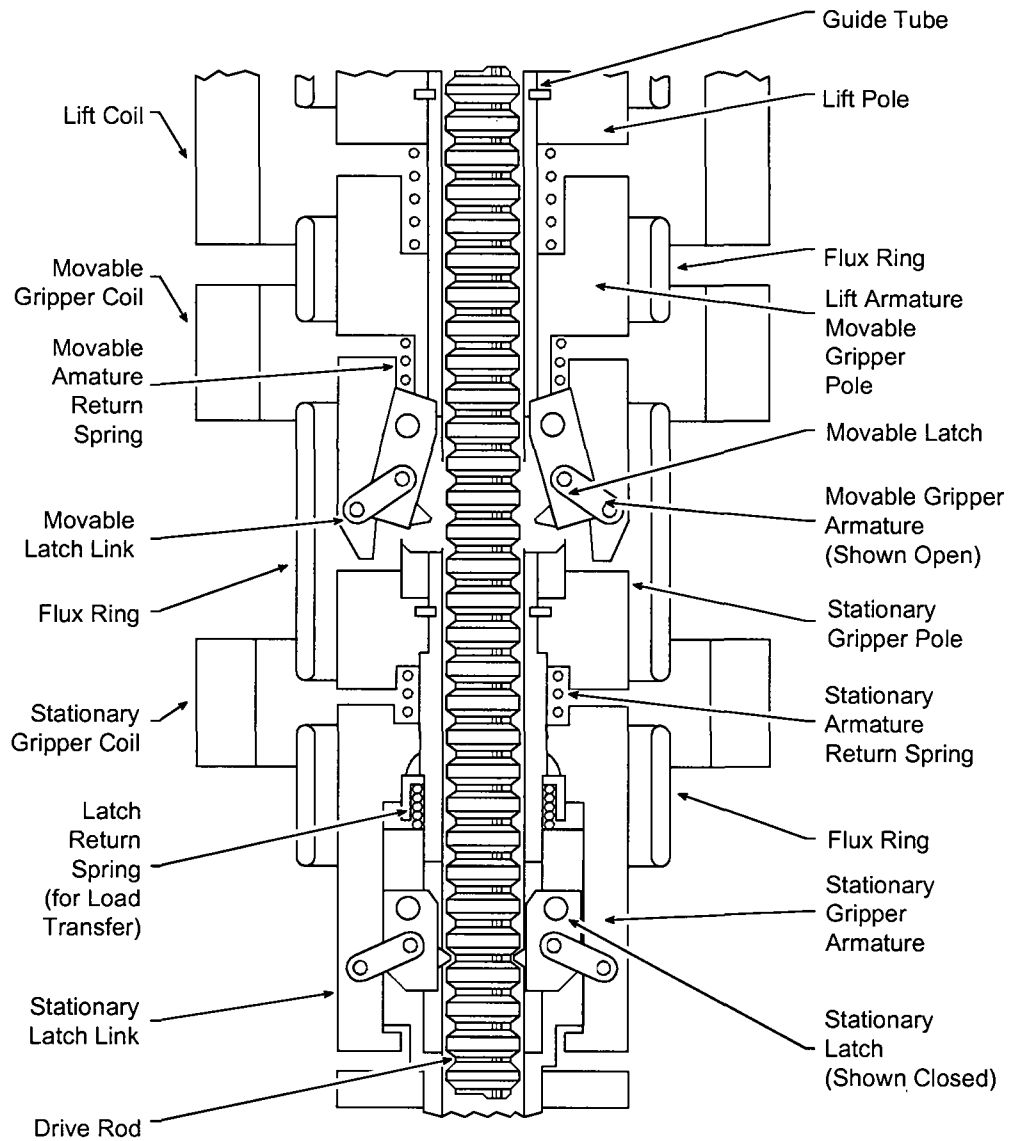
**Rod Stepping Mechanism**

Because the CRDM is inside the RCS pressure boundary in a low flow area above the reactor head, activated corrosion products (crud) can migrate and deposit in this area. Ferromagnetic and, to a lesser degree, paramagnetic materials would also be attracted to the CRDM components due to the strong magnetic fields created by the coils. Industry experience has demonstrated that these factors infrequently occur but can affect CRDM performance.
