Entergy Nuclear Operations, Inc.
Palisades Nuclear Plant
27780 Blue Star Memorial Highway
Covert, MI 49043

Palisades Nuclear Plant
Docket 50-255
License No. DPR-20

Request for Relief from ASME Section XI Code Requirements for Repair of Service Water System Pipe

**ENCLOSURE 1
REQUEST FOR RELIEF FROM ASME SECTION XI
INSERVICE INSPECTION PROGRAM**

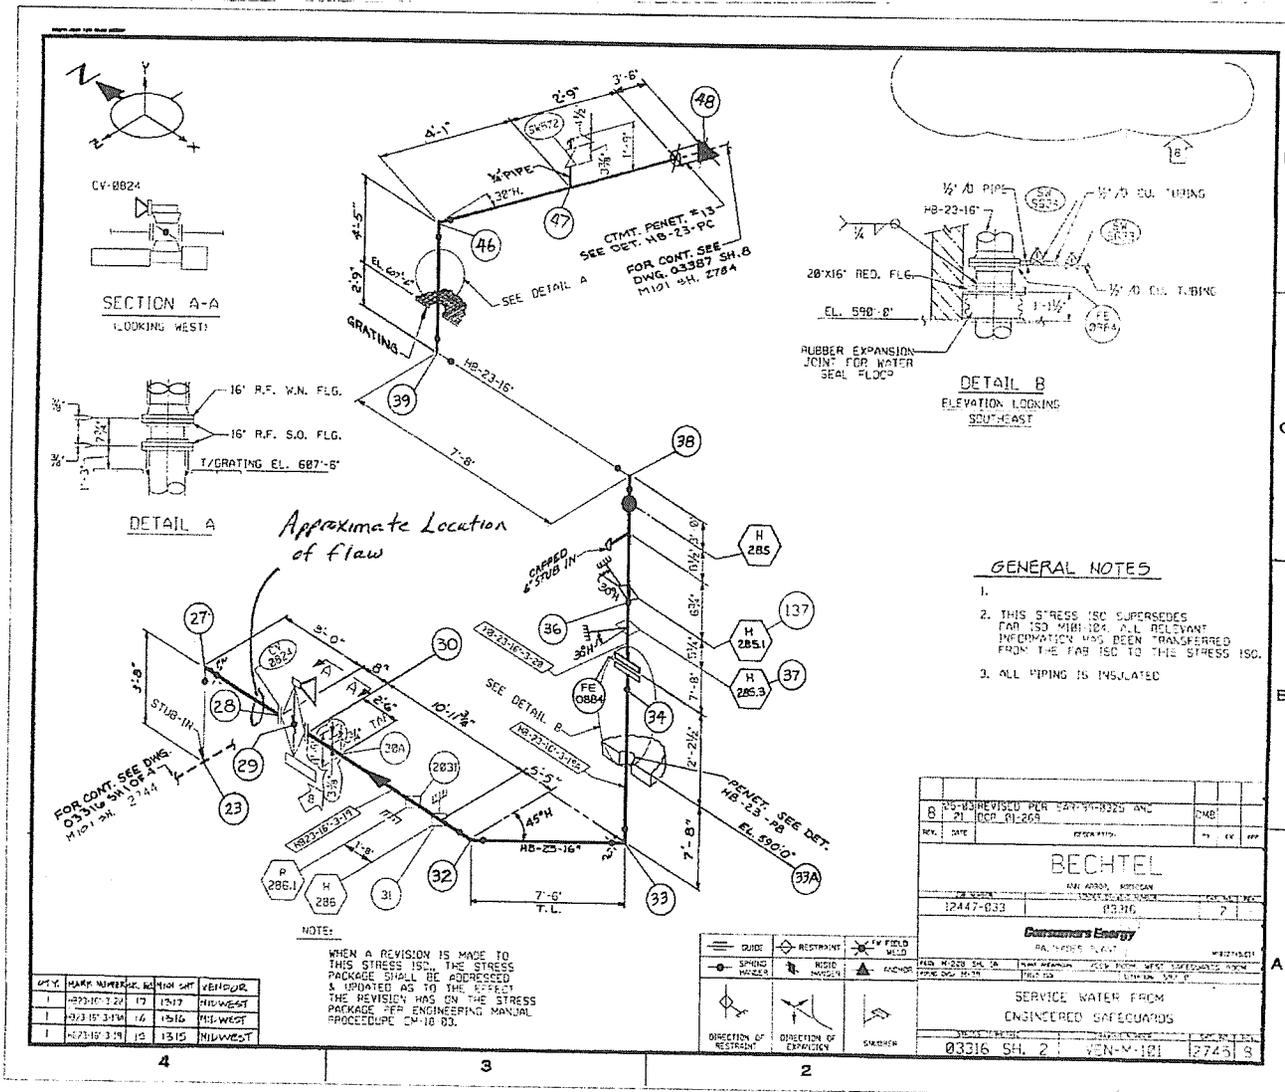
FIGURE 1

boundary of an ASME Class 3 system and affects the operability of the engineered safeguards system due to potential flooding and the SWS heat removal capability. Figure 1 provides an isometric drawing of piping section containing the flaw.

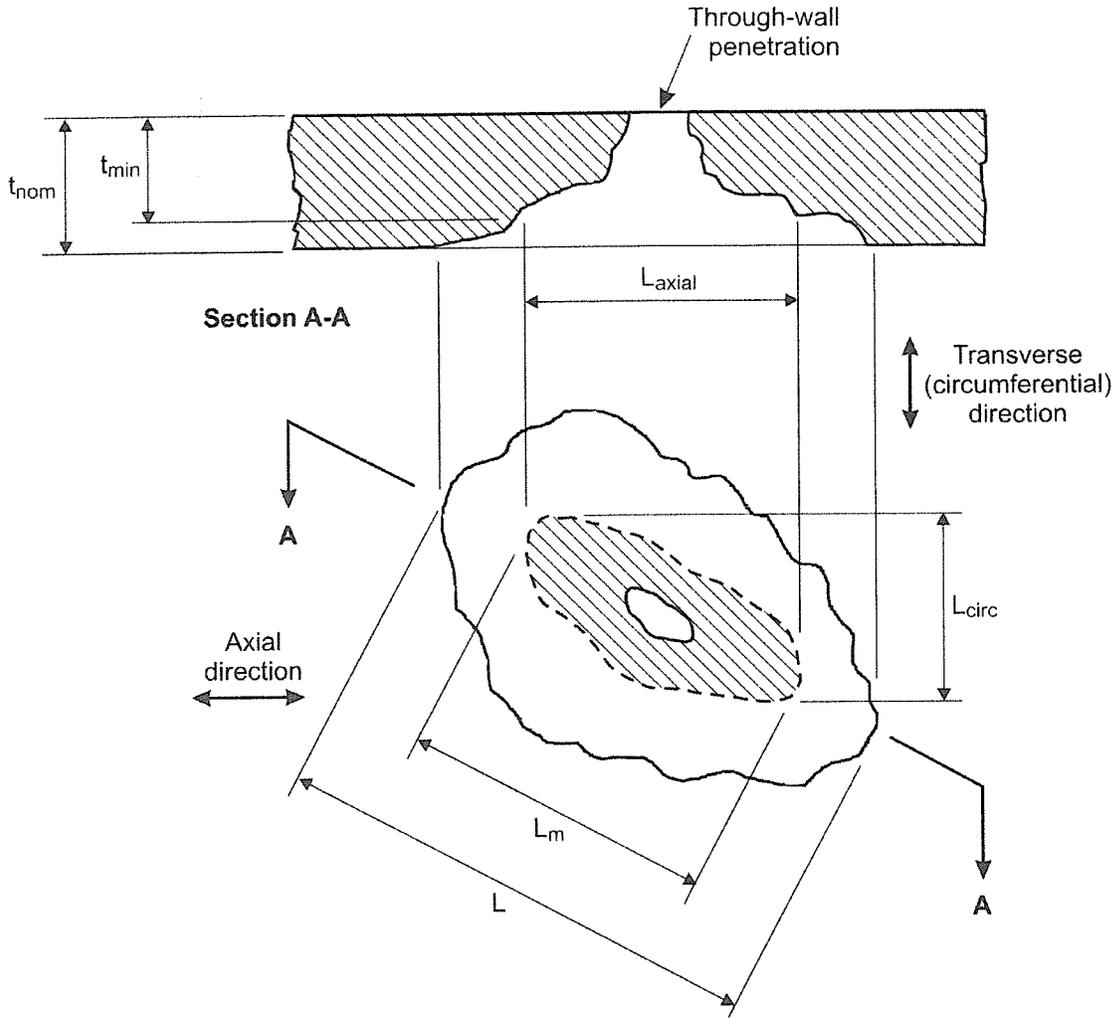
In July 2006, a pinhole leak was discovered approximately one foot downstream of control valve CV-0824 in the “Service Water Return from Containment” piping (HB-23-16) outside of the containment penetration MZ-13 [1]. This single pinhole is located on the bottom of the 16-inch carbon steel pipe in the 6 o’clock position [1]. The most recent NDE inspection data [2d] indicates that there are now 4 separate pinhole leaks in the same vicinity.

Figure 1. Planar Characterization of Through-wall, Nonplanar Flaw

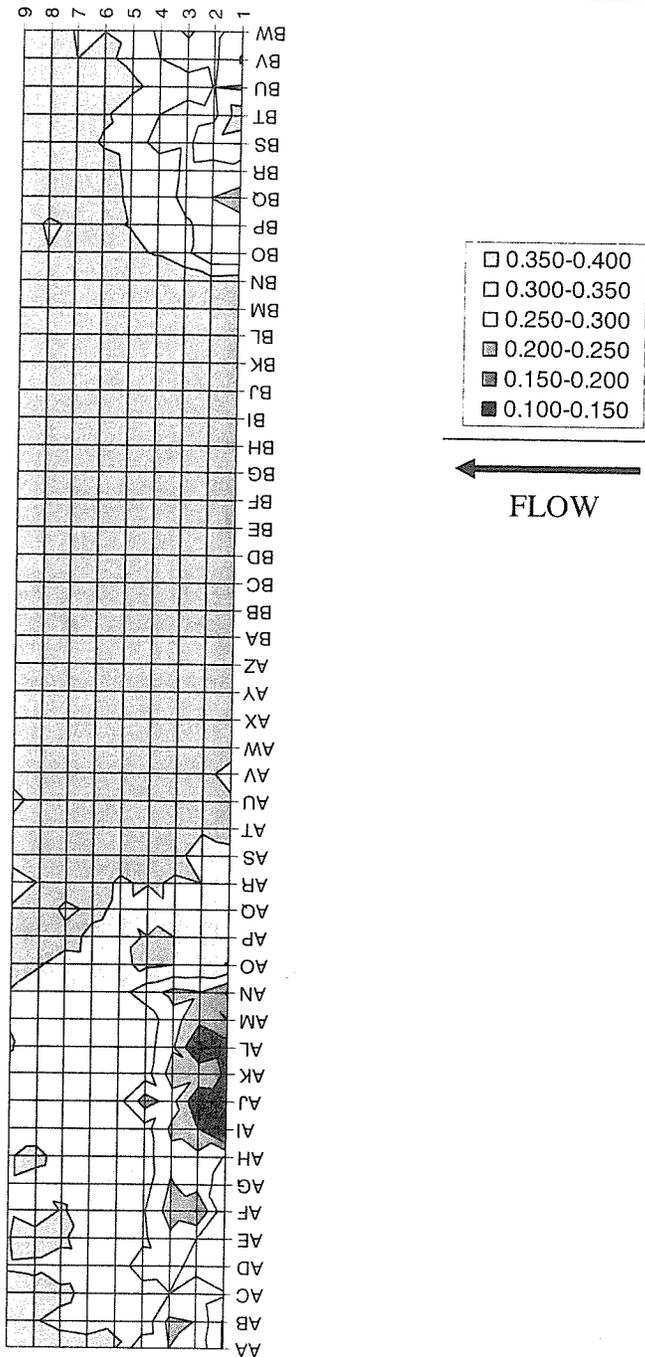
Figure 2. NDE Inspection Data of Effected Pipe Region from 10/27/06

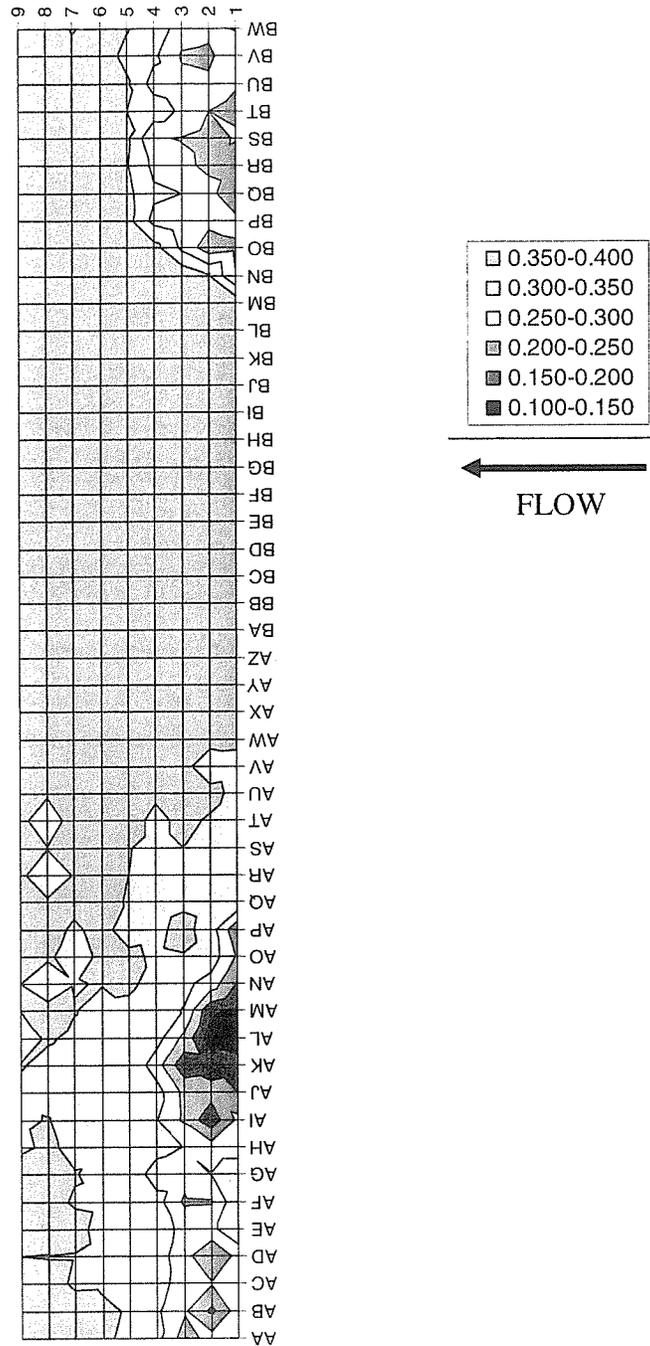
Figure 3. NDE Inspection Data of Effected Pipe Region from 2/14/07

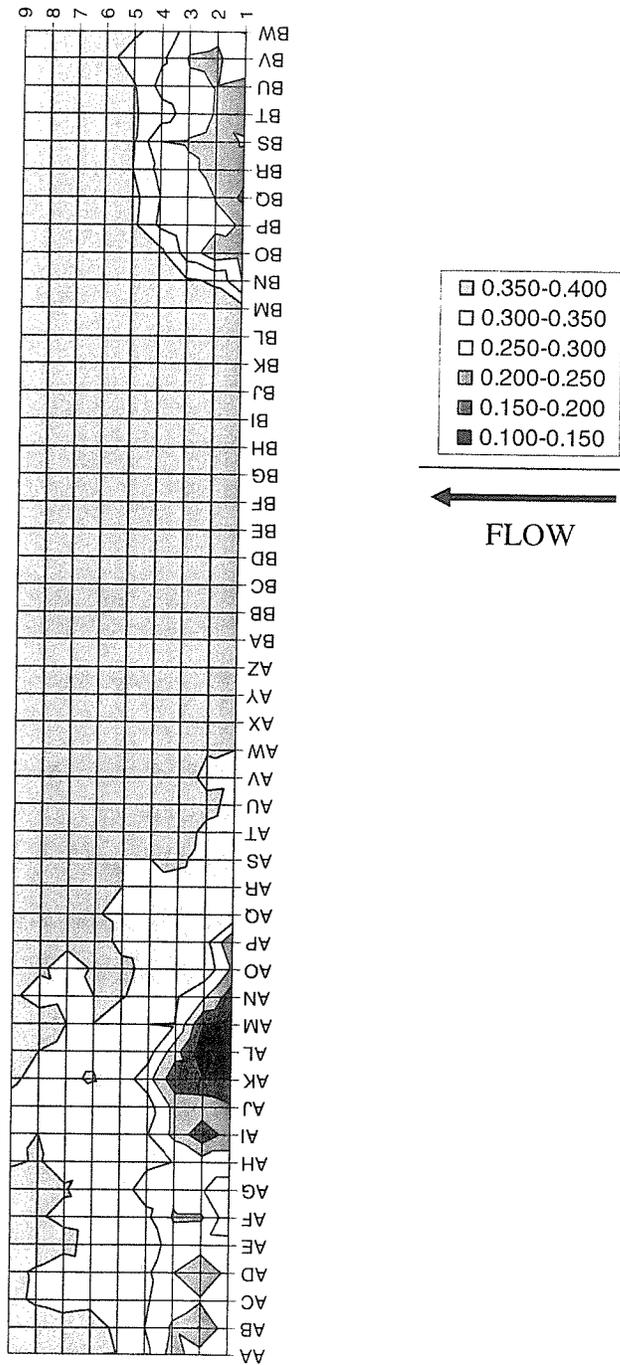
Figure 4. NDE Inspection Data of Effected Pipe Region from 5/09/07

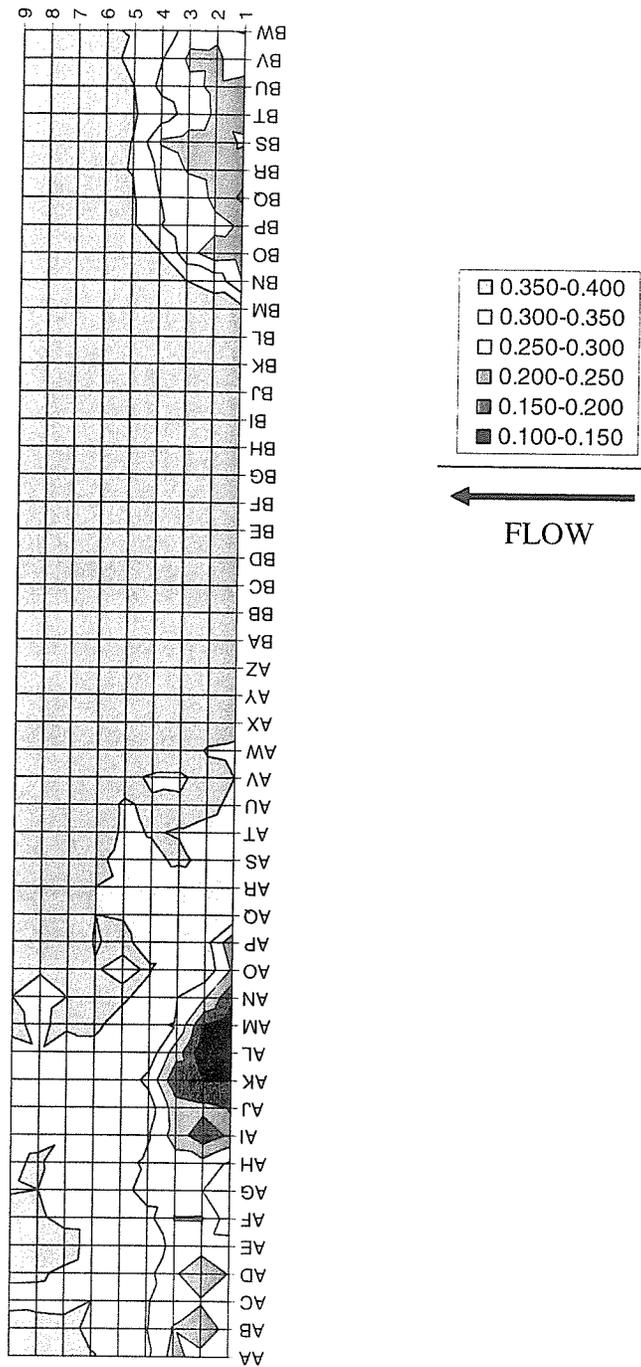
Figure 5. NDE Inspection Data of Effected Pipe Region from 7/02/07

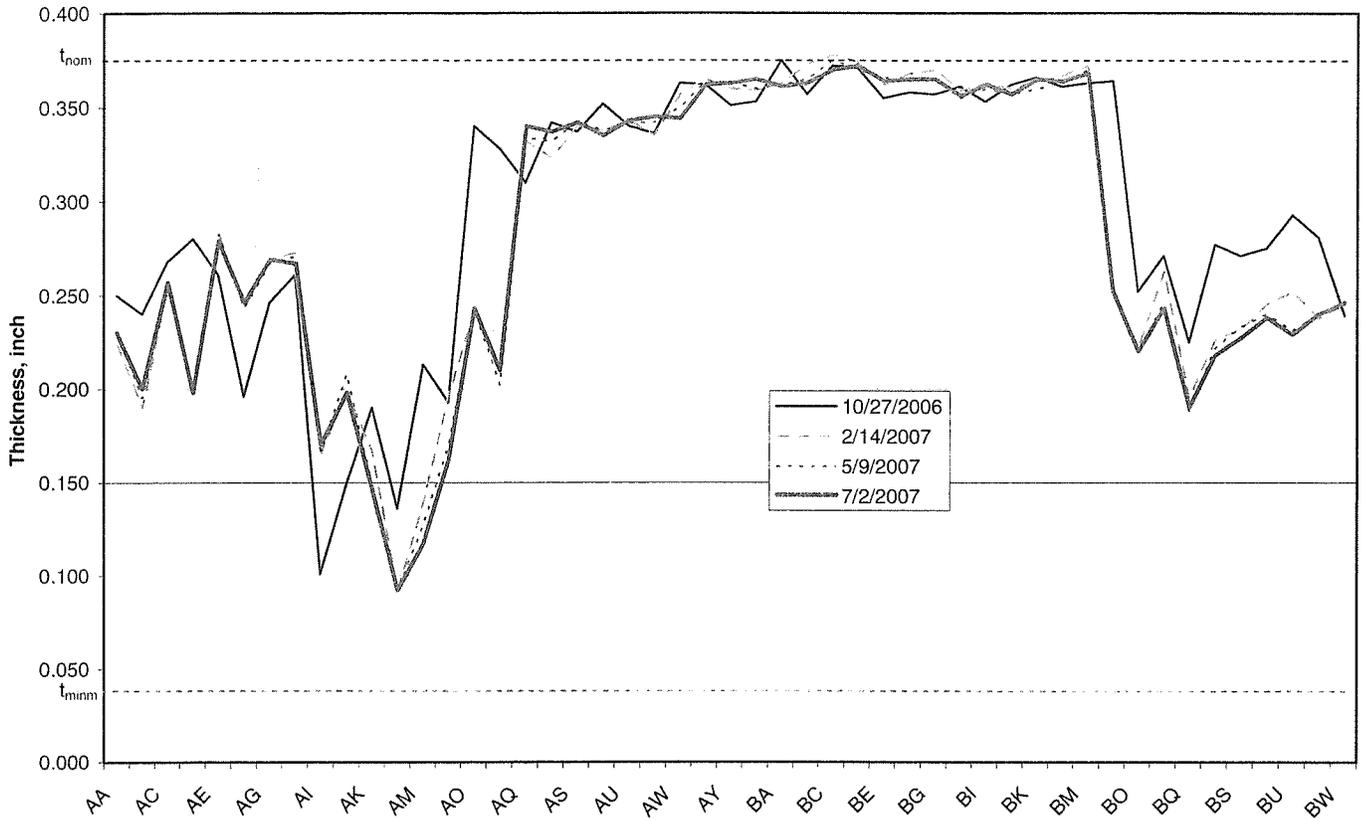
Figure 6. Circumferential Profile – Minimum Values

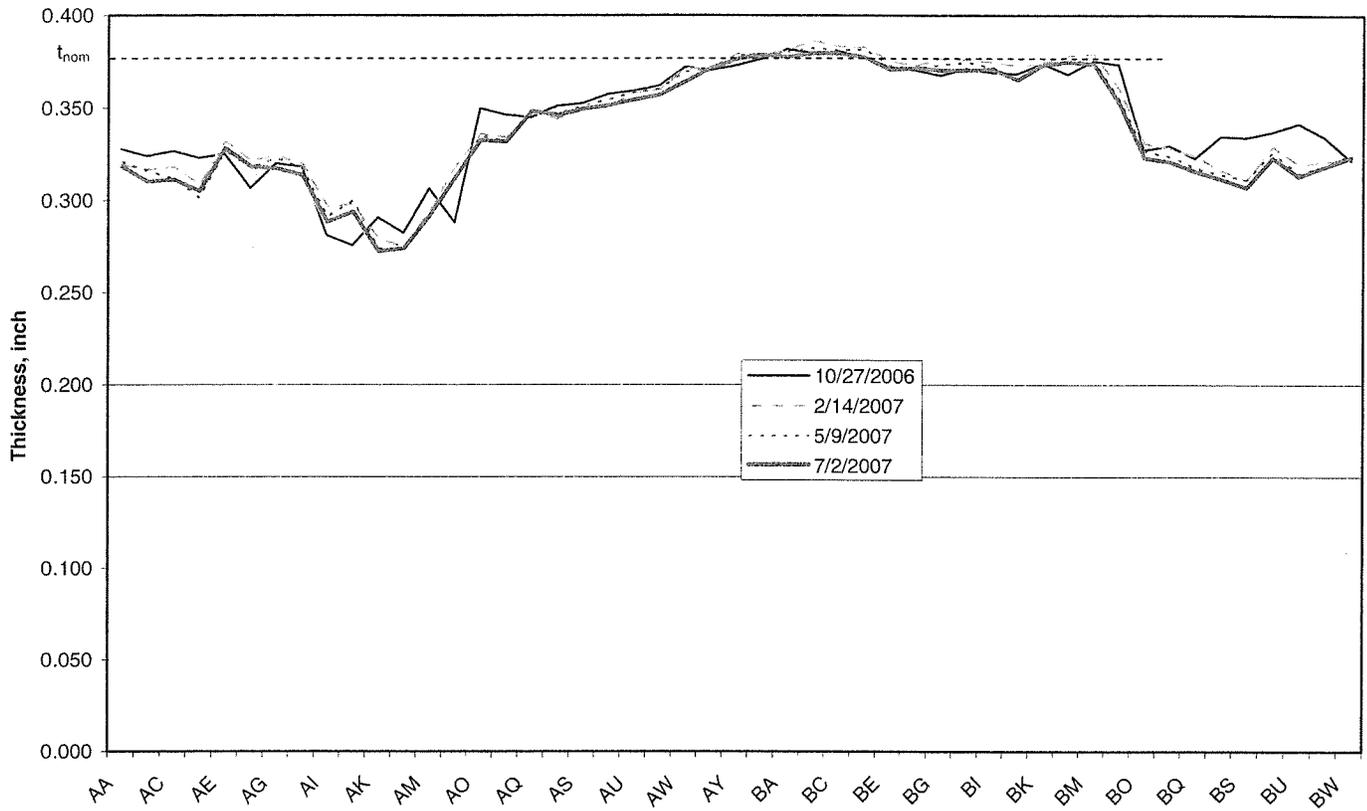
Figure 7. Circumferential Profile – Averages

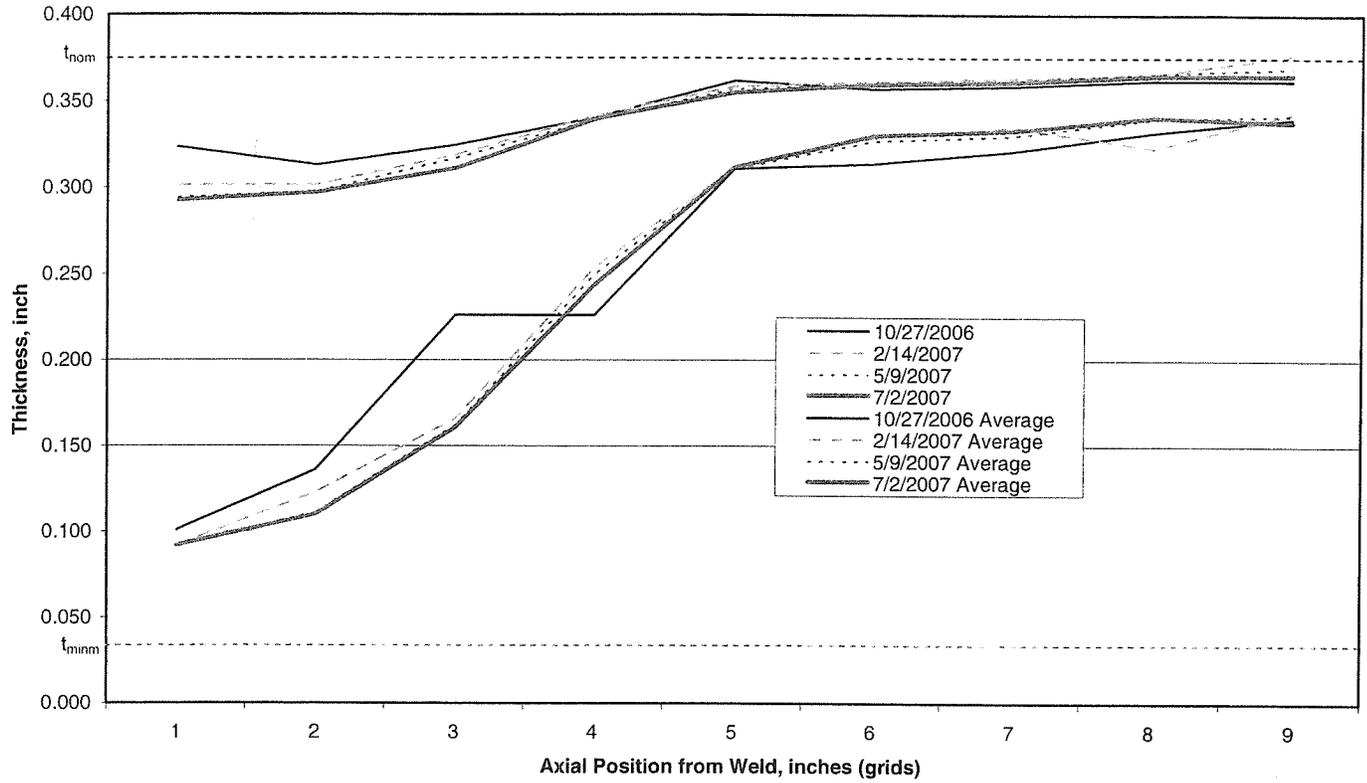
Figure 8. Axial Profiles

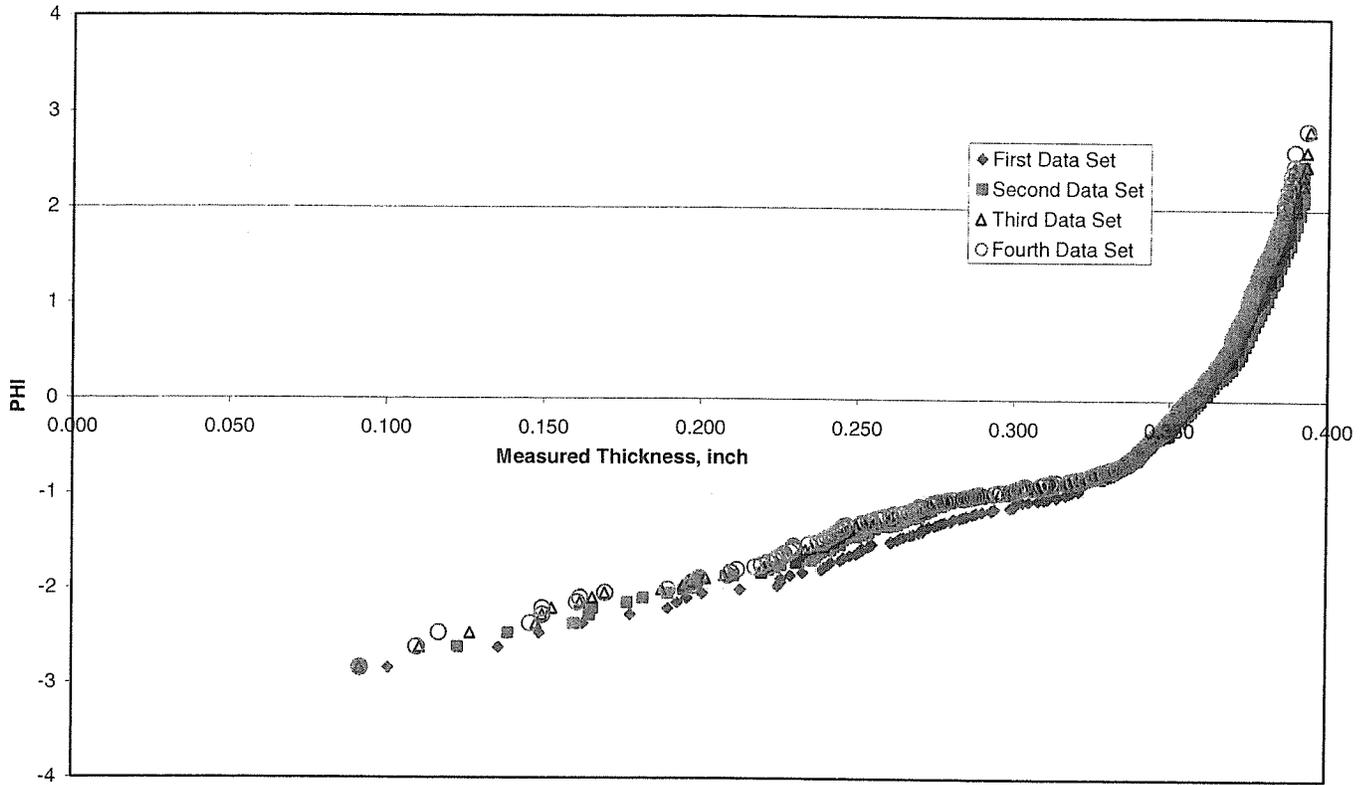
Figure 9. Cumulative Distribution of Measured Thickness

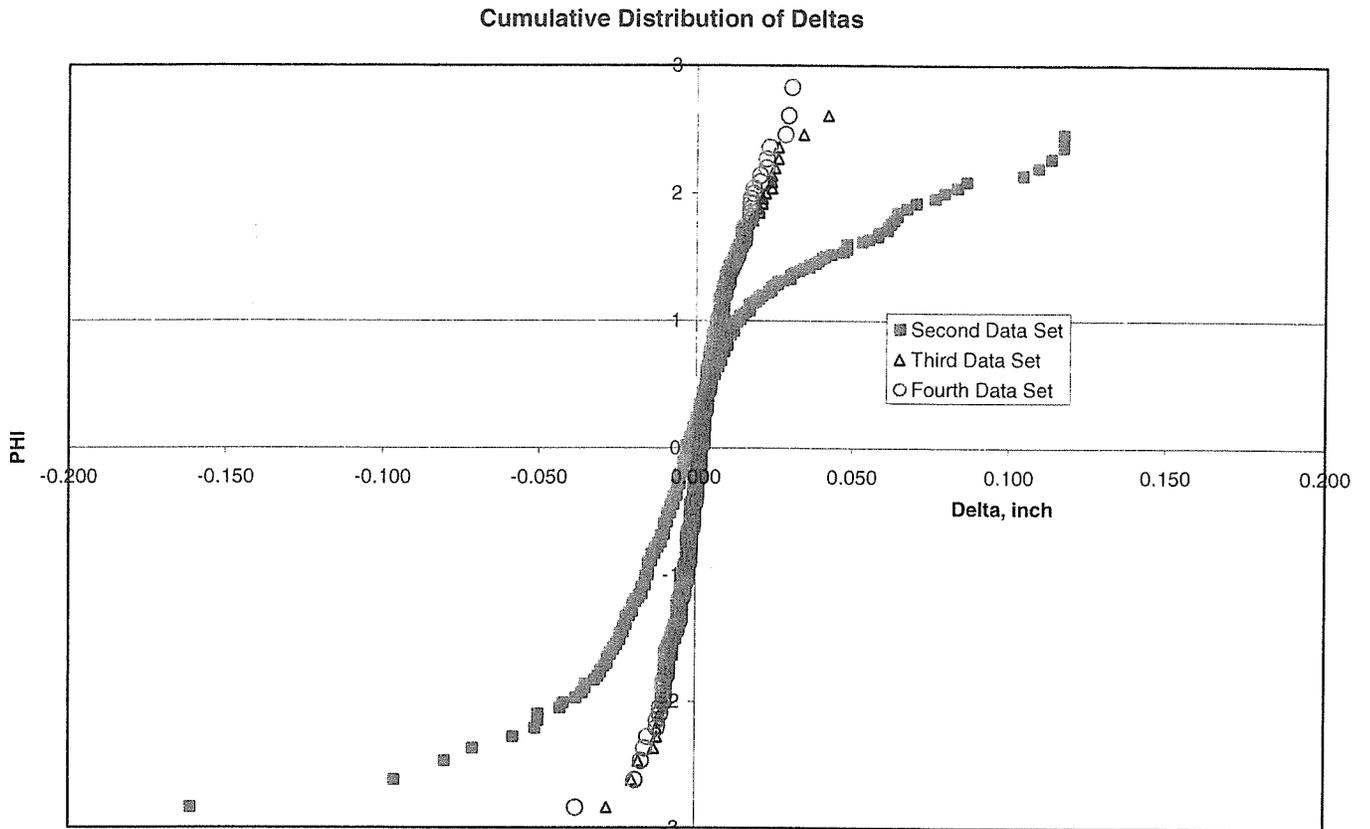
Figure 10 shows the same basic data in a different way. Figure 10 shows the same effect observed from Figures 6-8, but more quantitatively, using the apparent deltas as the measure. The advantage of evaluating delta is that effects show up directly and changes can be observed more readily. The primary disadvantage is that the error in measurements (each thickness measurement will have an error associated with it; typically ± 0.010 inch for UT thickness measurements) will be magnified with the differences between subsequent individual measurements are compared. The means of all three data sets (i.e., the value at PHI = 0) are very close to zero, implying that the mean metal loss over the three measurements is very near zero. Figure 10 also shows that the vast majority of the metal loss occurred before the initial inspection in October 2006, with a much smaller amount of metal loss at any point between October 2006 and February 2007. Since February 2007, metal loss

Figure 10. Cumulative Distribution of Deltas (point-to-point thickness differences from one examination to the next)

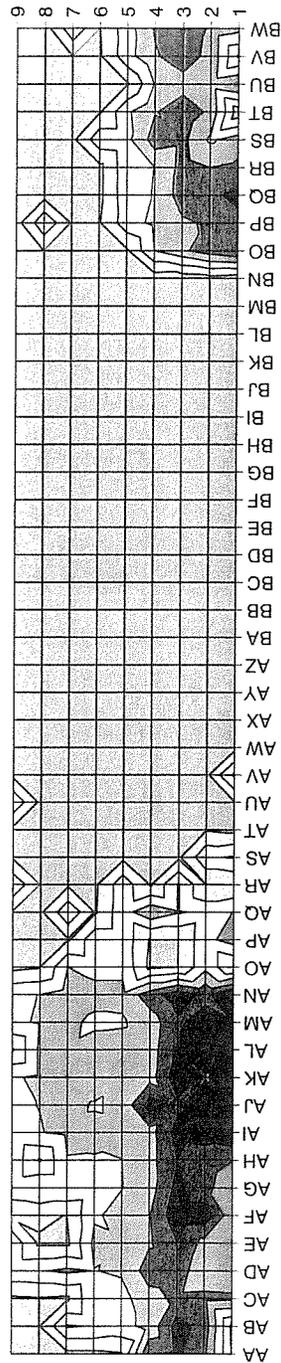
Extrapolating these results to September 2009 indicates the minimum thickness in any grid will be 0 (i.e., a leak is definitely predicted) and the minimum thickness of any circumferential band where thinning is occurring (actually half of a circumference) will be of the order of 0.150 inch. Using the extreme values that the statistical plots permit predicts that the cumulative distribution of thickness in September 2009 will look like the plot in Figure 11. If it is assumed that all thinning occurs in the one inch grid closest to the weld, the band averages for that one inch grid will decrease from 0.292 inch (July 2007) to 0.260 inch.

Figure 11. Predicted UT Thickness Map, September 2009
