**CORRO-CONSULTA**

**MEMORANDUM – REDACTED VERSION – JULY 19, 2007**

**Subject:** Update of Current Knowledge Regarding the State of Integrity of OCNCS Drywell Liner and Comments Pertaining to Aging Management Thereof

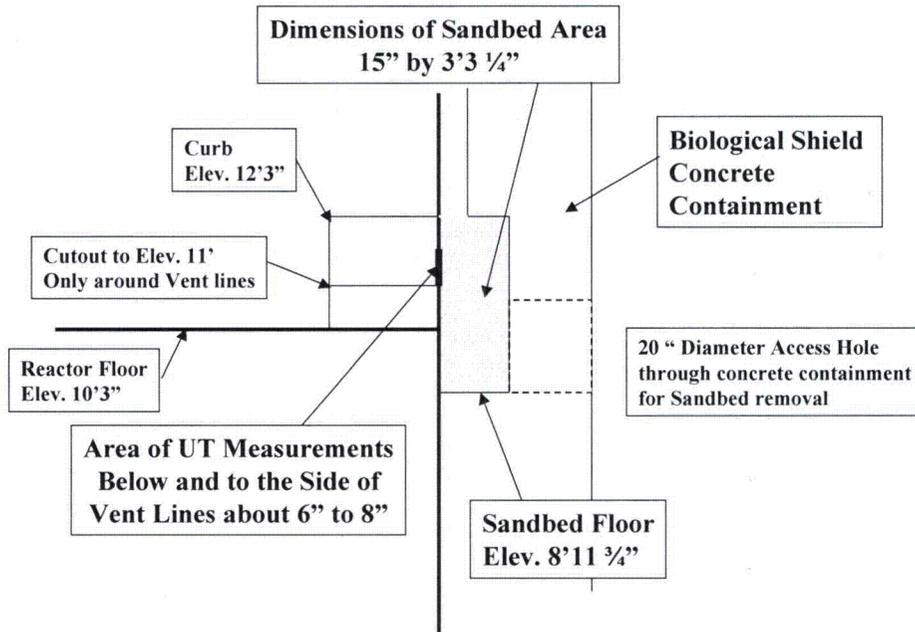
**Figure 1**

**Schematic Cross Section through Sandbed Area**  
(not to size)

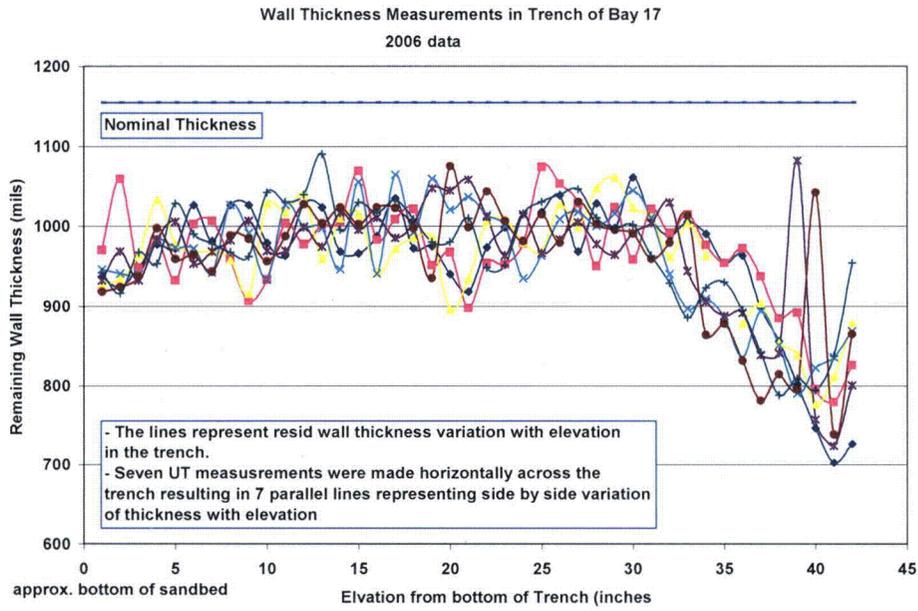
We take issue with this statement. In support of this contention, an effort was made to show graphically the remaining wall thickness observed in all of these various locations. Thus Figure 2 shows, by way of example, the remaining wall thickness from the 2006 UT measurements made with the help of 6 by 6 inch grids as a function of elevation in the **trench of Bay 17**. It is understood, as is described in Ref. 3 that 6 such grids were placed one on top of the other in the trench in order to capture the corrosion from the bottom to the top of the sandbed. Hence, if the bottom of the trench had the elevation about 9 feet, then the top of the 6 grids would have had an elevation of about 12 feet, which according to Figure 1 corresponds to the top of the sandbed and is at least 9 inches higher than the top of the grid used for UT measurements from the inside. (Note, none of these elevations is terribly accurate, however, the top of the trench measurements were definitely lower (deeper pits) by a good margin than the inside grid measurements). Figure 2 plots all individual 2006 measurements from the trench in bay 17. The 6 traces represent the variation of the wall thickness in the horizontal direction while the traces themselves extend from the bottom of the trench (left hand side) to the top of the trench (right hand side). The

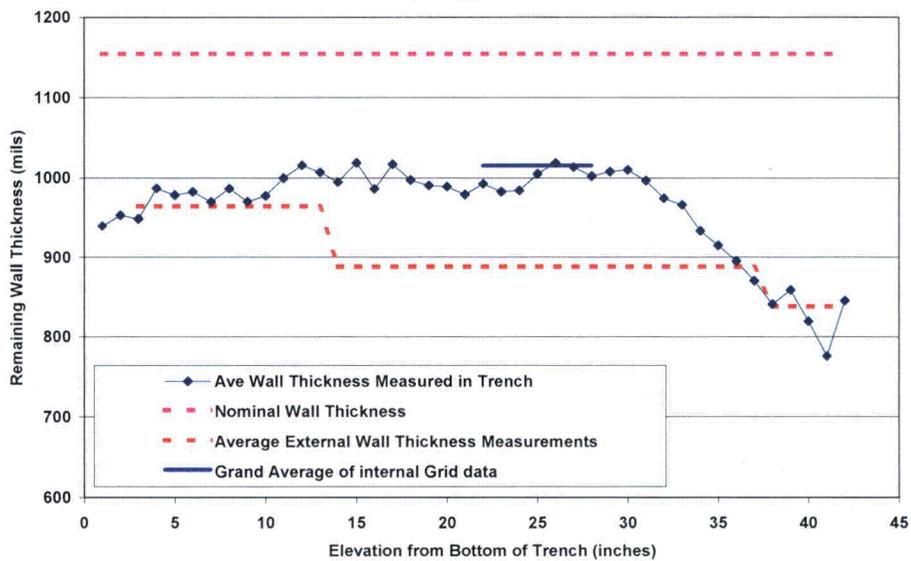
Figure 3

**Conclusion:** What the superposition of the UT measurements in Bay 17 demonstrates is that wall loss ranges from zero to 33 percent, however, only the trench and outside measurements come close to represent the most severe corrosion at the highest elevations. It should also be remembered that the grid measurements at the inside curb cutout as well as those in the trench are only 6 inches wide. One does not have, therefore any indications as to how far serious corrosion may have spread laterally around the circumference of the bay.

Comparison of Various Thickness Measurements in Bay 17  
2006 data

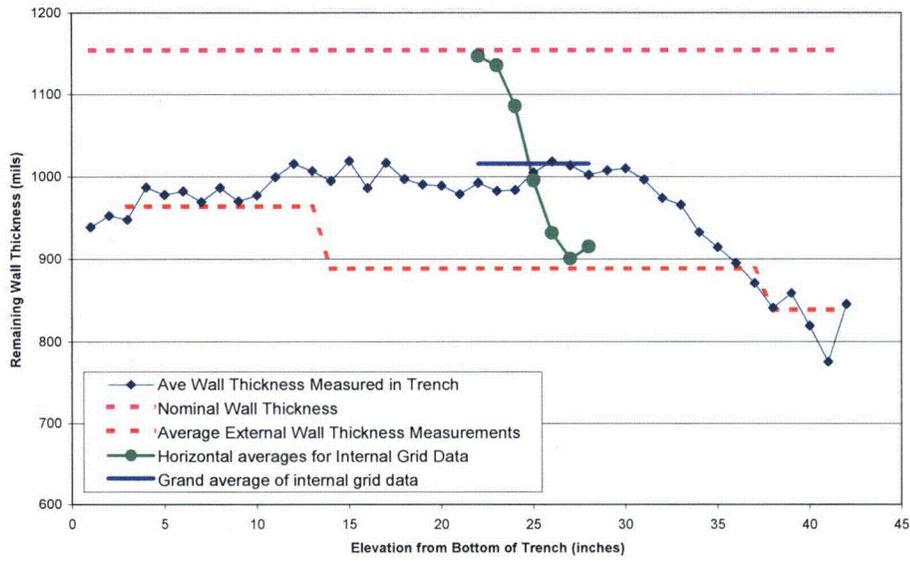
Figure 4

Comparison of Various Thickness Measurements in Bay 17  
2006 data

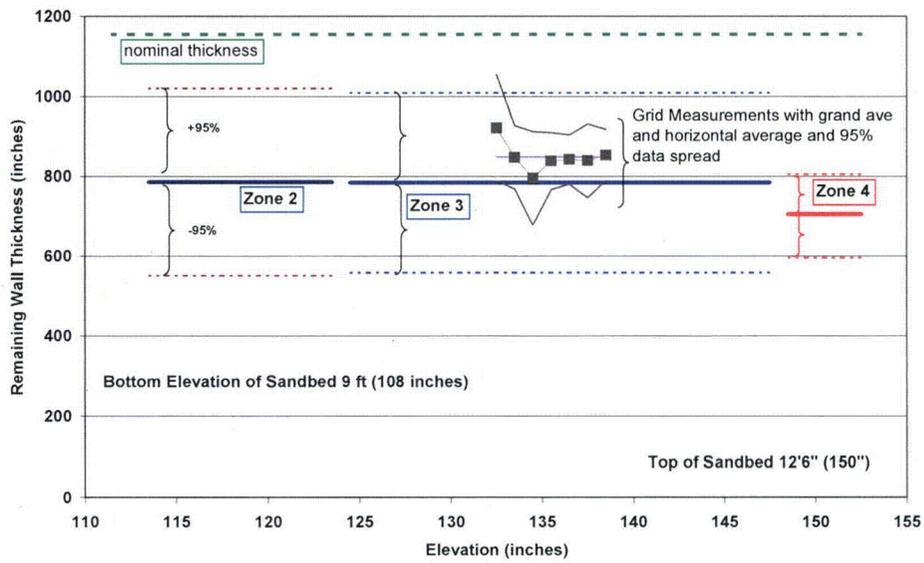
Figure 5 shows an analysis of the available 2006 data for Bay 13. Bay 13 is probably the second worst corroded bay apart from Bay 1. The averages for the external measurements for each zone are fairly similar, as are the 95% limits for the data spread. There is a 95% percent probability for the deepest penetration to be of the order of 48% of the original wall thickness. The superposition of the internal grid data shows a higher average and a narrower distribution of the data spread. Again one recognizes that the internal 6 by 6 inch grid measurements do not represent the worst corrosion degradation.

External 2006 UT Measurements in Bay 13  
averages and 95% limits of data spread

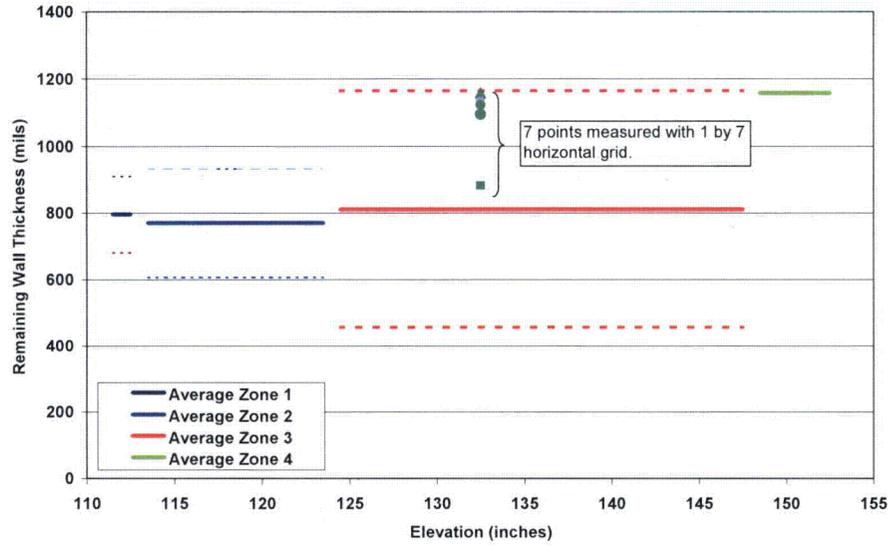
Figure 6

External UT Measurements 2006 in Bay 1  
Averages and 95% limits of data spread

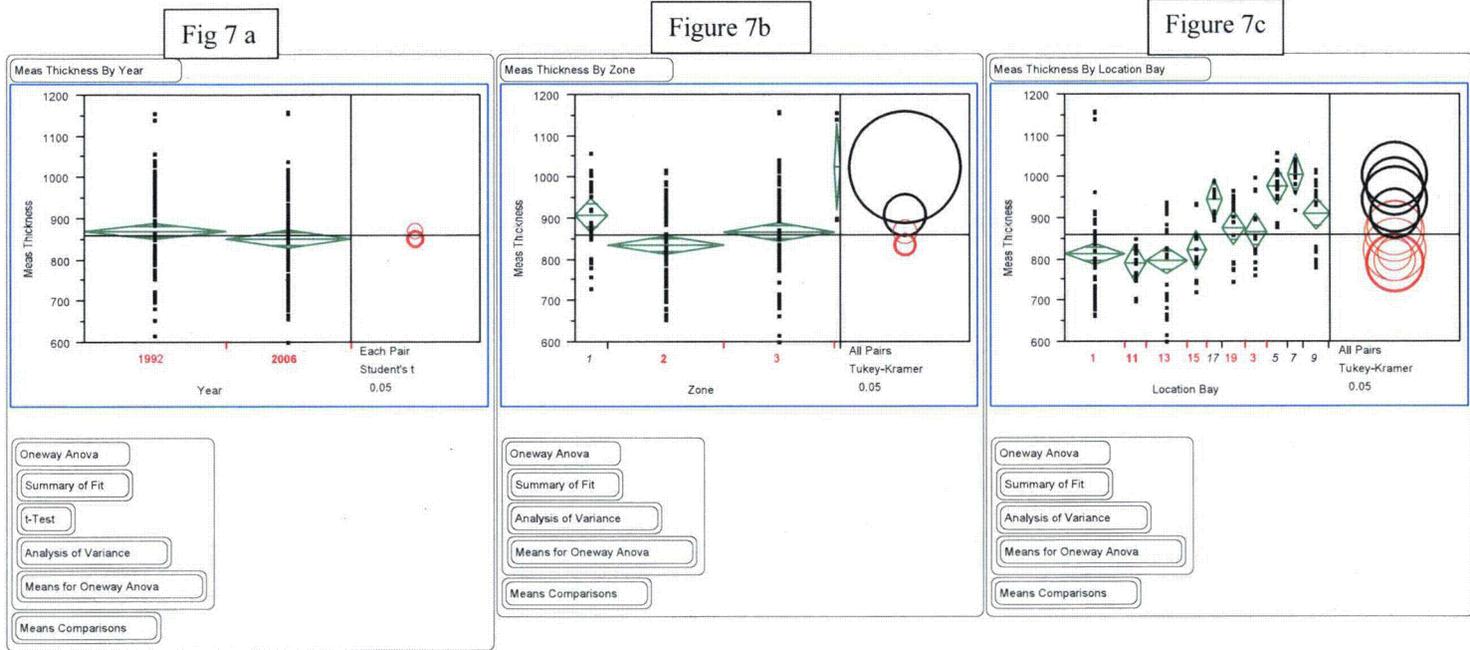
Figure 7

It was found that there is no significant effect of the time (Fig.7a). While there is a decrease of 19 mils between 1992 and 2006, this difference is not statistically significant within the variability of the data. The differences between the zones, however are significant. Zone 2 is by far the most corrosive zone. When the bays are compared, one finds as expected that some bays have experienced little corrosion in contrast to others. The importance of these observations is obvious: they point again to the fact that the intensity of corrosion is a clear function of elevation and bay. Hence, averaging data and generalization may lead to doubtful conclusions.

### Statistical Analysis of all External UT Measurements

Figure 7a: Comparison between measurements I 1992 and 2006 show no significant difference. The means from 1992 and 2006 show a bias of 0.018 inches, but the bias is statistically not significant despite of the many data points. Fig. 7b: The comparison between the "zones" (elevations) is significant. Zones 1 is significantly different from zones 2 and 3. For zone 4 there are not enough data for statistical significance. Fig. 7c: Some bays, red ones, are significantly different from the black ones.

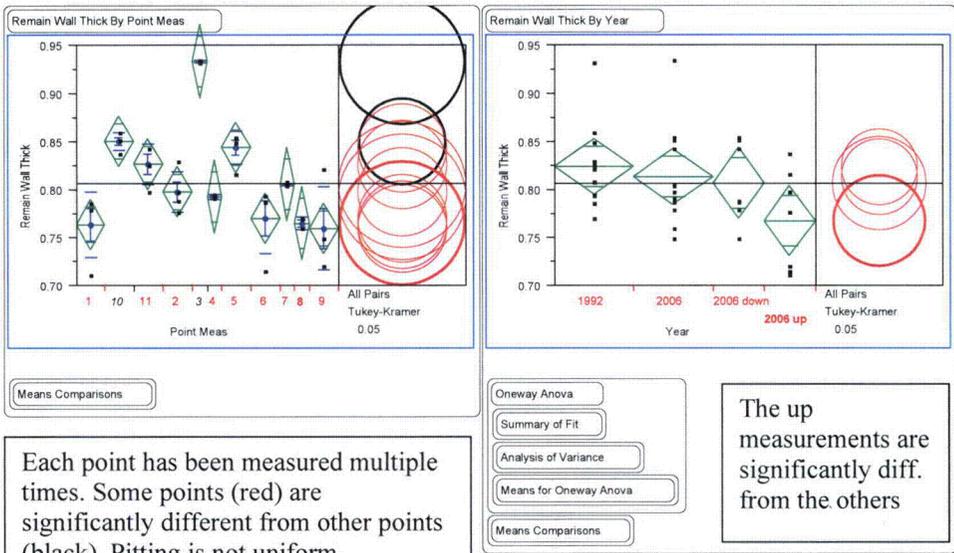
Figure 8: External UT Measurements in Bay 15

In this sense the external measurements of Bays 1, 15, and 19 have been reexamined, and as Table 1 shows, at least in Bay 15 there is no additional margin for continued corrosion in the areas that have been monitored to this point.

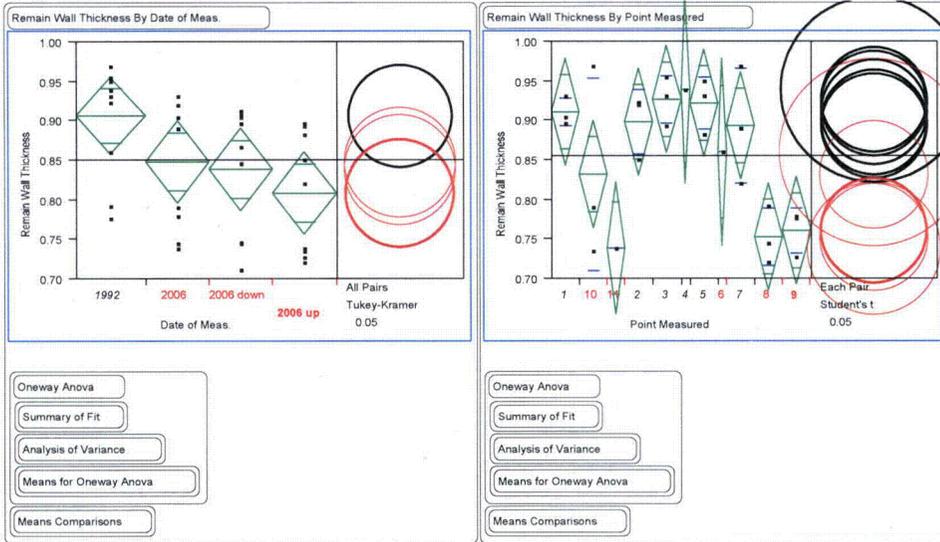
**Figure 10: External UT measurements in Bay 19**

Again one finds that the “up” measurements are significantly lower from the 1992 measurements.

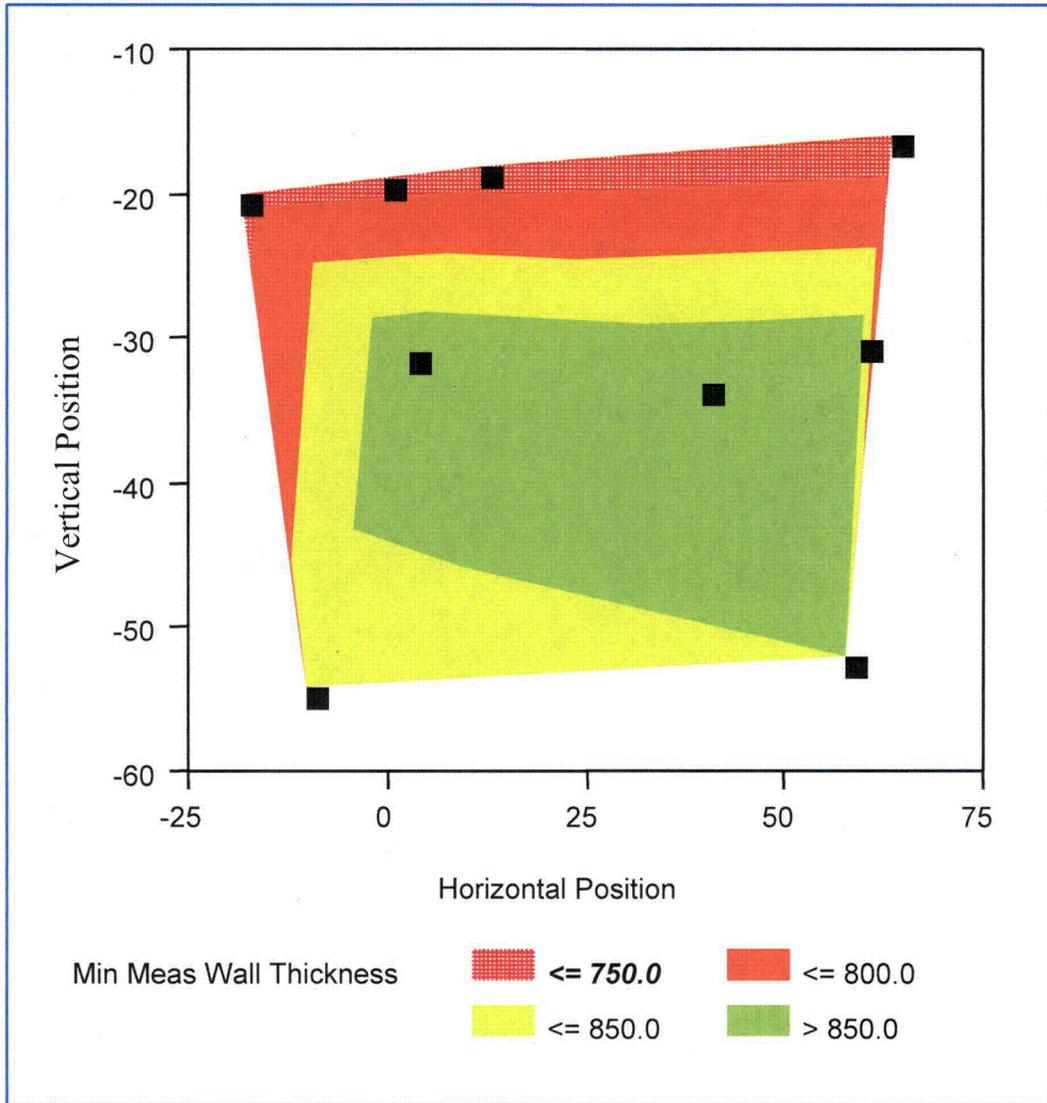
**Figure 1** mentioned previously shows a heavily corroded area in Bay 19 at elevation -20. The extent of this area is highly uncertain because it was not further defined by additional UT measurements toward higher elevations (>-20). Indeed, one could find here an extended bathtub ring area.

Bay 19 External 2006 UT Measurements, Minimum Values

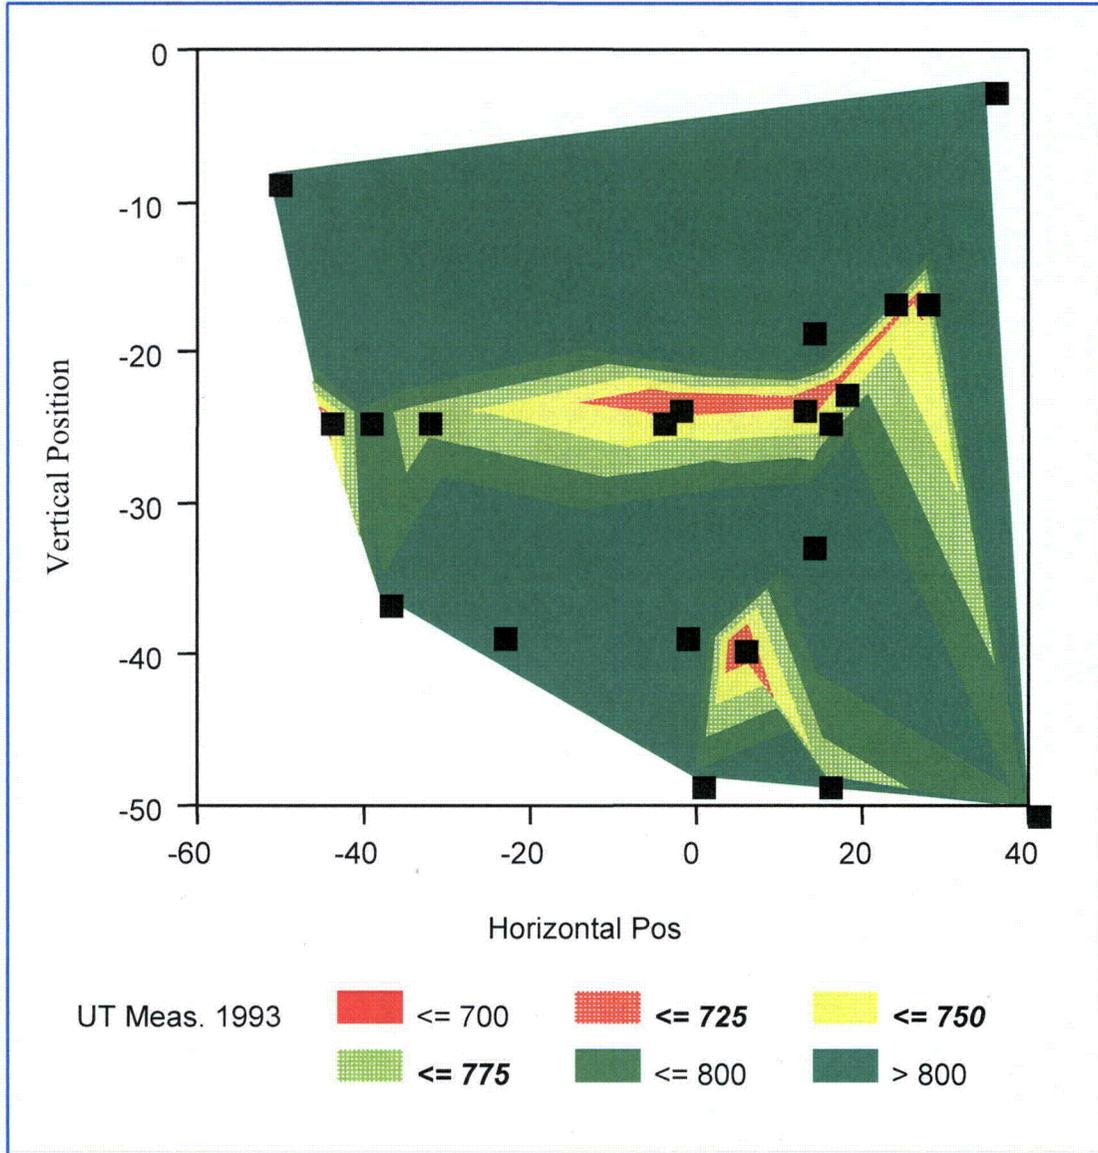
**Figure 2**

The data used for the analysis are contained in Tables 1 and 2 for Bays 1 and 13 as extracted from AmerGen documents. Presumably, these were the most corroded Bays. Figure 2 shows a contour plot for Bay 1 obtained with the data from 1992. The dimensions of the points in the plot are 2.5 by 2.5 inches. Again, one needs to remember that the specific shape of the contours depends not only on the residual wall thickness measured at the locations indicated, but on the density of measurements as well. (For instance, an additional measurement at coordinates h (-20) v (-25) could completely alter the contours and in all likelihood extend the area of wall thickness below -750 mils<sup>4)</sup>.

**Contour Plot For Bay 1: 1992/1993 External UT Measurements**

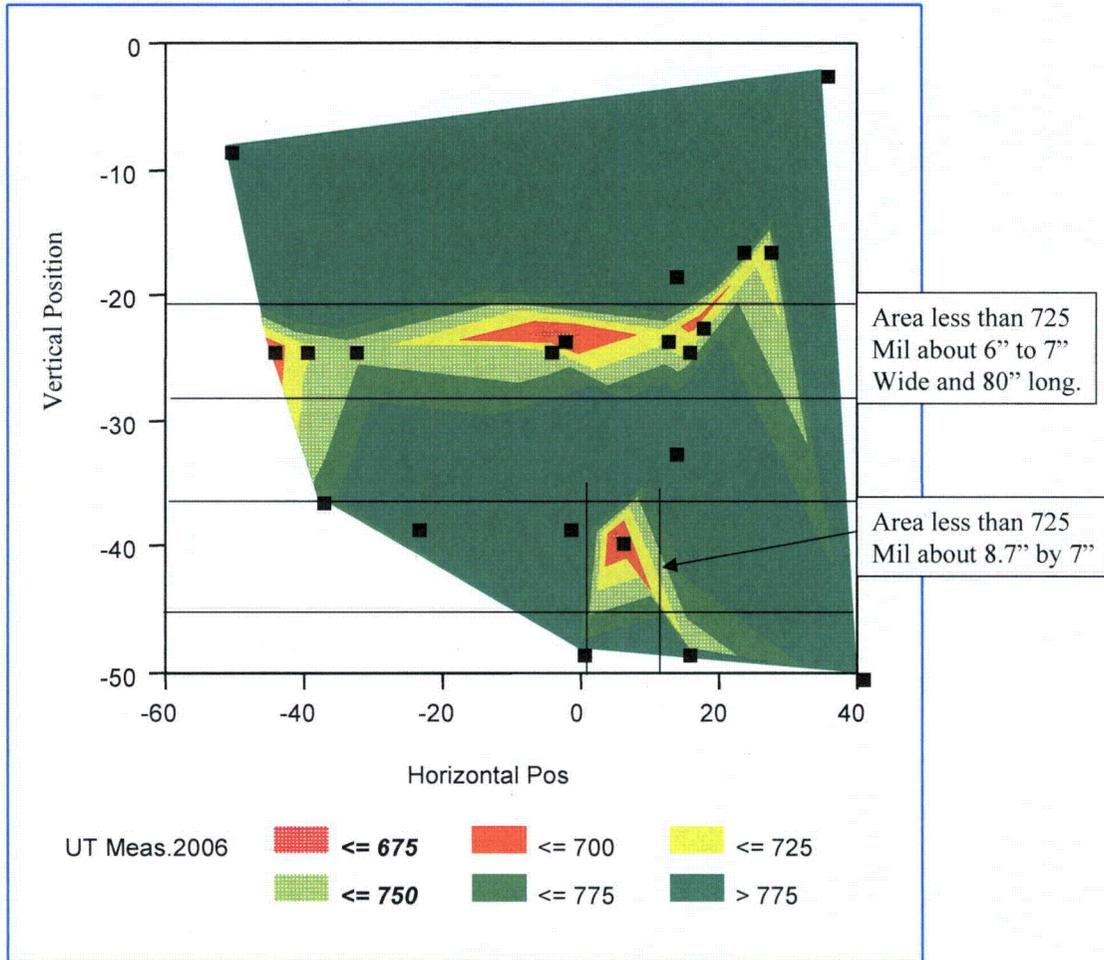
**Figure 3**

Based on Figure 3, together with an assessment of the accuracy (reliability) of the data one must conclude that there is a good likelihood that the entire bathtub ring area extending from 40 to -40 inches on the horizontal axis and from about -30 to perhaps -20 inches on the vertical axis is below the 0.736 inch criteria for general thinning and is, much larger than the one square foot acceptance criterion. (Of course, since this area is the most corroded, it will taper off to higher wall thickness on both sides of the vertical axis). The corroded area is indeed shaped quite irregular, but one could venture a guess that the contoured areas below 750 mils are of the order of 4 to 7 square feet all together. This estimated area does not include the area to the left of -40, which probably contains additional area below 0.750 inches.

**Contour Plot for Bay 1 2006 External UT Measurements 2006**

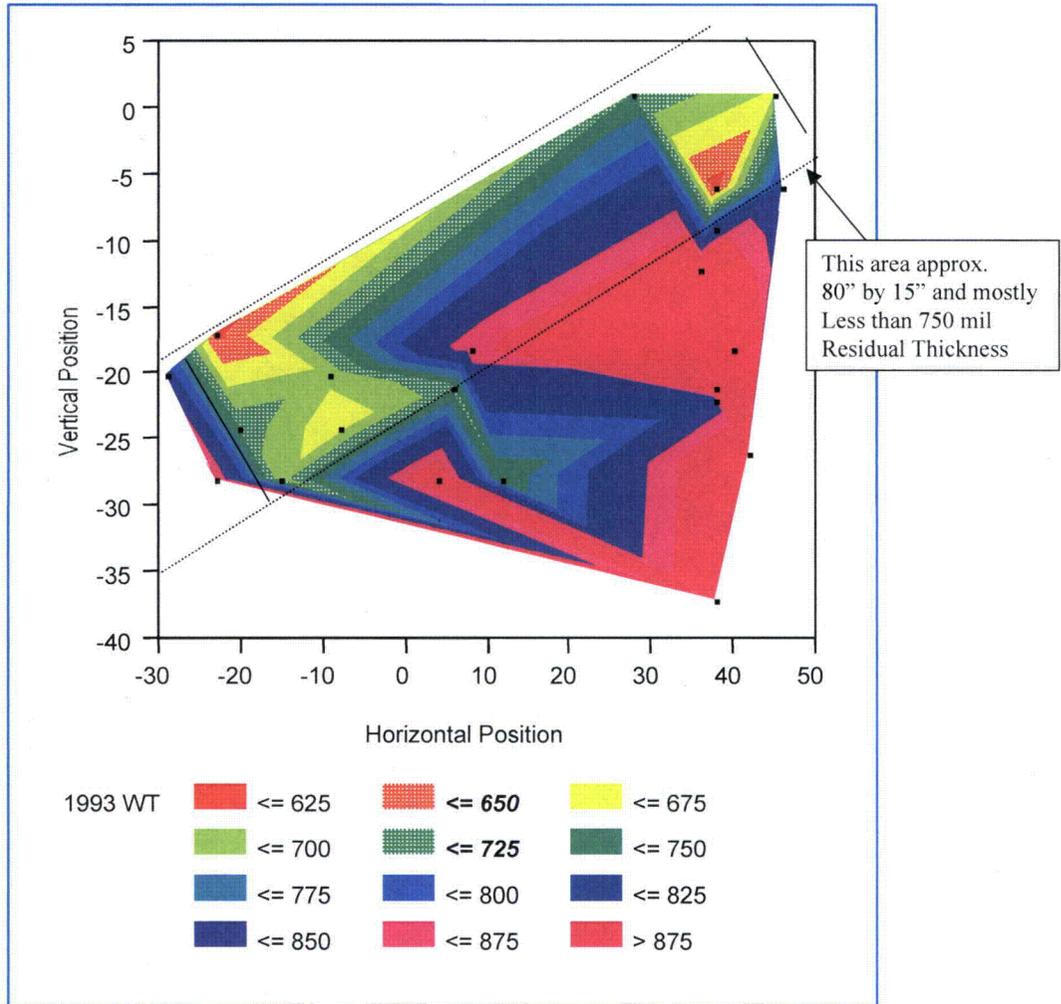
Figure 4

**Figures 4 and 5** show the contours for Bay 13, 1992 and 2006 data, respectively. Here large areas exist with wall thicknesses below 700 mils and at least two seemingly unconnected areas where the residual wall thickness is less than 650 mils. It could be argued that those heavily corroded areas are less than 1 square foot and therefore are still acceptable according to the 636 mil criterion. However, the heavily corroded area on the left hand side (-20, -20) has not been further explored. One therefore does not know whether it might extend further. Similarly, the area on the right ((40, -7), clearly showing a fairly deep pit, was not further explored and was not even measured in 2006. While in Bay 1 the bathtub ring was at elevation -20 to -25 (from the reference point) in Bay 13 there is no clearly prominent bathtub ring. This may be because it was not there, but it may also be because the measurements were not extended toward elevation -15 and -10. We are therefore left with a great uncertainty as to the true extension of the damage in this Bay.

Contour Plot for Bay 13 1992/1993 External UT Data

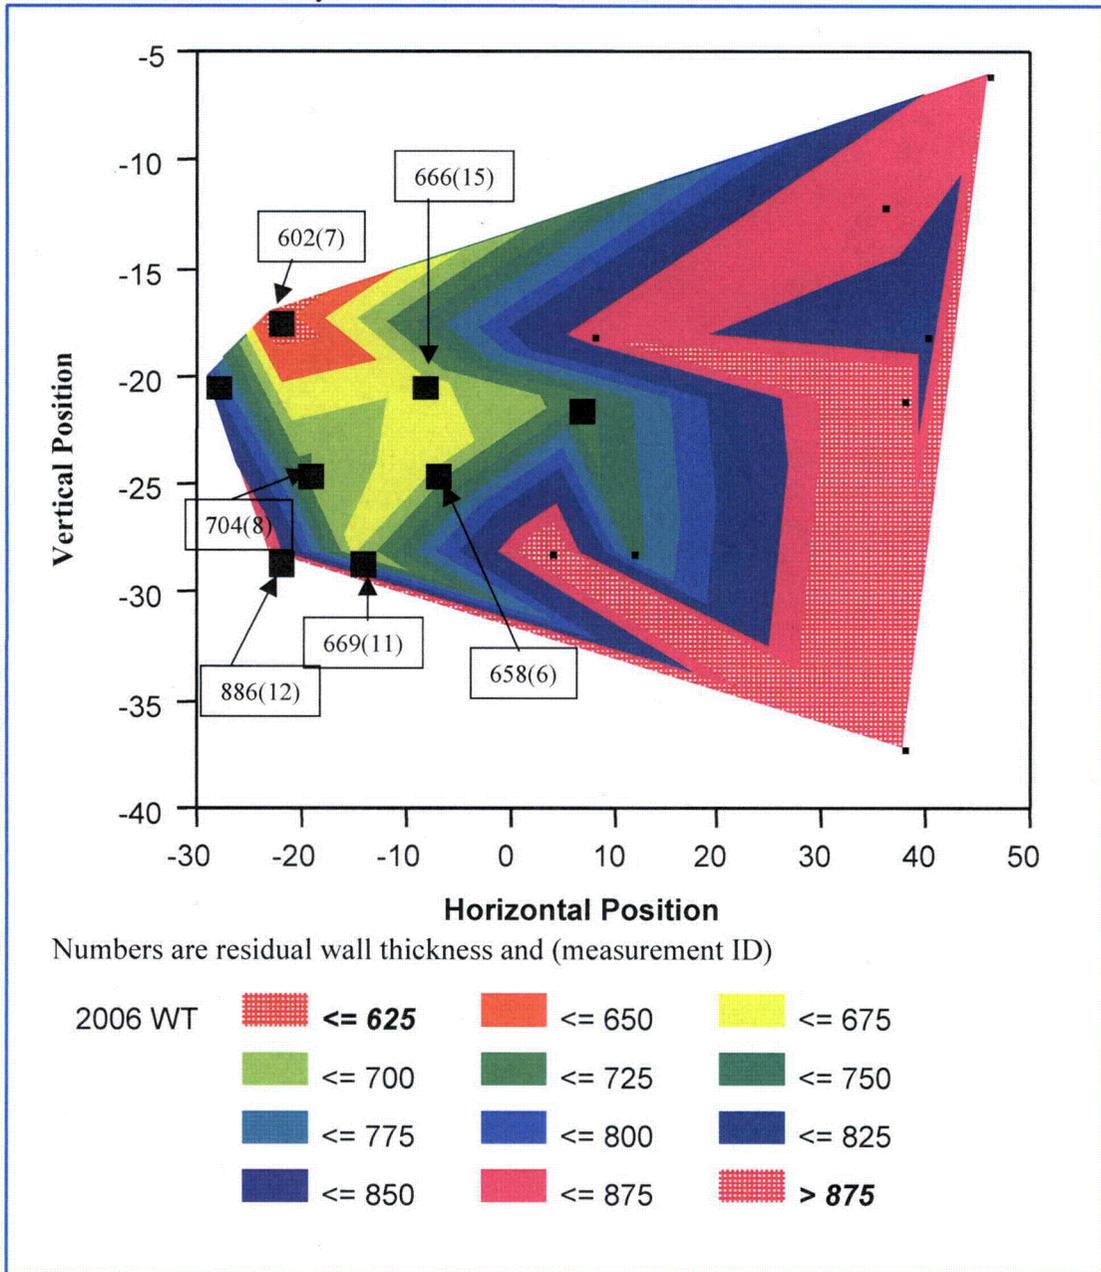
Figure 5

Bay 13 Contour Plot 2006 UT Data

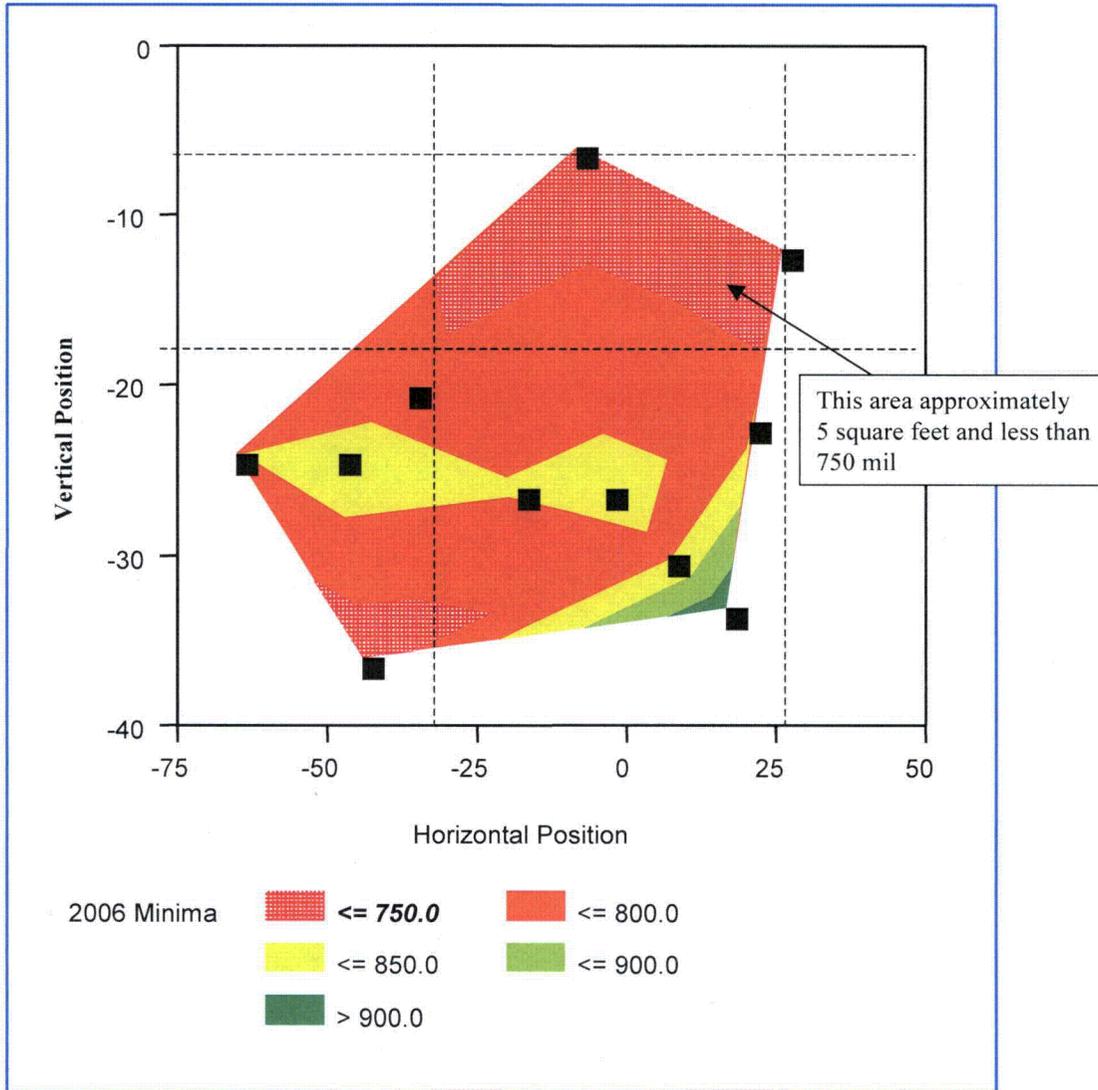
Figure 6

**Figure 6** shows the contours for Bay 15. There is a heavily corroded area at elevation -10 with an extension of 1 ft by about 4.5 feet. However, this area was explored only with 2 measurements and was not extended beyond about 2 feet either side of the centerline. It appears that the majority of the measurements occurred in the non-corroded zones. Interestingly there appears some serious corrosion near the sandbed bottom, but the occurrence was not further explored either.

Contour Plot for Bay 15 2006 External UT Measurements

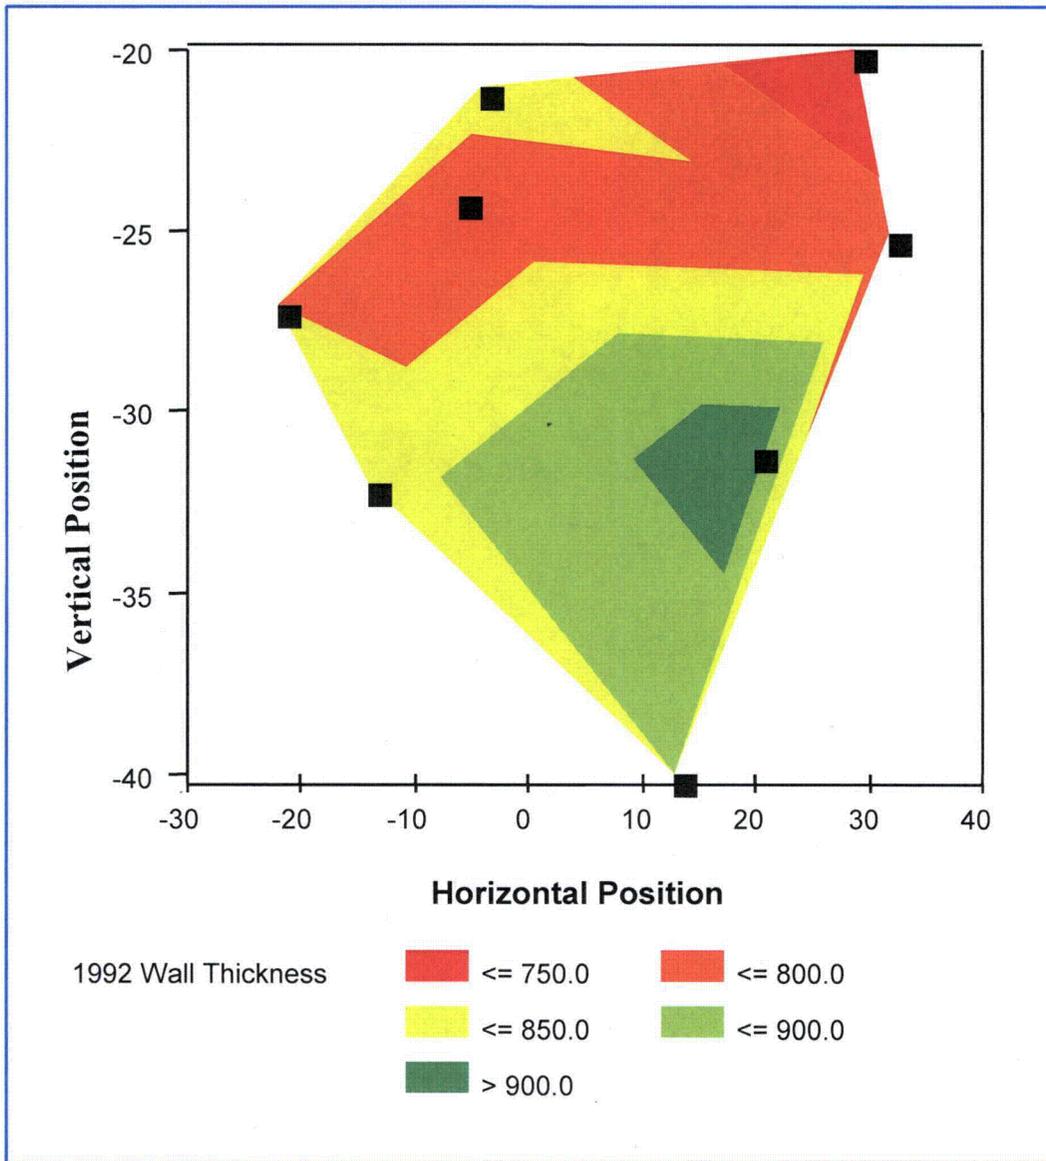
Figure 7

Contour Plot for External UT 1992 Data Bay 11
