Subject: Duke Power Company LLC d/b/a Duke Energy Carolinas, LLC (Duke)
McGuire Nuclear Station, Unit 1
Docket No. 50-369
Relief Request 07-MN-001
Relief Request from Immediate ASME Code Flaw Repair of
Charging Pump Discharge Line Valve 1NV-240

RELIEF REQUEST NO. 07-MN-001

**McGuire Nuclear Station – Unit 1
Relief Request Number 07-MN-001
Operability Evaluation**

***Calculation Title: “Flaw Evaluation of Class 2 Isolation
Valve 1NV-240 Pinhole Leak in Charging Supply Piping”***

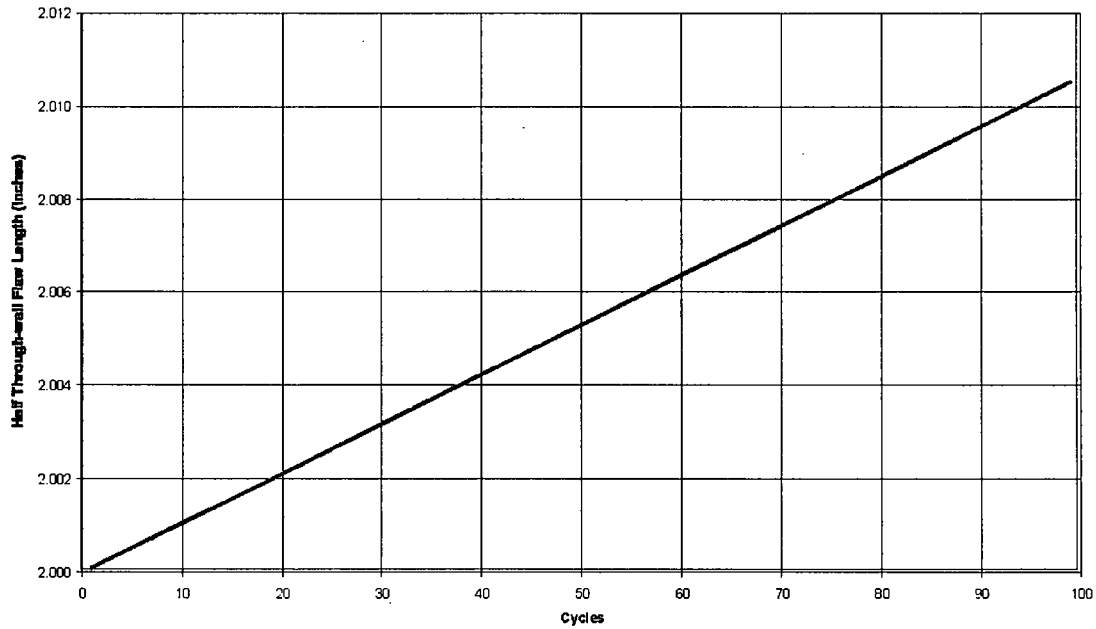
Figure 1.
Typical Crack Growth Evaluation Results
(Axial Flaw with Full Thickness)

Figure 1 below, taken from the SIA calc, shows that the fatigue crack growth is negligible for any credible size flaw. (An initial axial flaw length of 4 inches is used.) Thus the allowable present flaw size is nearly or is equal to the allowable flaw sizes given above in Table 1, as shown in the below Table 3, taken from the SIA calc.

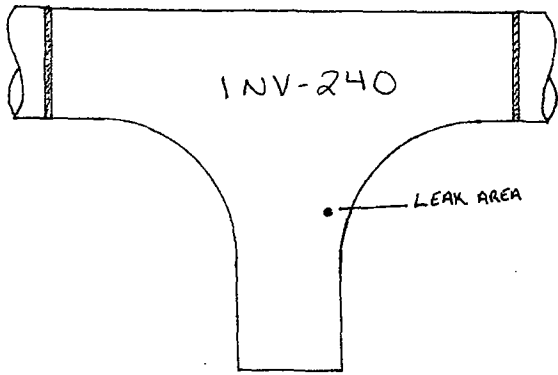
**ATTACHMENT 1
INV-240 UT Results
*6/20/07***

<p>1NV-240</p> <p>LEAK AREA</p> <p>LOOKING EAST</p> <p>DRAWING NOT TO SCALE</p> | | | RESULTS: UT READINGS CAN NOT BE CONFIRMED 100 PERCENT ACCURATE DUE TO CAST STAINLESS STEEL MATERIAL NOT BEING COMPATIBLE WITH UT TECHNIQUES. READINGS IN AREA OF LEAK RANGED FROM .773" TO .903". SUSPECT READINGS TO BE BACKWALL INDICATION (ID OF PIPE). * STAINLESS STEEL CAL BLOCK 03-7088 USED IN LIEU OF CAST STAINLESS STEEL CAL BLOCK. NO CAST STAINLESS STEEL CAL BLOCK AVAILABLE. | | RG62 <input type="checkbox"/> RG174 <input checked="" type="checkbox"/> Length: 6 ft. Initial Calibration Time: 1850 Cal Checks

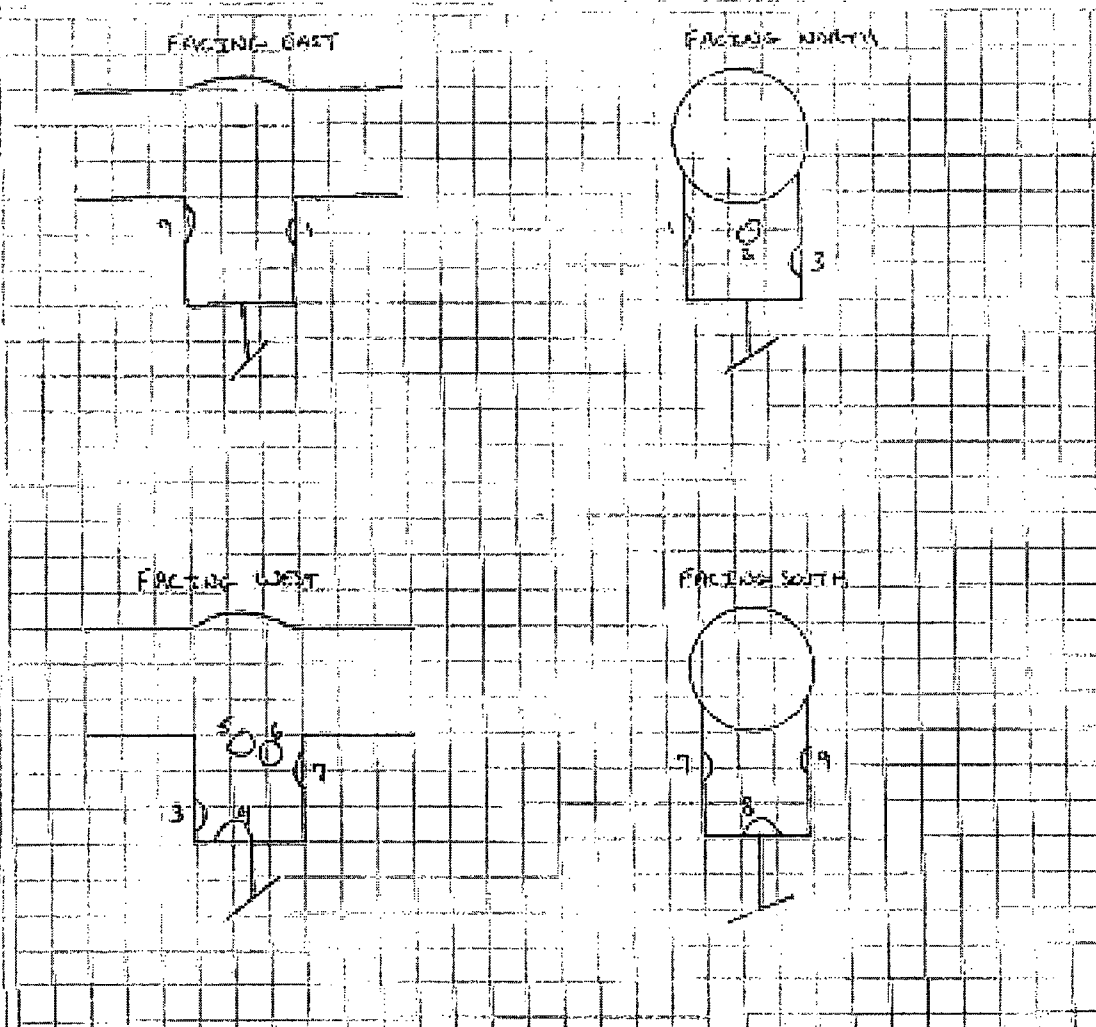
Station MNS Unit 1 Rev. 1 File No. Sheet 2 of 3
Subject AREA LOCATION IMPACT BY SOOT CURRENT
YAYE : INV-240 by L. Chen Date 06-24-2007
Prob No. Checked By Date

A surface Eddy Current examination using a pencil probe was performed which located nine areas where the base material had been repaired by welding. One such area was at the leak location. The locations of the repairs were recorded on a roll-out drawing on the valve neck.

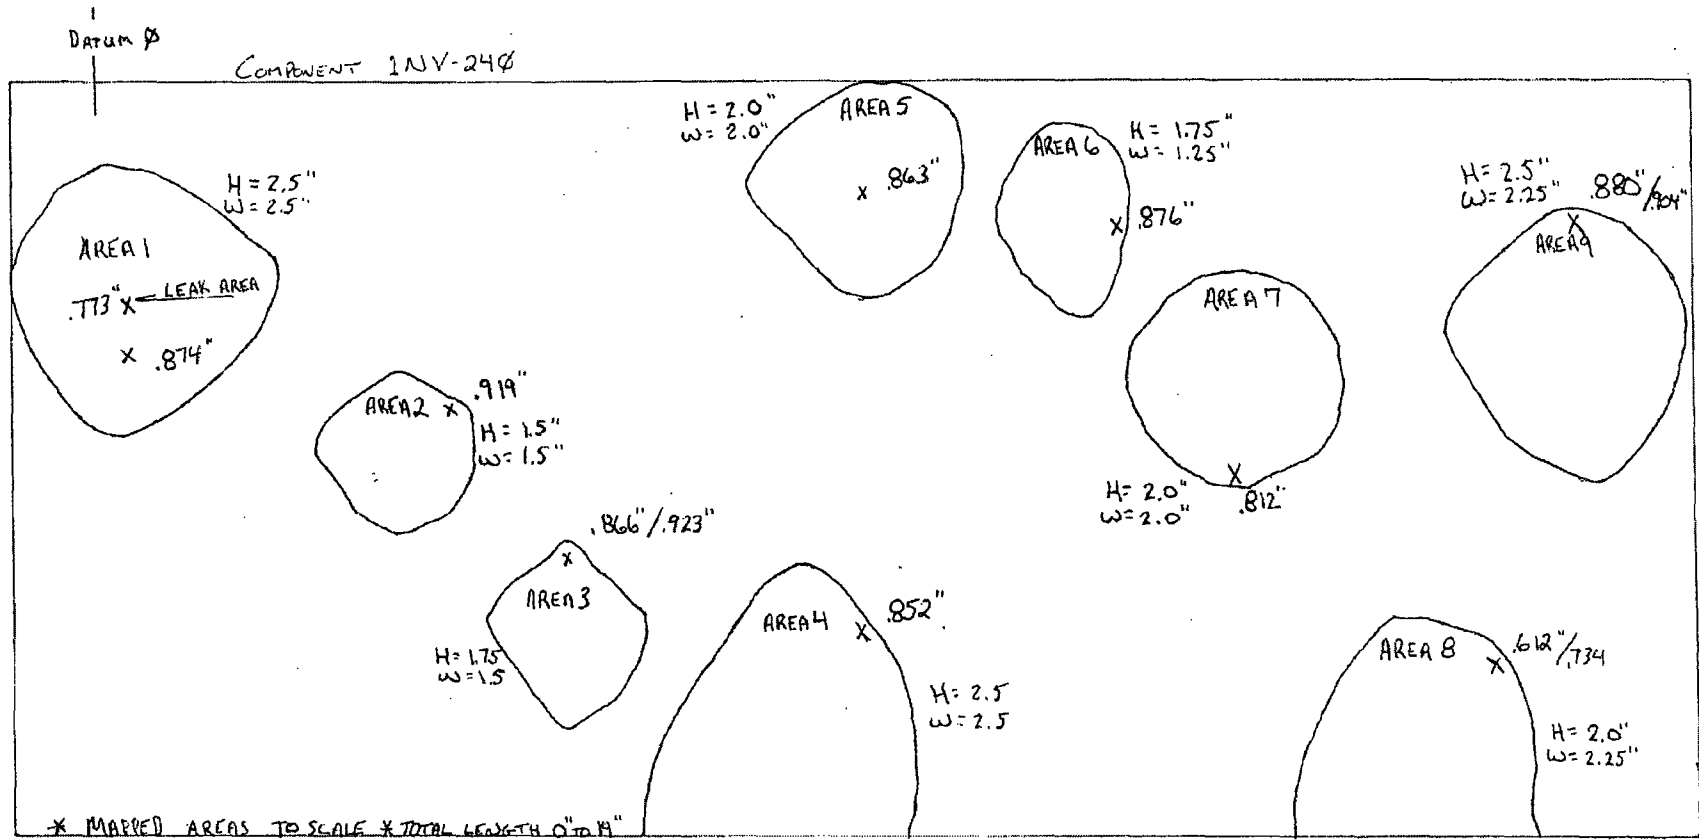
ATTACHMENT 3
1NV-240 Body Neck UT Thickness Mapping
6/22/07

| DUKE POWER COMPANY | | | | FORM NDE-940B | |
|---|--|---|--|---|---|
| | | RESULTS: UT READINGS CAN NOT BE COMFIRMED 100 PERCENT ACCURATE DUE TO CAST STAINLESS STEEL MATERIAL NOT BEING COMPATIBLE WITH UT TECHNIQUES. READINGS TAKEN IN AREAS IDENTIFIED BY EDDY CURRENT. READINGS RANGED FROM .612" TO .919". SUSPECT READINGS TO BE STAINLESS STEEL TO CAST STAINLESS STEEL INTERFACE AND/OR BACKWALL INDICATION (ID OF PIPE). * STAINLESS STEEL CAL BLOCK MFB005 USED IN LIEU OF CAST STAINLESS STEEL CAL BLOCK. NO CAST STAINLESS STEEL CAL BLOCK AVAILABLE. | | RG62 <input type="checkbox"/> RG174 <input checked="" type="checkbox"/> Length: 6 ft. | |

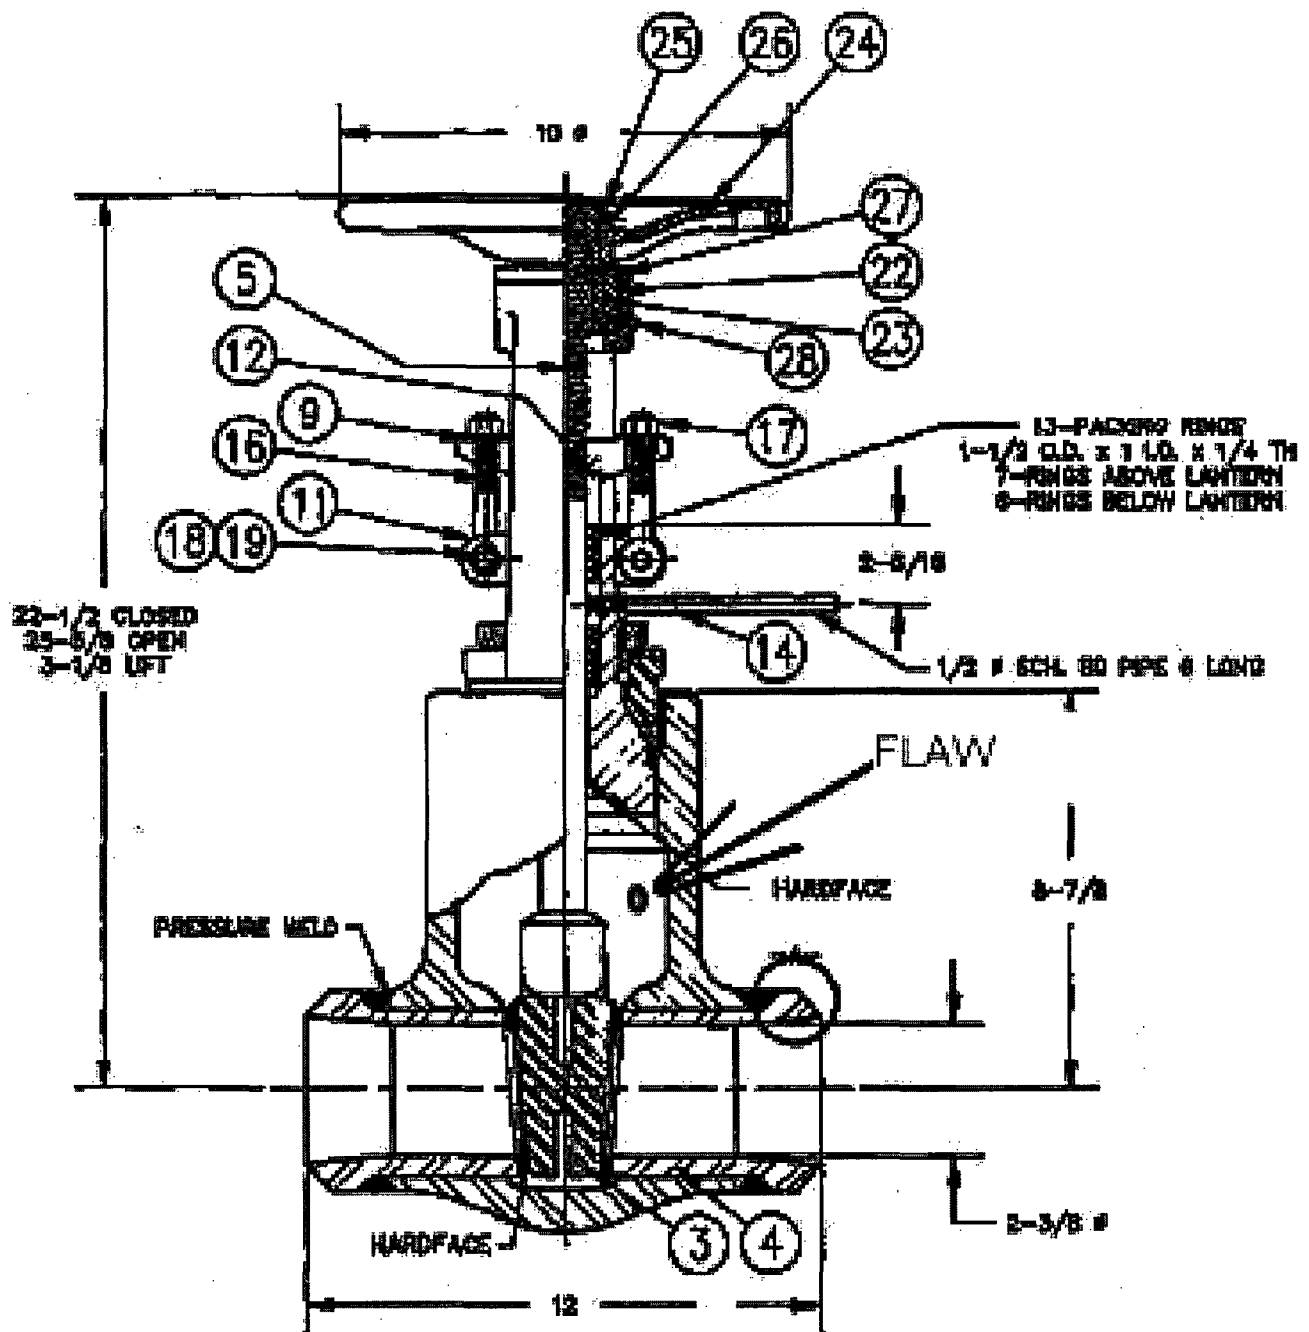
Figure 1: Location of Flaw in Valve 1NV-240

- The allowable flaw size at the location of the defect is at least 5.36 inches in the circumferential direction and 3.89 inches in the axial direction.
- Flaw growth assuming a conservative initial flaw size of 0.25 inch is less than 1 mil resulting in a maximum final flaw size of 0.26 inch, which is well below the allowable flaw sizes in either the circumferential or axial direction.
- Based on the above, it is concluded that the defect in the valve is acceptable for continued operation for at least one cycle.

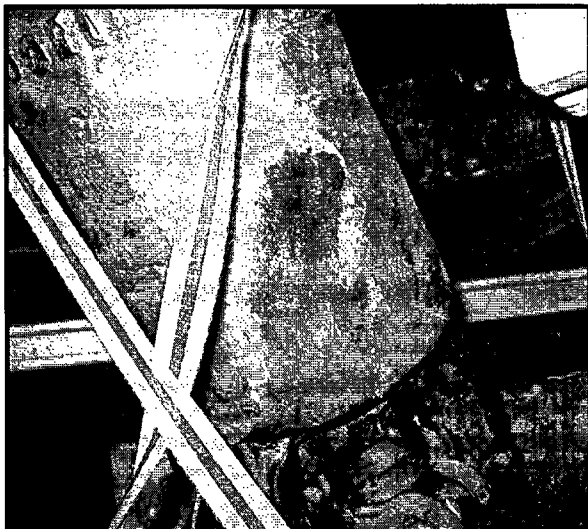
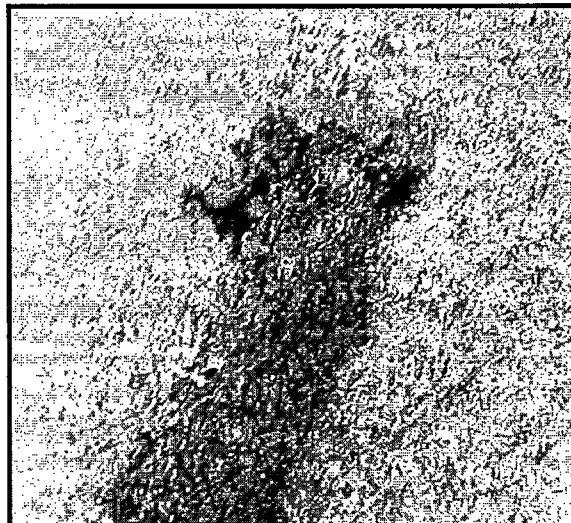
Site Inspection Results: Initial inspections performed under W/R 00927504 indicated the leak was possibly emanating from two small pinhole defects (see photo below). The pinholes are in close proximity and appear to be located at small depressions in the rough, casting surface. More careful inspection of the photos suggests that the flaw may actually be associated with a small thumbnail-shaped defect interconnecting the two primary leak sites (see photo below).

Subsequent UT examinations determined that the leak is located in the center of a 2.5 inch diameter circular-shaped weld repair. Per the MCTR, the weld filler material used for the repair was E316-16. This is one of 9 documented weld repair areas performed on the valve body by the original manufacturer.

Comments on Probable Damage Mechanism: The flaw appears to be curved and discontinuous where it is breaking the OD surface of the valve body. This is not consistent with a mechanically driven crack. Therefore the possibility of fatigue cracking seems unlikely.
