**Entergy****CONDITION REPORT****CR-VTY-2007-02133****Originator:** Fales, Neil**Originator Phone:** 8024513057**Originator Group:** Eng P&C Codes Staff**Operability Required:** Y**Supervisor Name:** Lukens, Larry D**Reportability Required:** Y**Discovered Date:** 05/28/2007 17:06**Initiated Date:** 05/28/2007 17:11**Condition Description:**

Steam Dryer Inspection Indications

# **INR-IVVI-VYR26-07-10- Steam Dryer Interior HB-V04**

Engineering Report Title:  
EVALUATION OF NEW RFO26 STEAM DRYER INDICATION

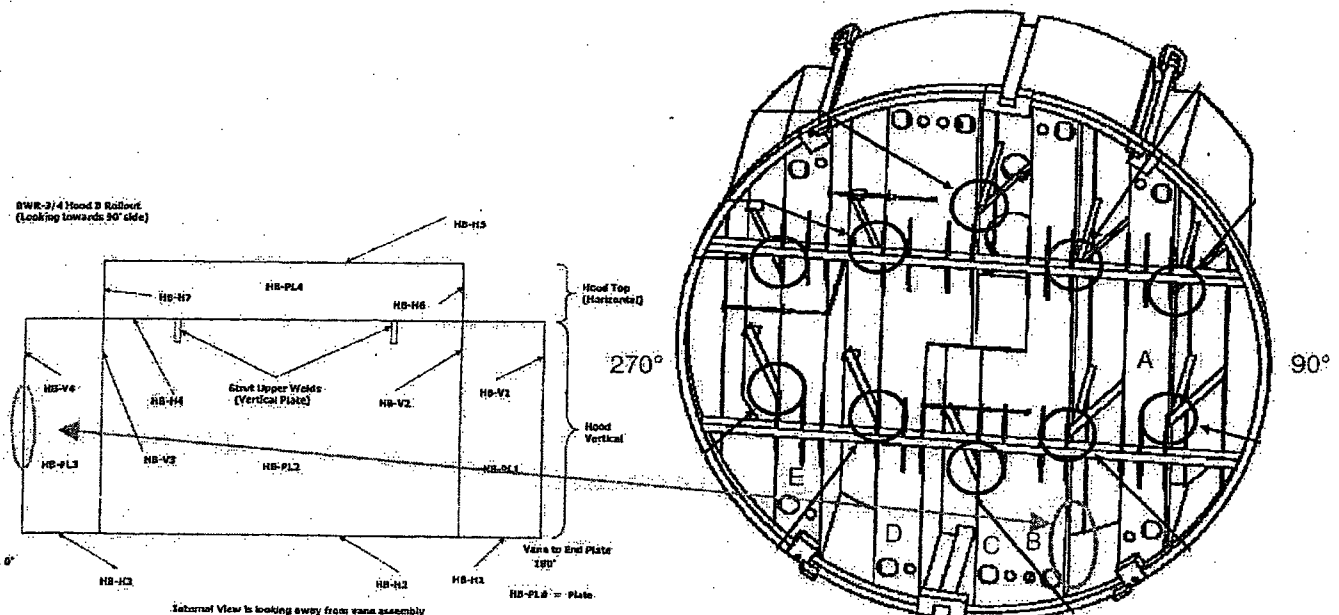
Sketch on the left shows the weld map rollout The sketch on the right shows a bottom view of the dryer.

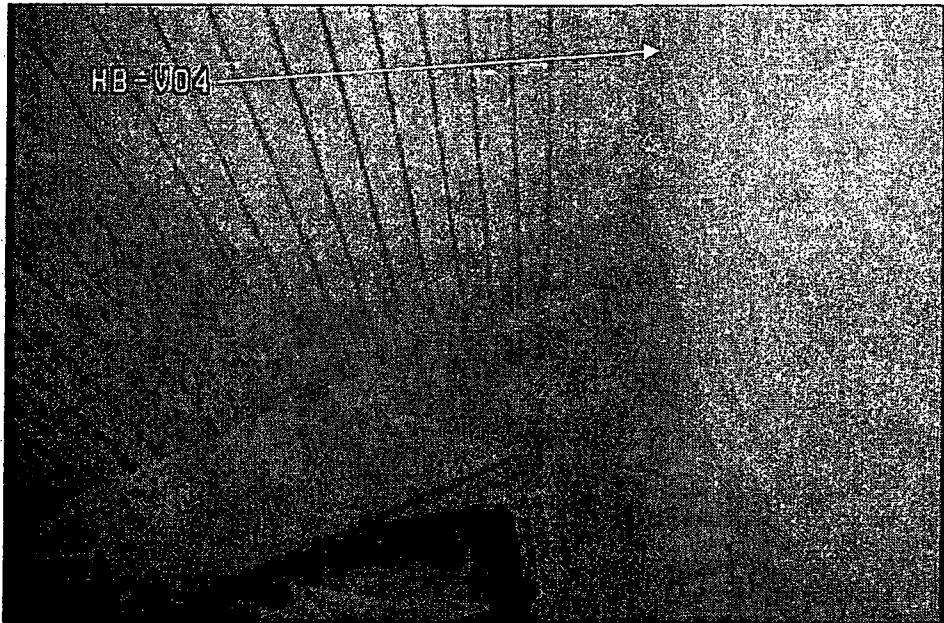
This 2007 photo shows the interior of the dryer and the location of HB-V04 vertical weld.

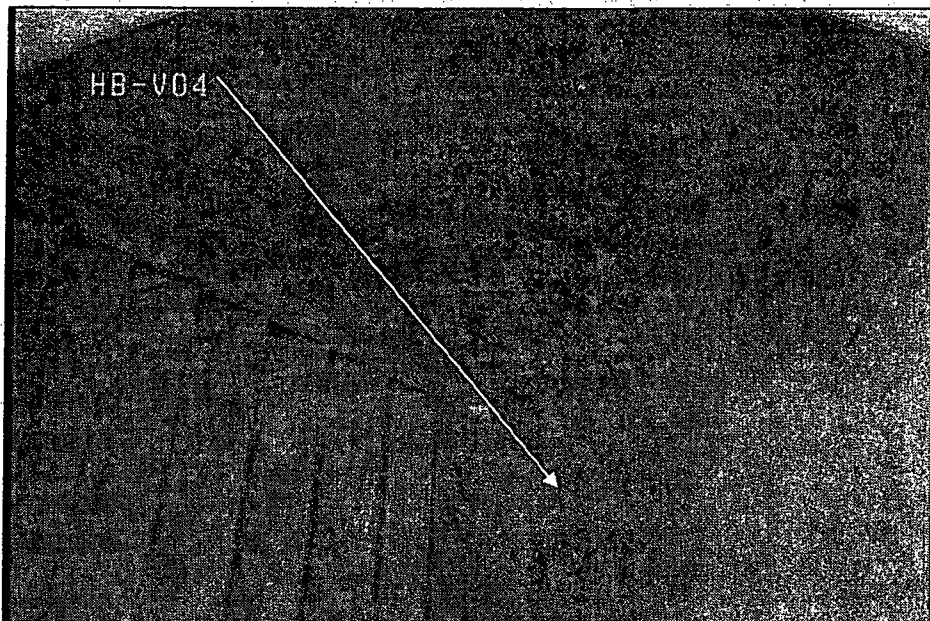
This 2007 photo shows the top of the vane bank (on the left) and the end panel (on the right) and the vertical weld in the center

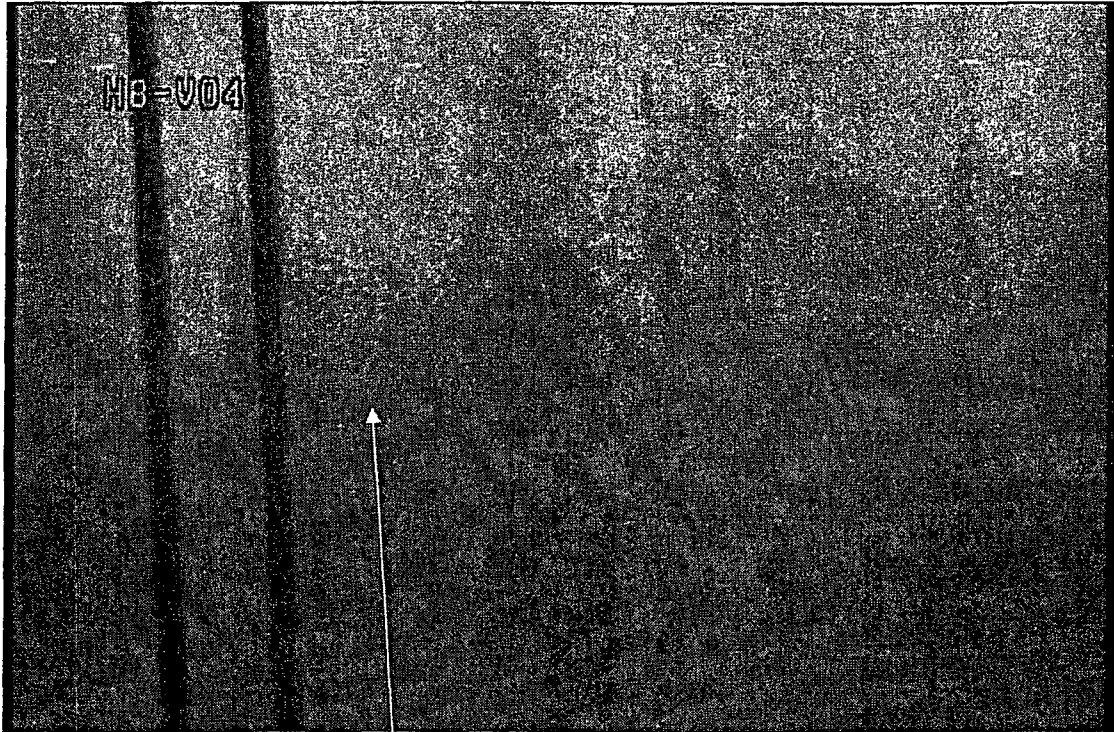
This 2007 photo is of the 1<sup>st</sup> indication from top down (Correlates to RFO25: 1<sup>st</sup> indication).

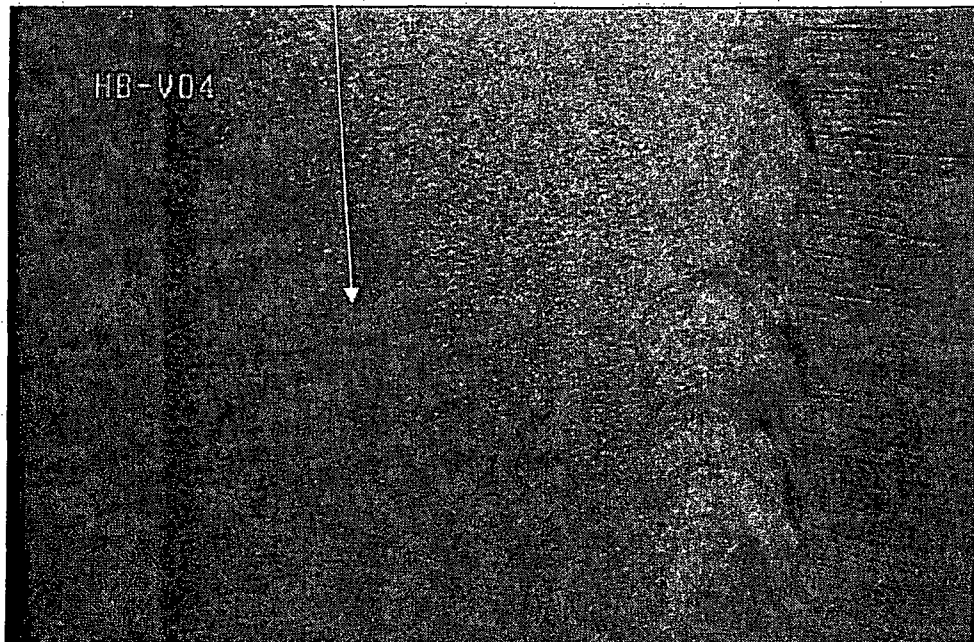
This 2007 photo is a close-up of the 1<sup>st</sup> indication (Correlates to RFO25: 1<sup>st</sup> indication).

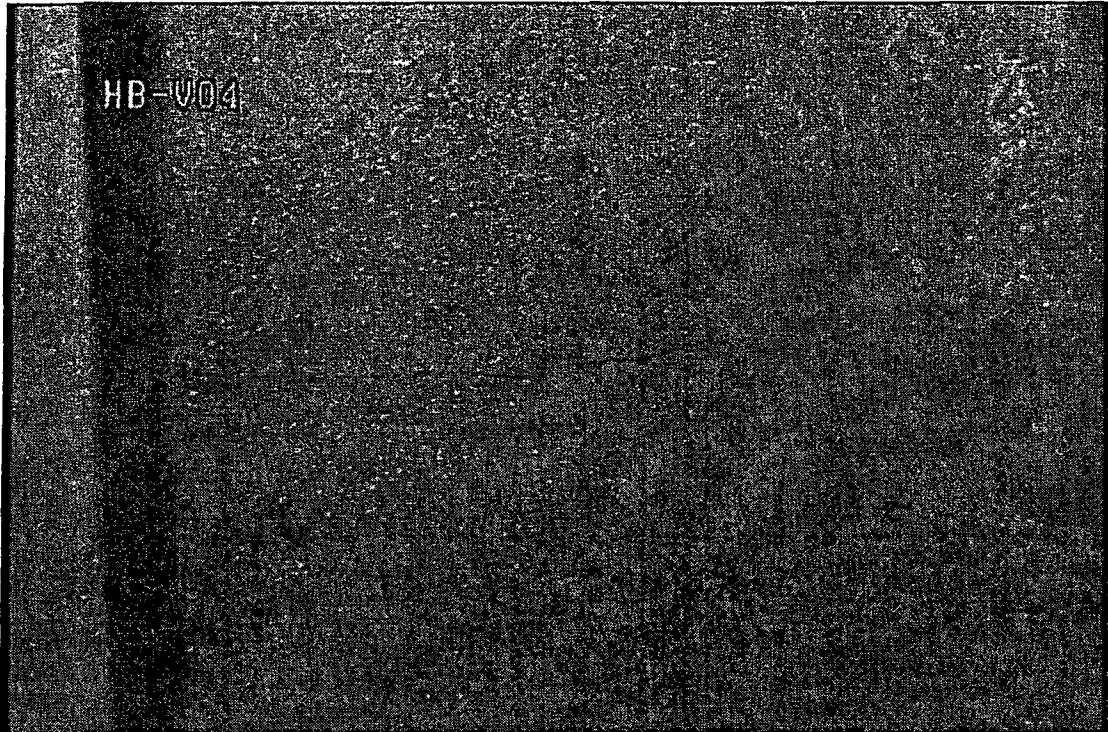
This 2007 photo is the 2<sup>nd</sup> indication (Correlates to RFO25: 2<sup>nd</sup> indication).

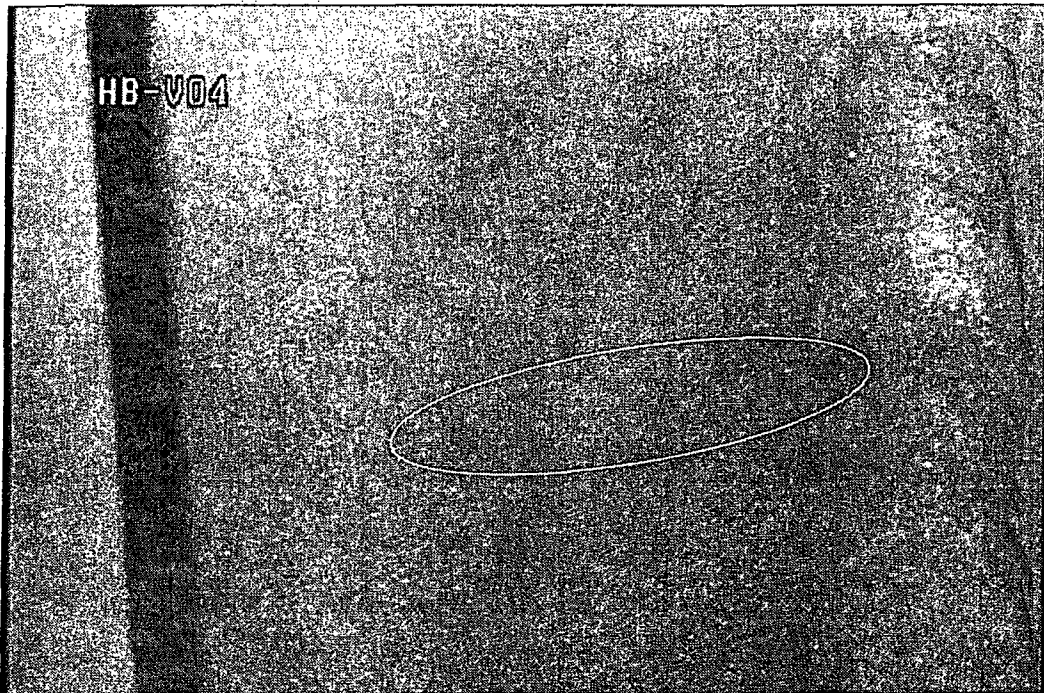
This is a 2007 photo of the 3<sup>rd</sup> indication and is a new RFO26 indication.

One new indication was found adjacent to weld HB-V04, located on bank B at the 0° end and is labeled as the 3<sup>rd</sup> indication on INR-IVVI-VYR26-07-10 Rev.1 (Reference 2). This indication is of similar appearance, orientation and size as those previously seen. Because of this it is being treated similar to those indications identified in RFO25. The remainder of indications on the steam dryer listed as References 1-10 were previously identified and show no signs of growth. These indications are acceptable to leave as is per GE evaluation GENE-0000-0047-2767 (Reference 11) performed in RFO25. Therefore, the one new indication described above is the only one requiring an evaluation.

GE's evaluation in RFO25 cites IGSCC as being the likely cause of most of the indications previously observed. This is based on the jagged appearance and location in the weld heat affected zone (HAZ). The unit end plates may have cold work resulting from cold forming. Cold working Type 304 material can promote initiation of stress corrosion cracks when exposed to the BWR environment. The dryer unit end plates are located in the dryer interior and are not subjected to any direct main steam line acoustic loading. Continued growth is unlikely because all of these indications appear to have stopped without propagating into the vertical weld; this is indicative of IGSCC behavior as opposed to fatigue, since weld material is more resistant to IGSCC. The flanges have experienced a near infinite number of fluctuating load cycles and if fatigue driven, more significant cracking is likely to have occurred after many years of operation. IGSCC in steam dryers has been typically limited in depth and length since in many cases it is caused by cold work or weld induced residual stress.

The new indication was evaluated by Code Programs, see the attached document. The evaluation accepts the indication as is with no repair required. The steam dryer will be inspected per the same scope in RFO27 and RFO28 per letter BVY 04-097, therefore the area of this indication will be inspected again during the next two outages.

The dryer unit end plates flaw assessment is based on the following factors: (1) it is a highly redundant structure and there is no structural consequence of the cracking and (2) postulated significant flaw extension leading to the flaw reaching the full section of the channel geometry would not create the opportunity for loose parts. Field experience supports this as-is operation decision in the context that the indications will be re-inspected at the next outage. It is recommended that the new visual indication given in Reference 2 be accepted as is. Repair is not recommended.

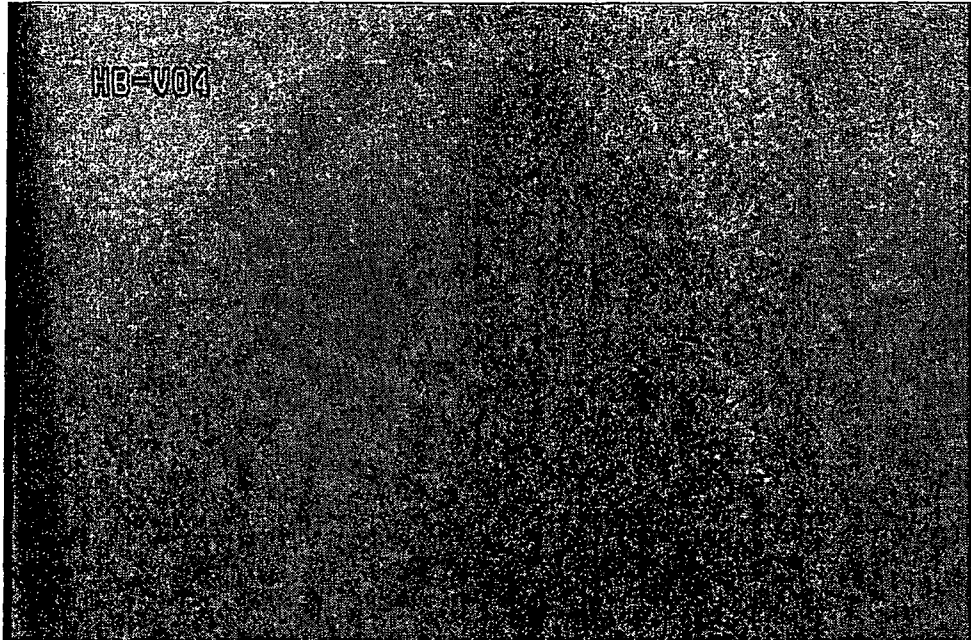
This is a 2007 photo of the 4<sup>th</sup> indication (Correlates to RFO25: 3<sup>rd</sup> indication)

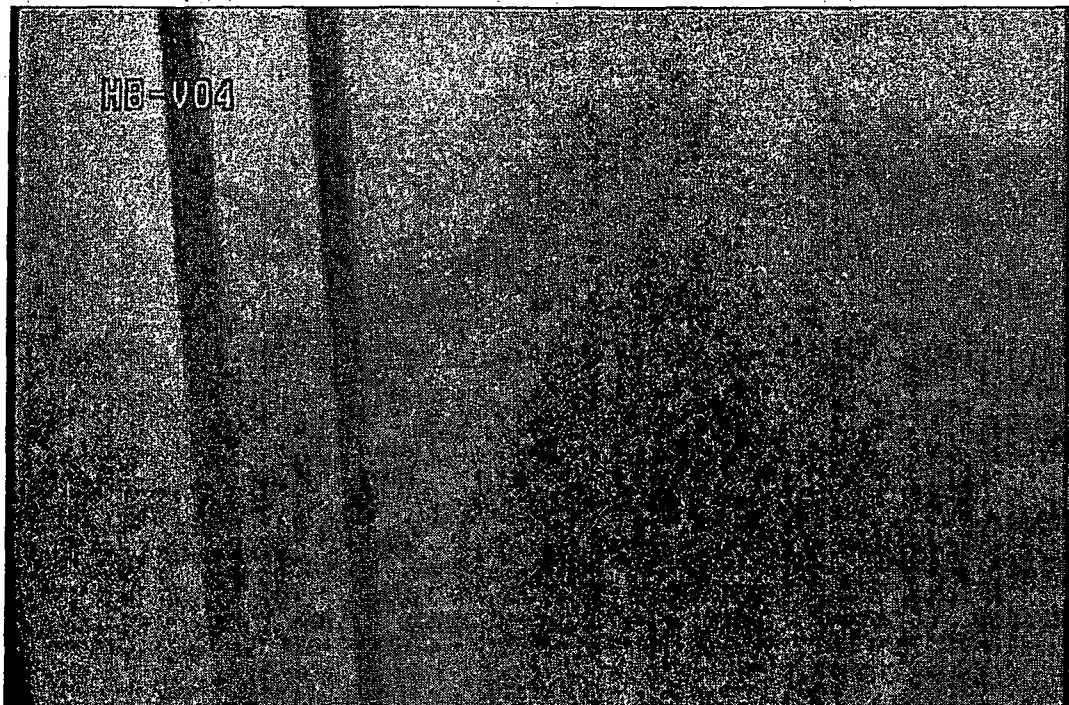
This is a 2007 photo of the 5<sup>th</sup> indication (Correlates to RFO25: 4<sup>th</sup> indication).

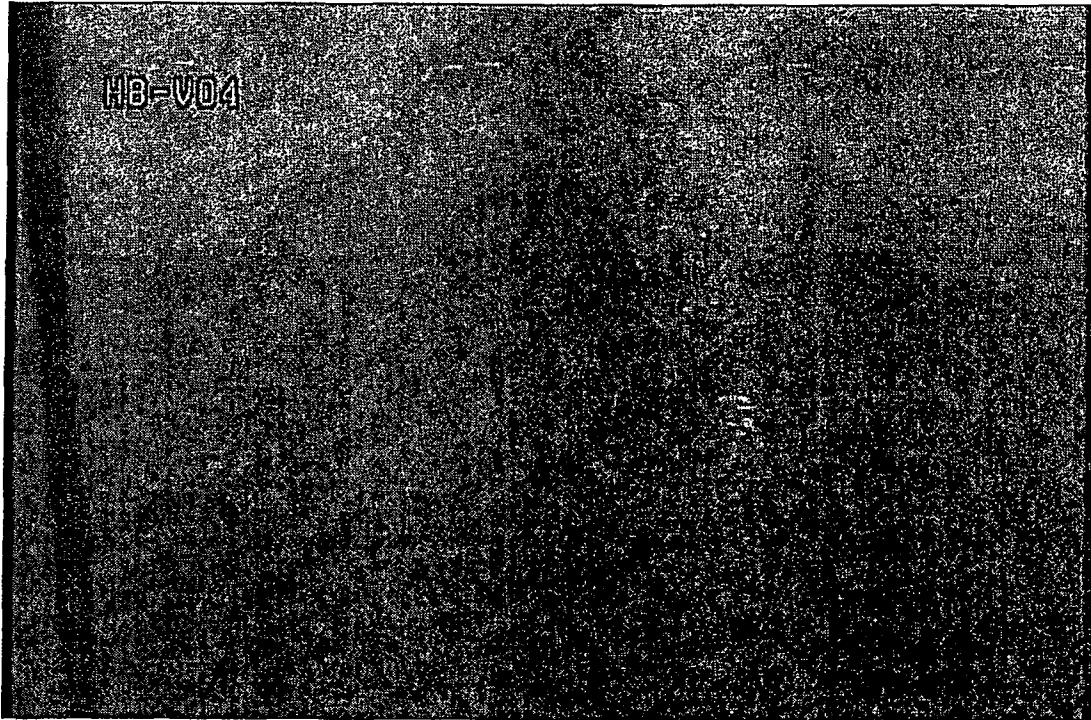
This is a 2007 photo of the 6<sup>th</sup> indication (Correlates to RFO25: 5th indication).

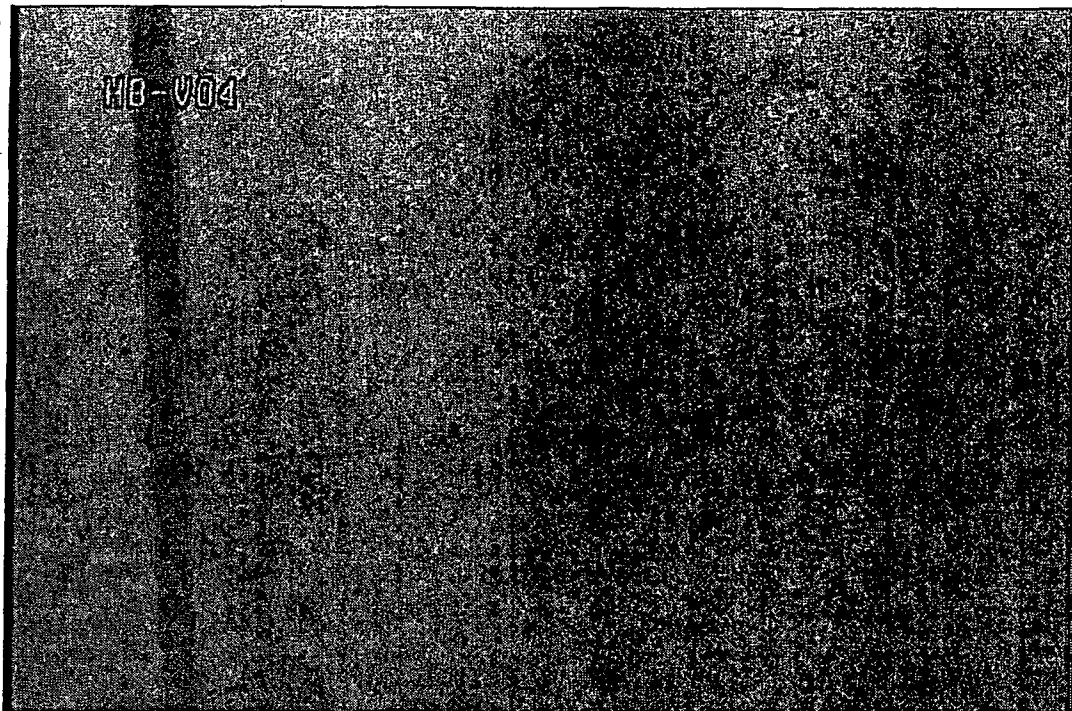
This is a 2007 photo of the 7<sup>th</sup> indication (Correlates to RFO25: 6th indication).

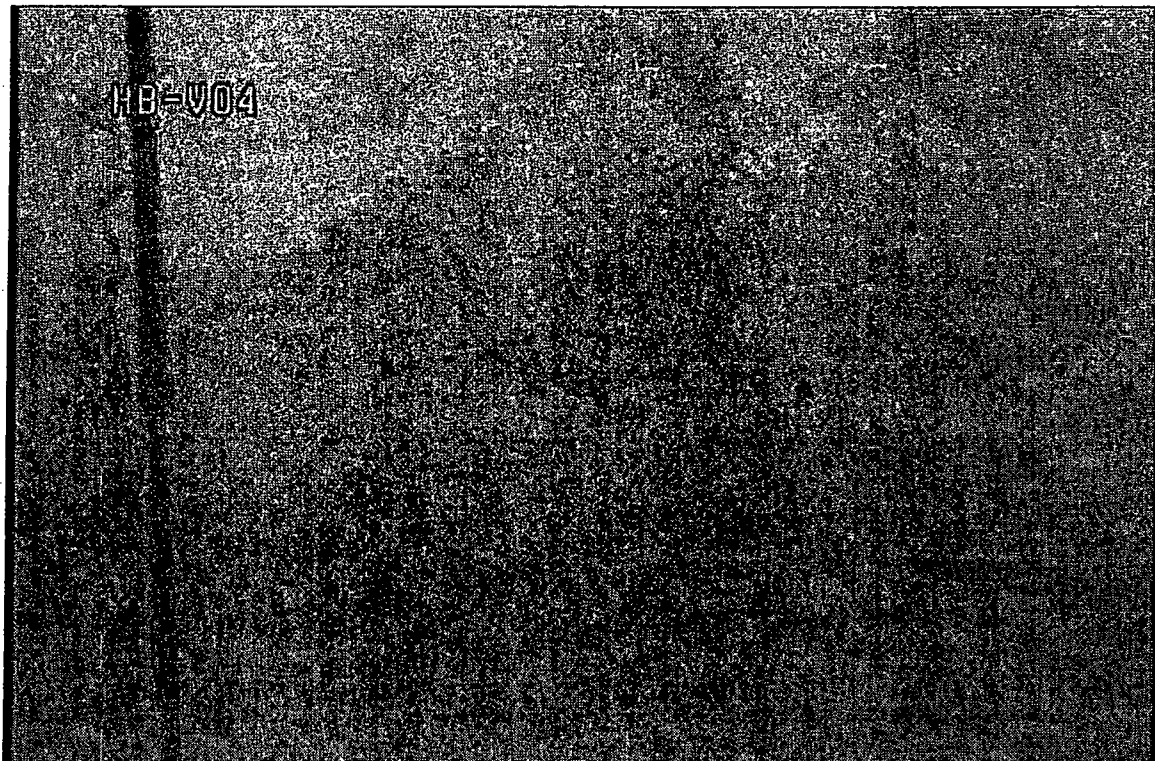
This is a 2007 photo of the 8<sup>th</sup> indication (Correlates to RFO25: 7<sup>th</sup> indication).

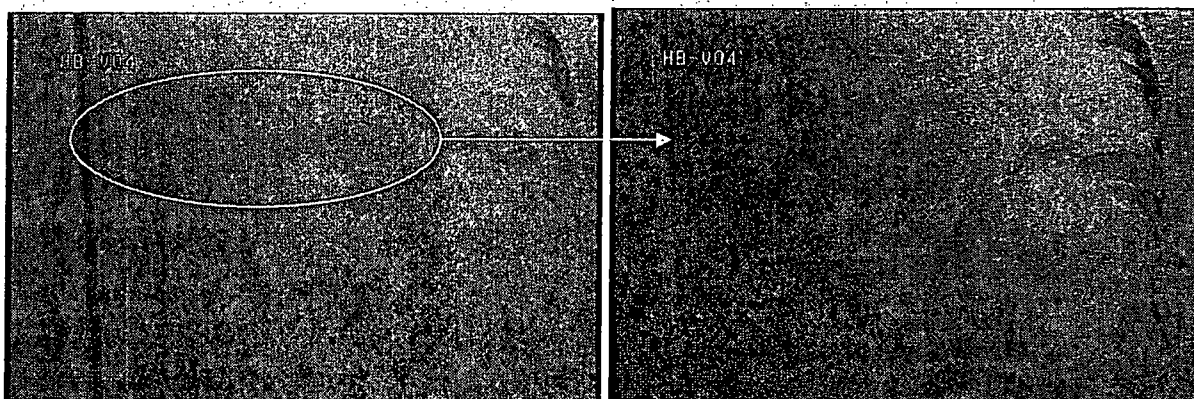
These 2007 photos show a linear indication and change of lighting and show a non-relevant indication (Correlates to RFO25: 9<sup>th</sup> indication).

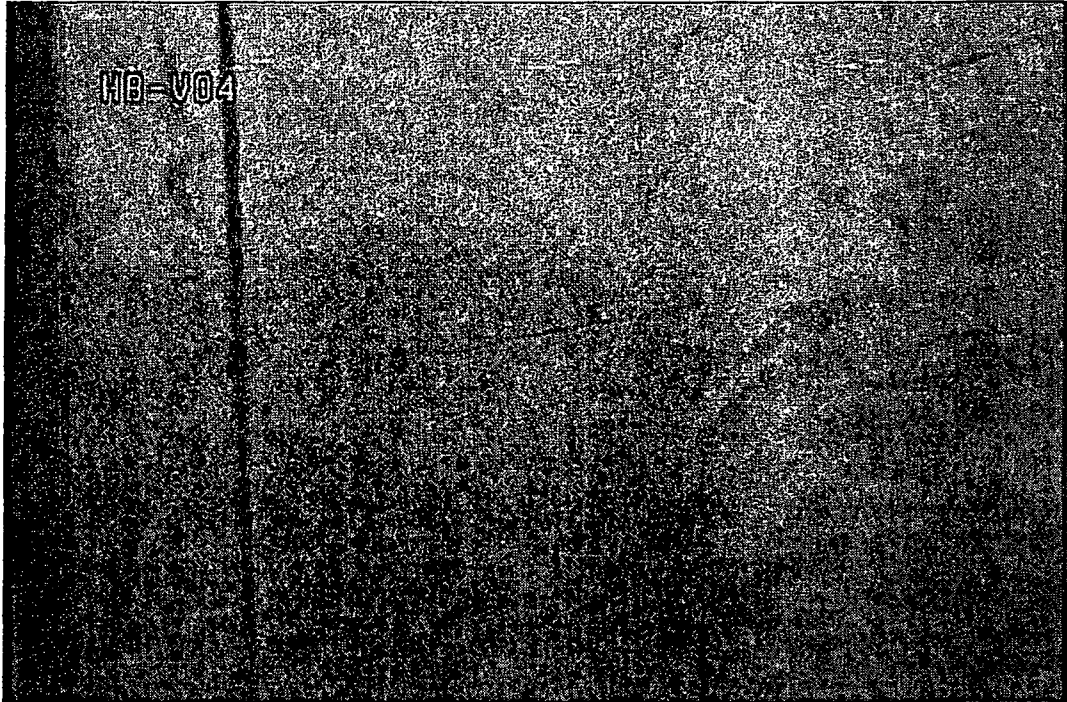
This is a 2007 photo of the 9<sup>th</sup> indication (Correlates to RFO25: 10th indication).

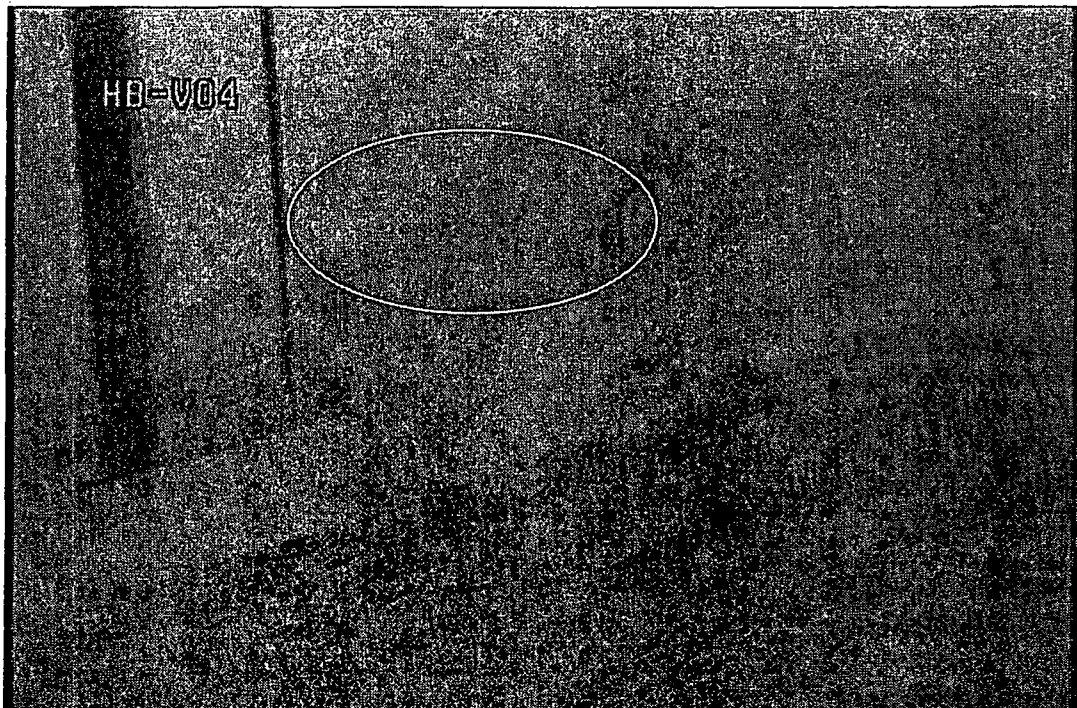
This is a 2007 photo of the bottom weld area and crud line.

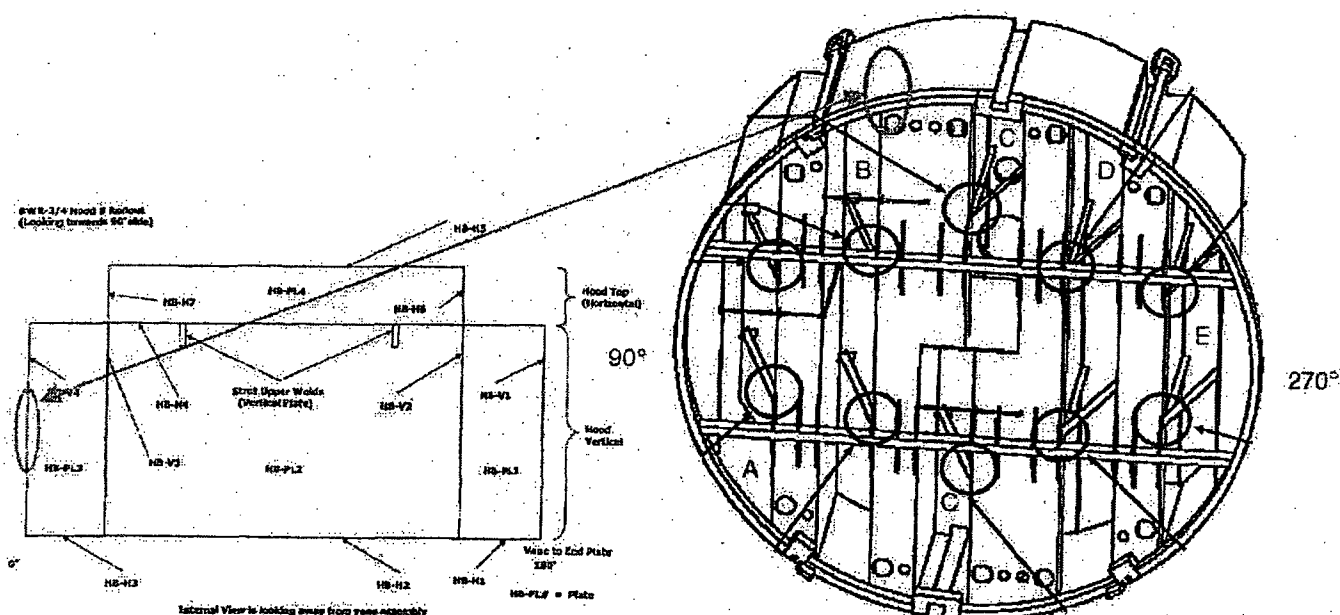
Sketch on the left shows the weld map rollout The sketch on the right shows a bottom view of the dryer.

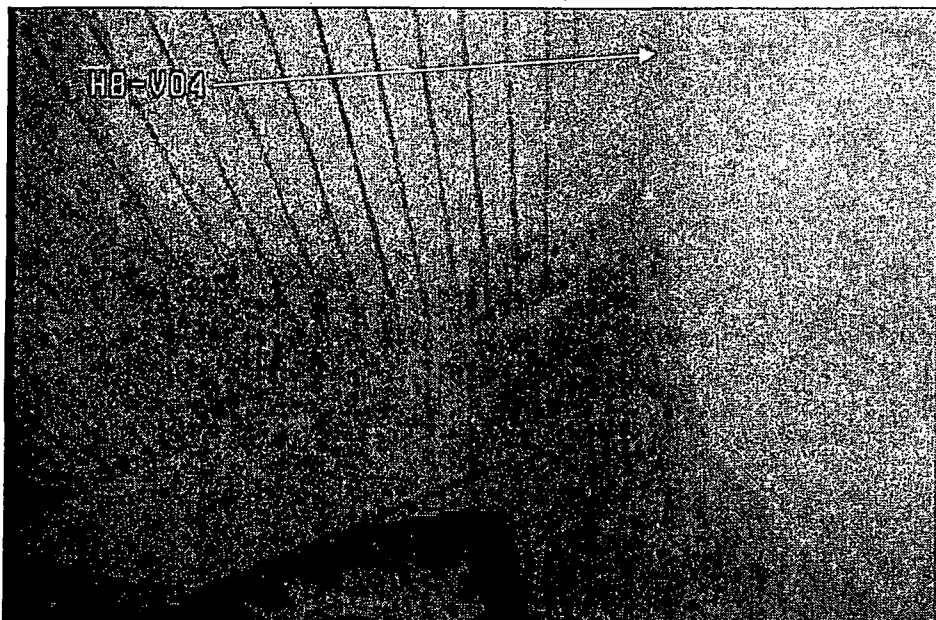
This 2007 photo shows the interior of the dryer and the location of HB-V04 vertical weld.

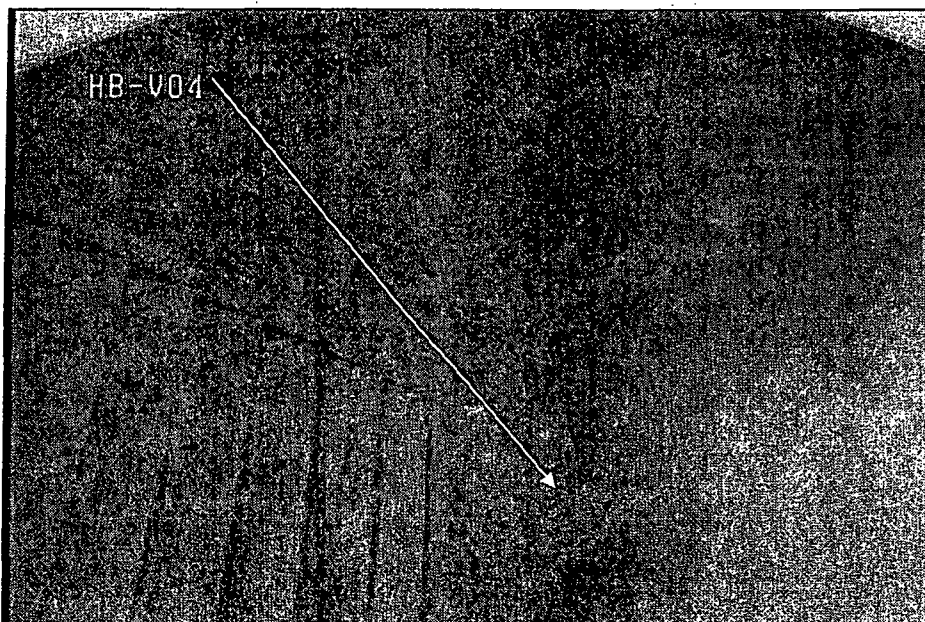
This 2007 photo shows the top of the vane bank (on the left) and the end panel (on the right) and the vertical weld in the center

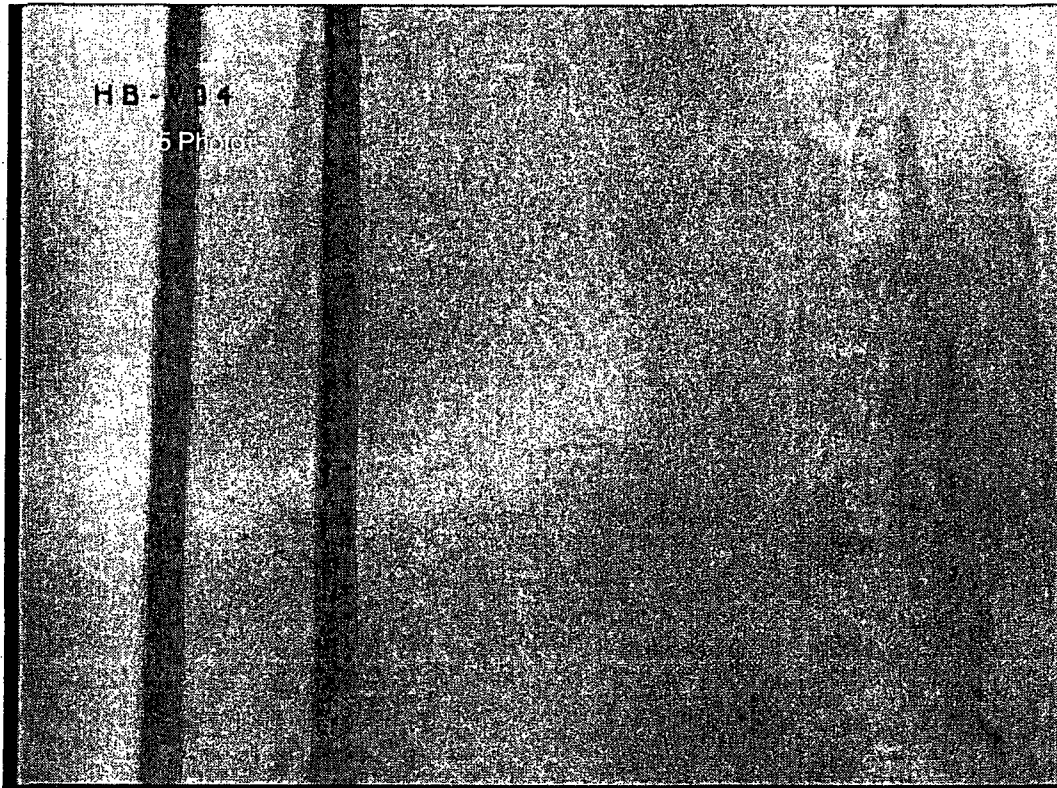
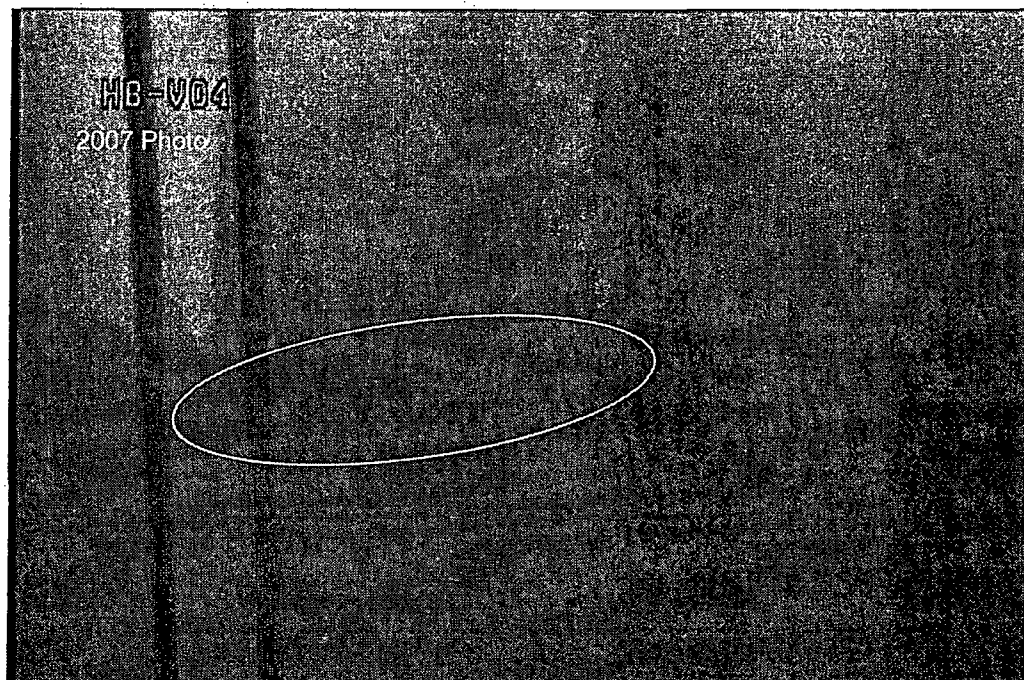
This 2007 photo is of the 1<sup>st</sup> indication from top down (Correlates to RFO25: 1<sup>st</sup> indication).

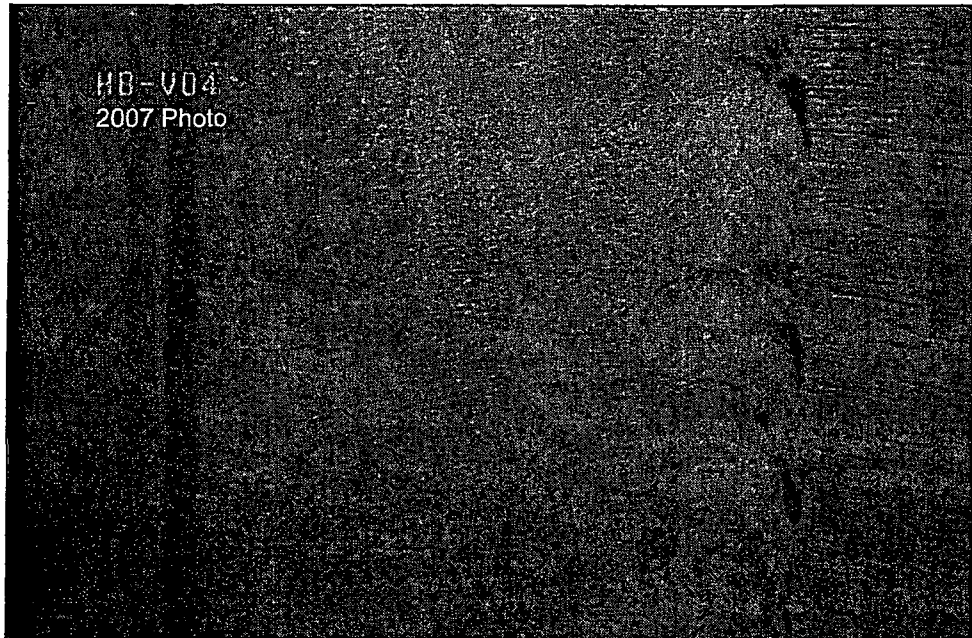
This 2007 photo is a close-up of the 1<sup>st</sup> indication (Correlates to RFO25: 1<sup>st</sup> indication).

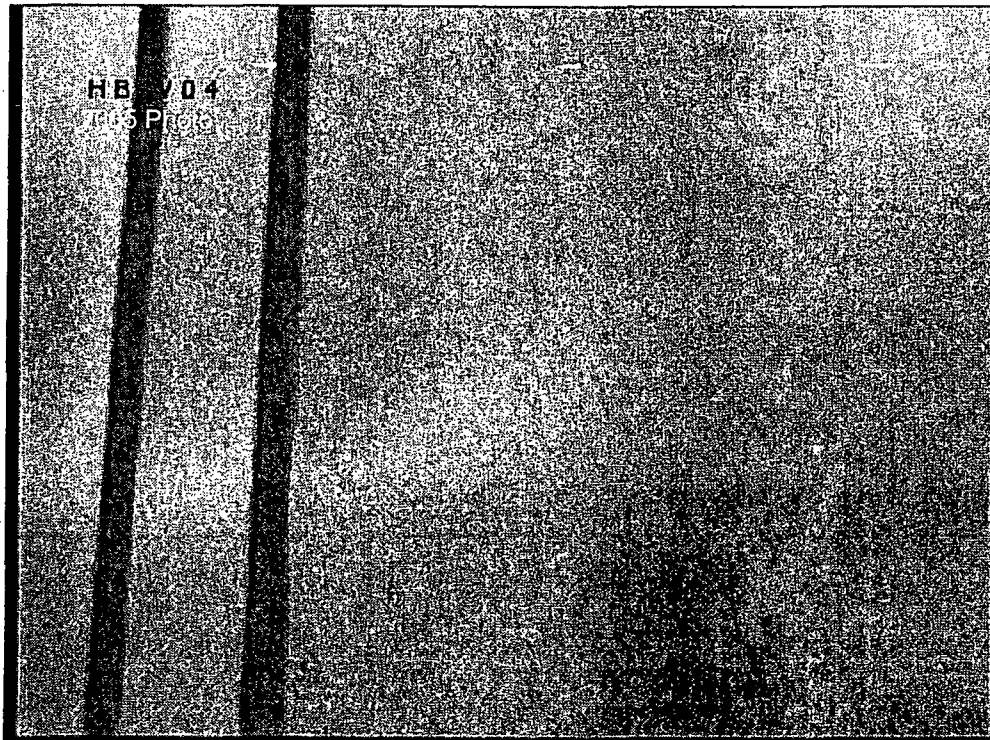
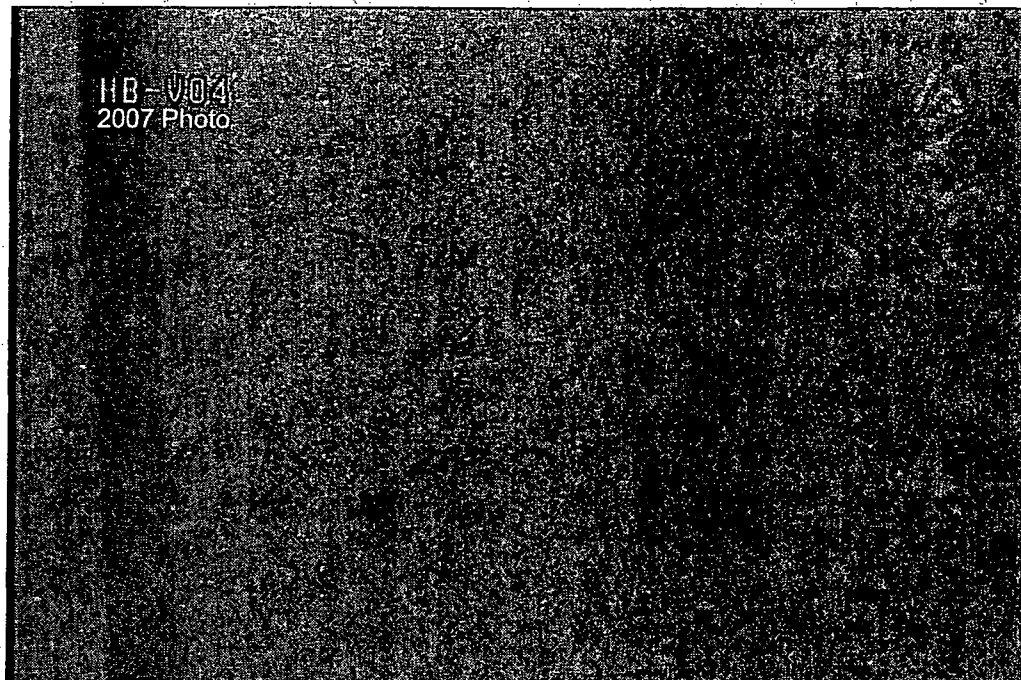
This 2007 photo is the 2<sup>nd</sup> indication (Correlates to RFO25: 2<sup>nd</sup> indication).

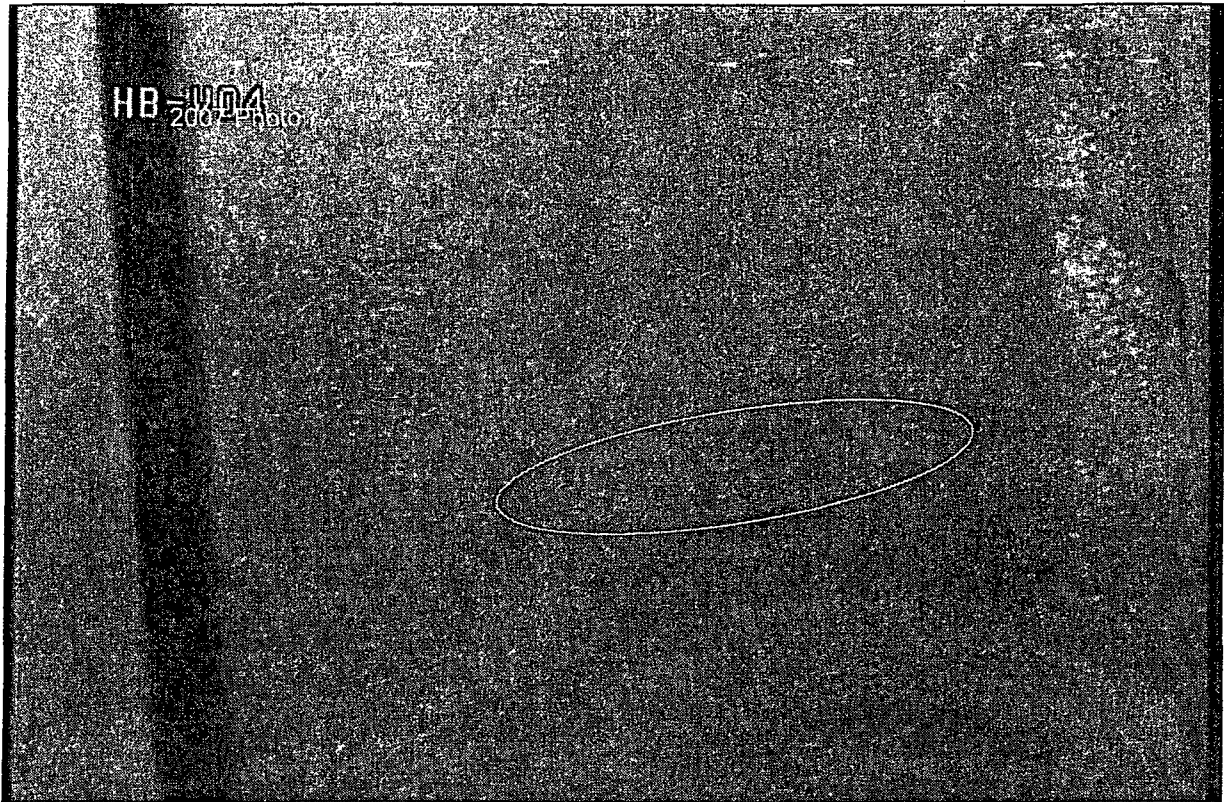
One new indication was found adjacent to weld HB-V04, located on bank B at the 0° end and is labeled as the 3<sup>rd</sup> indication on INR-IVVI-VYR26-07-10 Rev.1 (Reference 2). This indication is of similar appearance, orientation and size as those previously seen. Because of this it is being treated similar to those indications identified in RFO25. The remainder of indications on the steam dryer listed as References 1-10 were previously identified and show no signs of growth. These indications are acceptable to leave as is per GE evaluation GENE-0000-0047-2767 (Reference 11) performed in RFO25. Therefore, the one new indication described above is the only one requiring an evaluation.

GE's evaluation in RFO25 cites IGSCC as being the likely cause of most of the indications previously observed. This is based on the jagged appearance and location in the weld heat affected zone (HAZ). The unit end plates may have cold work resulting from cold forming. Cold working Type 304 material can promote initiation of stress corrosion cracks when exposed to the BWR environment. The dryer unit end plates are located in the dryer interior and are not subjected to any direct main steam line acoustic loading. However, continued growth by fatigue cannot be ruled out. Nevertheless, all of these indications appear to have stopped without propagating into the vertical weld; this is indicative of IGSCC behavior as opposed to fatigue, since weld material is more resistant to IGSCC. The flanges have experienced a near infinite number of fluctuating load cycles and if fatigue driven, more significant cracking is likely to have occurred after many years of operation. IGSCC in steam dryers has been typically limited in depth and length since in many cases it is caused by cold work or weld induced residual stress.

This is a 2007 photo of the 3<sup>rd</sup> indication and is a new RFO26 indication.

The plant can start up with the dryer indications left as is. The new dryer indication is of the same appearance, orientation and size as those previously observed. Since this new indication is located in the heat affected zone and is consistent with the other indications, this is most likely caused by IGSCC. This is consistent with the evaluations by GE. See the INR and evaluation provided.

The dryer unit end plates flaw assessment is based on the following factors: (1) it is a highly redundant structure and there is no structural consequence of the cracking and (2) postulated significant flaw extension leading to the flaw reaching the full section of the channel geometry would not create the opportunity for loose parts. Field experience supports this as-is operation decision in the context that the indications will be re-inspected at the next outage. It is recommended that the new visual indication given in Reference 2 be accepted as is. Repair is not recommended.

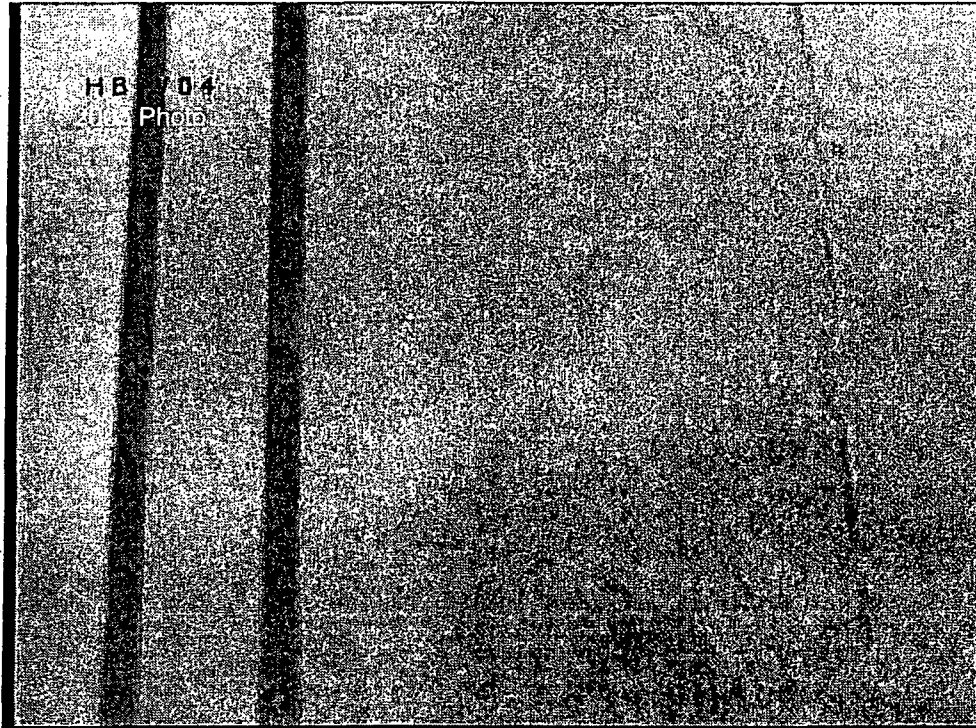
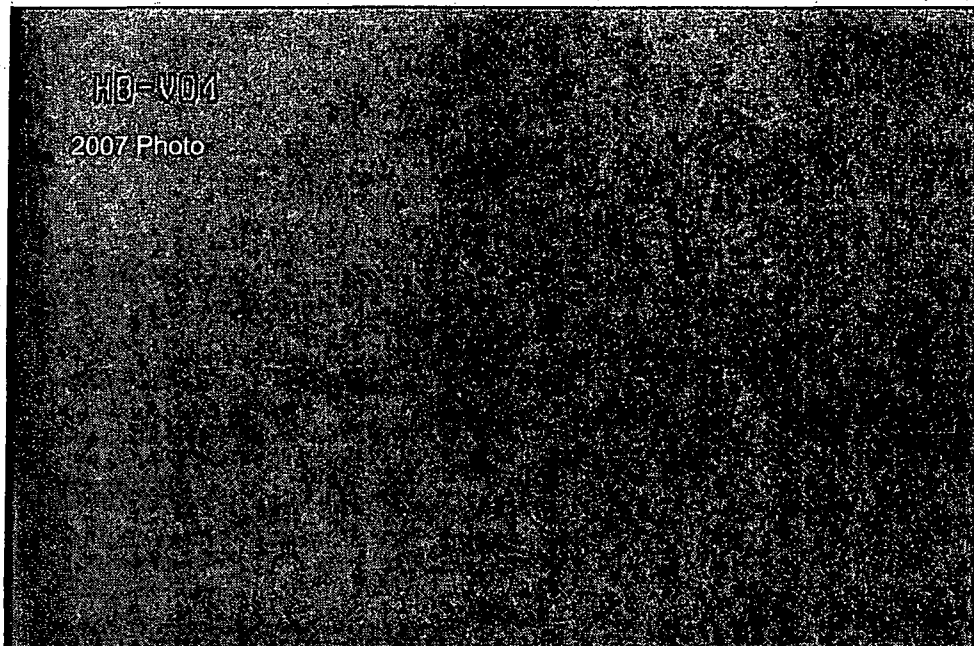
This is a 2007 photo of the 4<sup>th</sup> indication (Correlates to RFO25: 3<sup>rd</sup> indication)

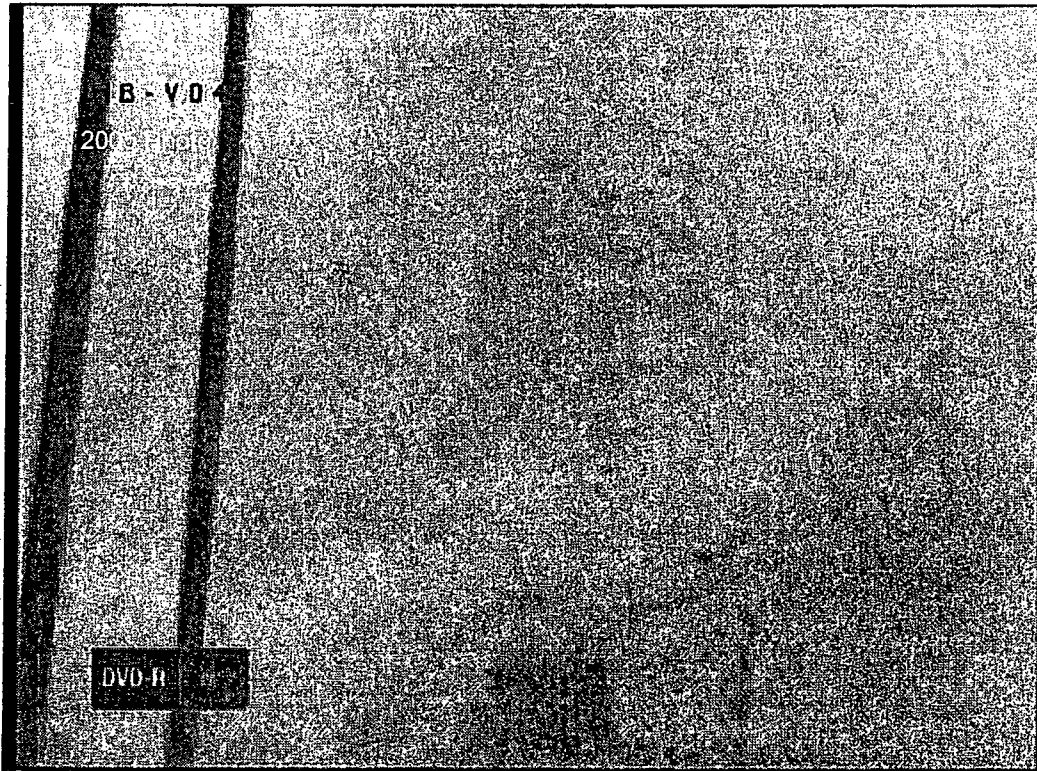
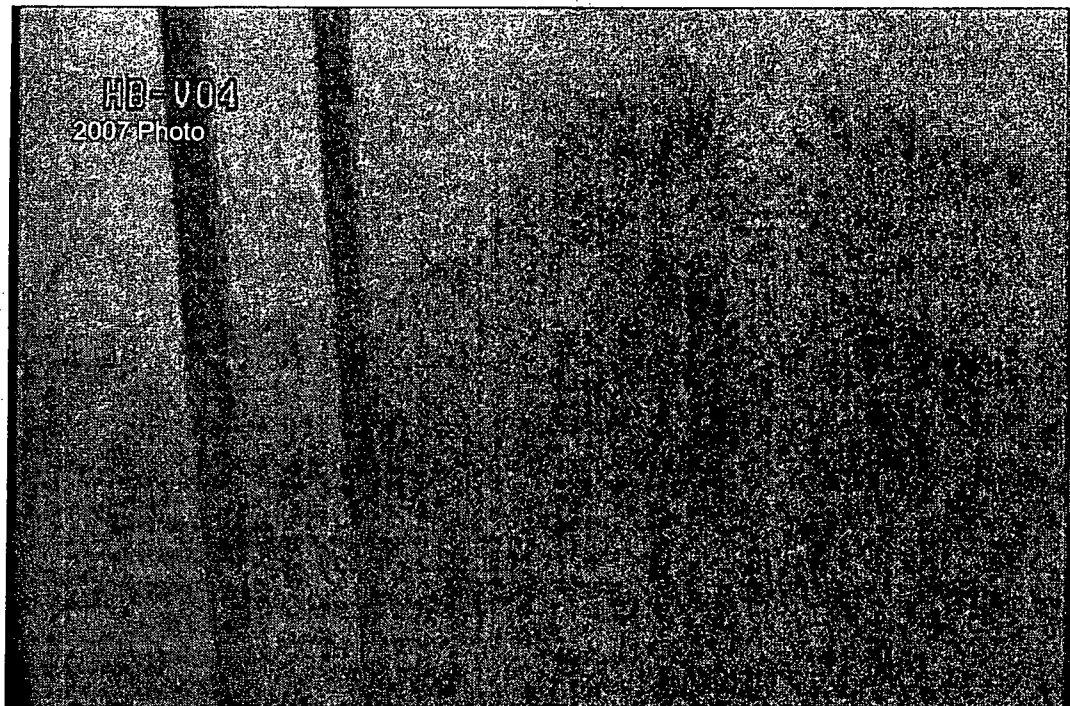
This is a 2007 photo of the 5<sup>th</sup> indication (Correlates to RFO25: 4th indication).
