**Entergy****CONDITION REPORT****CR-VTY-2007-02133****Originator:** Fales, Neil**Originator Phone:** 8024513057**Originator Group:** Eng P&C Codes Staff**Operability Required:** Y**Supervisor Name:** Lukens, Larry D**Reportability Required:** Y**Discovered Date:** 05/28/2007 17:06**Initiated Date:** 05/28/2007 17:11**Condition Description:**

Steam Dryer Inspection Indications

# **INR-IVVI-VYR26-07-10- Steam Dryer Interior HB-V04**

Engineering Report Title:  
EVALUATION OF NEW RFO26 STEAM DRYER INDICATION

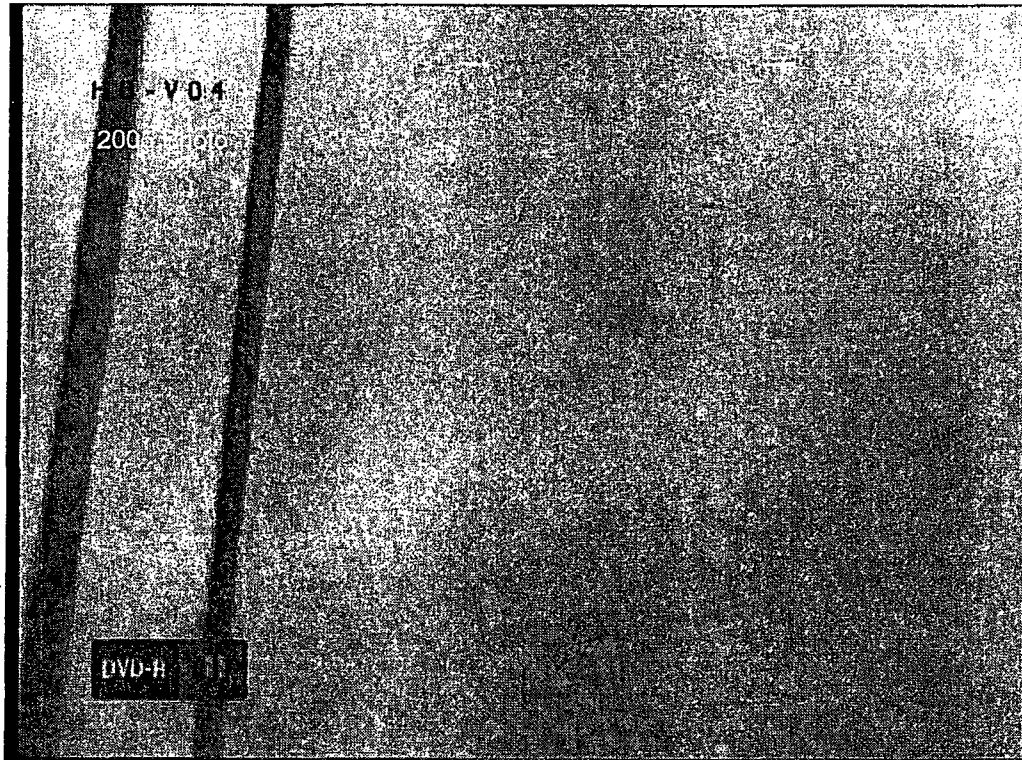
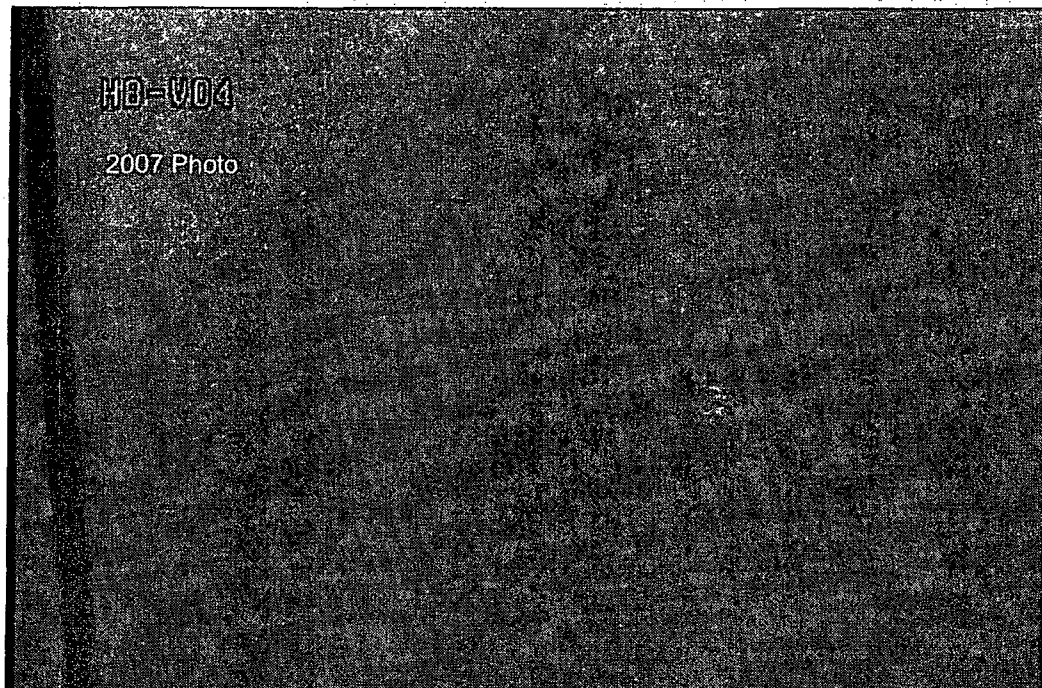
This is a 2007 photo of the 6<sup>th</sup> indication (Correlates to RFO25: 5th indication).

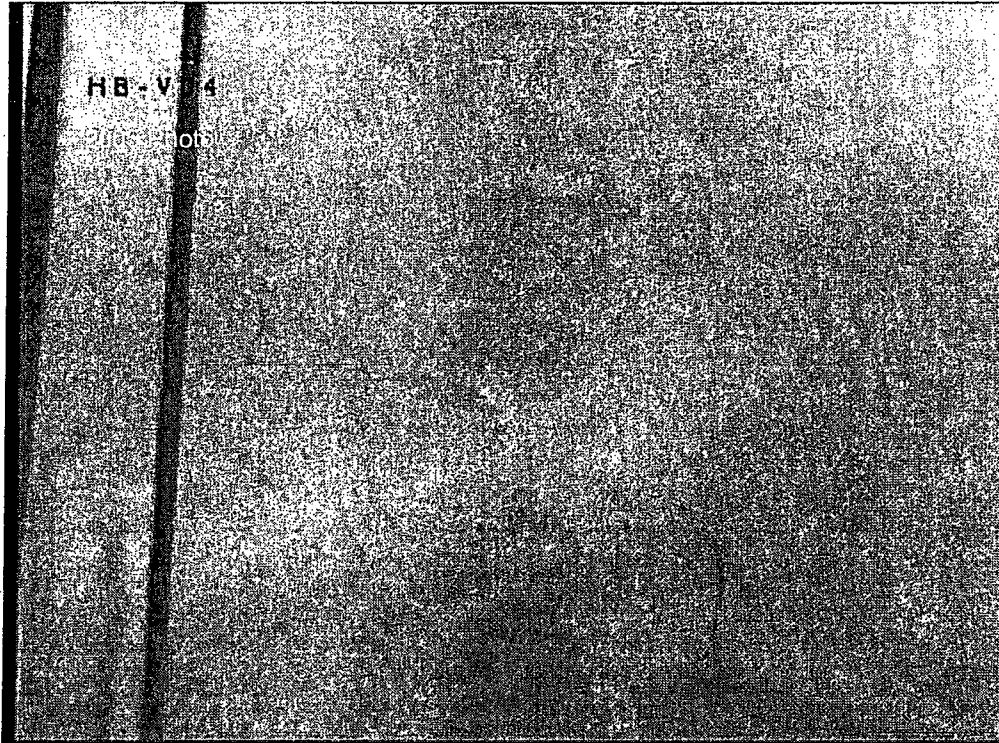
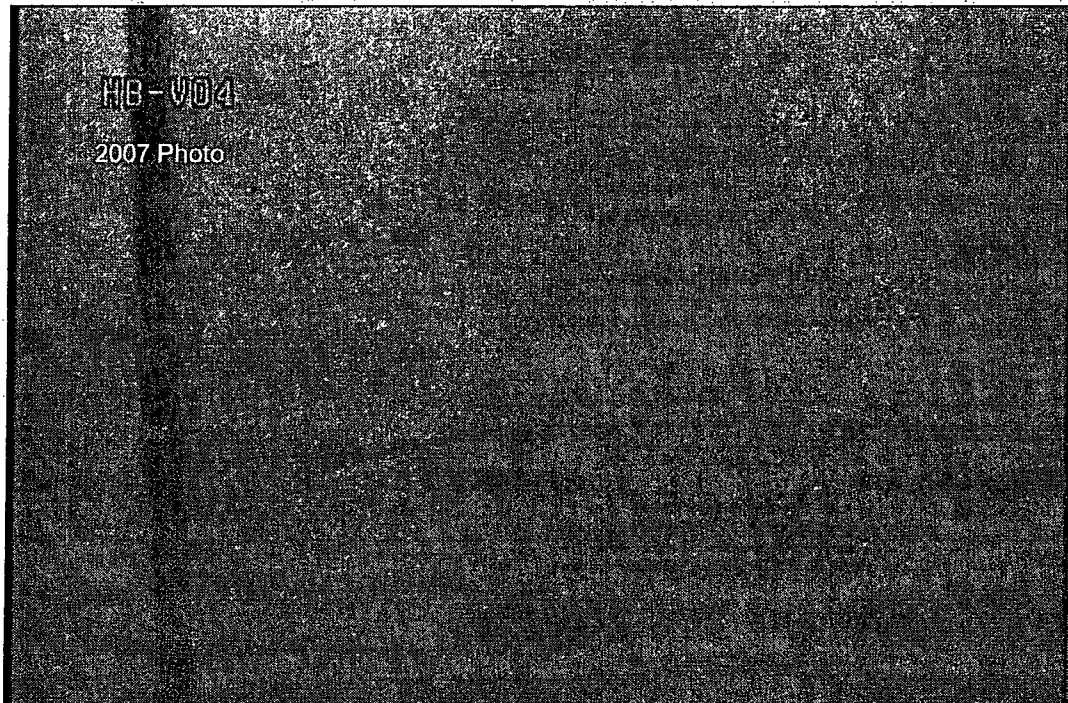
This is a 2007 photo of the 7<sup>th</sup> indication (Correlates to RFO25: 6th indication).

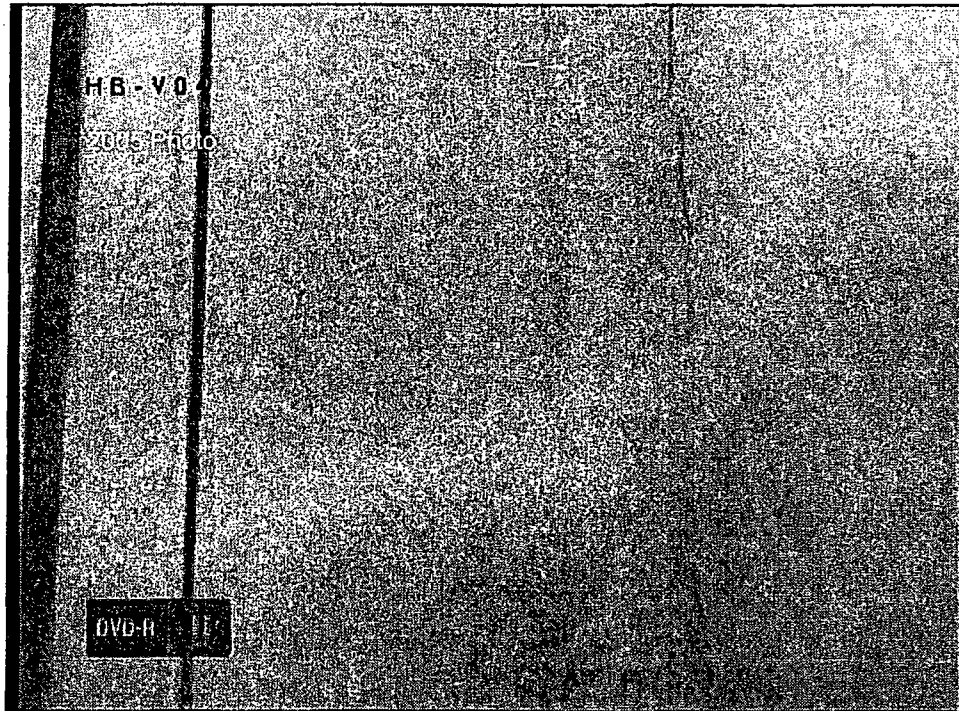
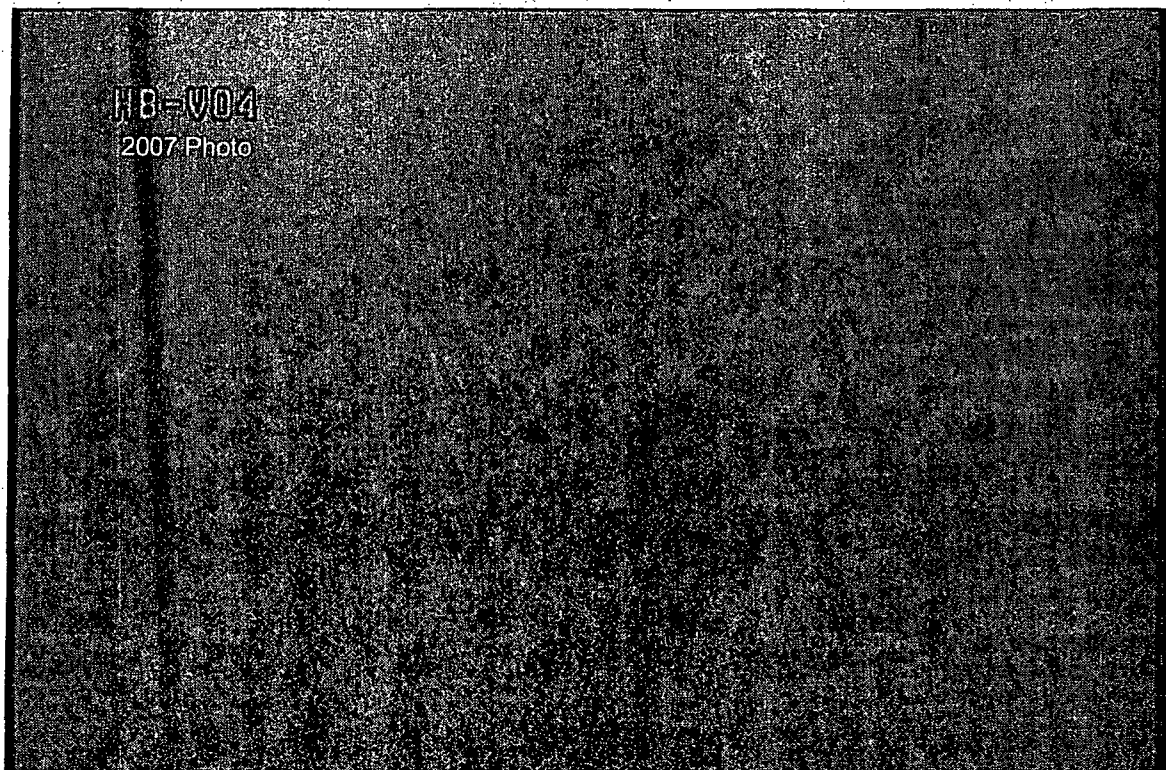
This is a 2007 photo of the 8<sup>th</sup> indication (Correlates to RFO25: 7th indication).

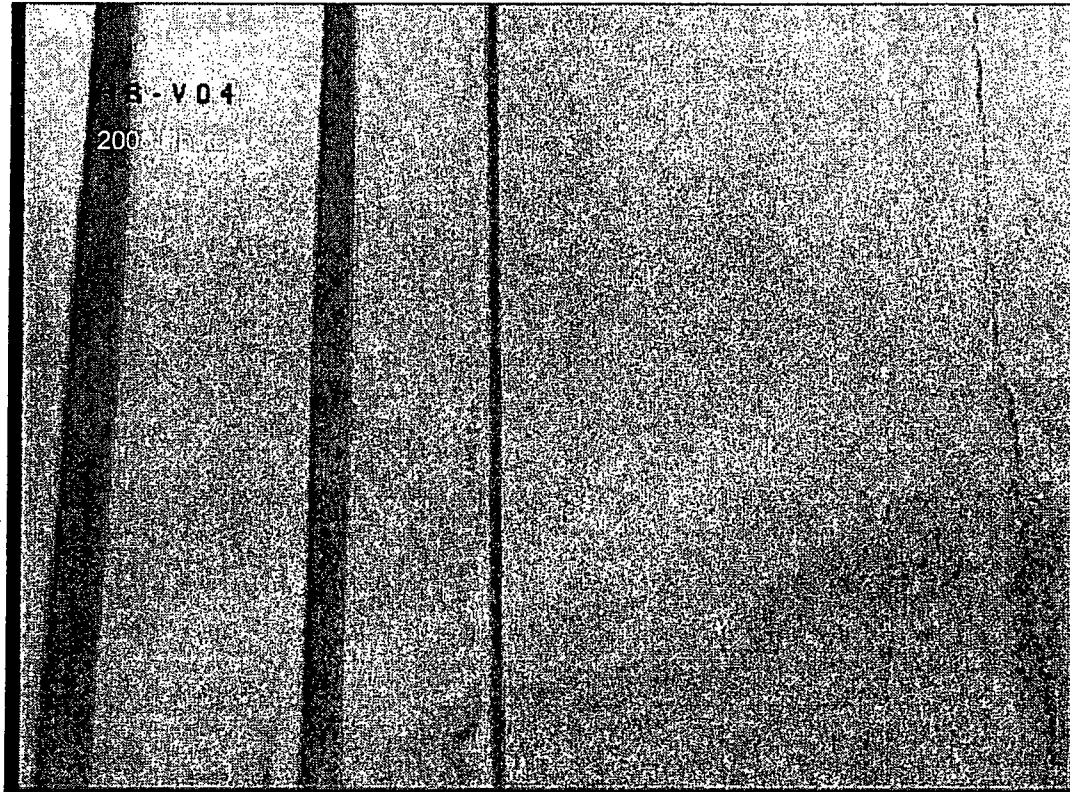
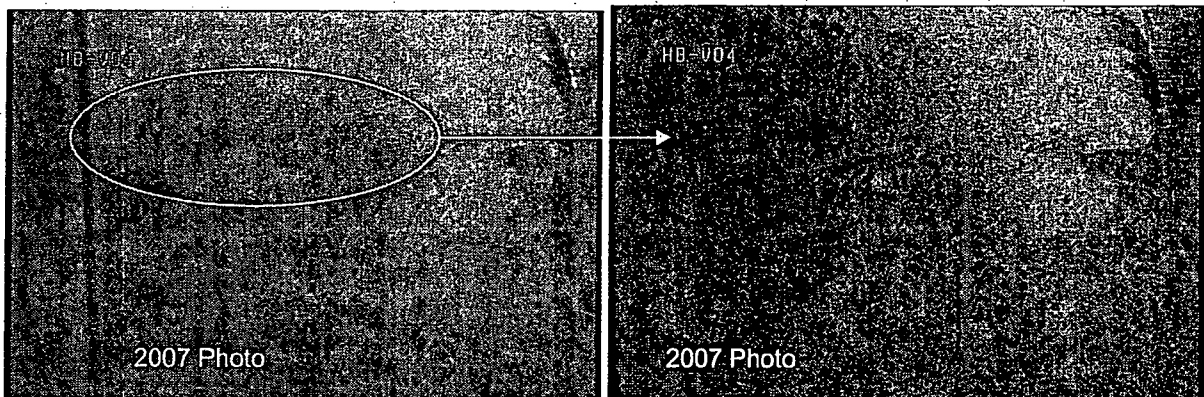
These 2007 photos show a linear indication and with a change of lighting there is no indication. This indication is considered non-relevant. (Correlates to RFO25: 9<sup>th</sup> indication).

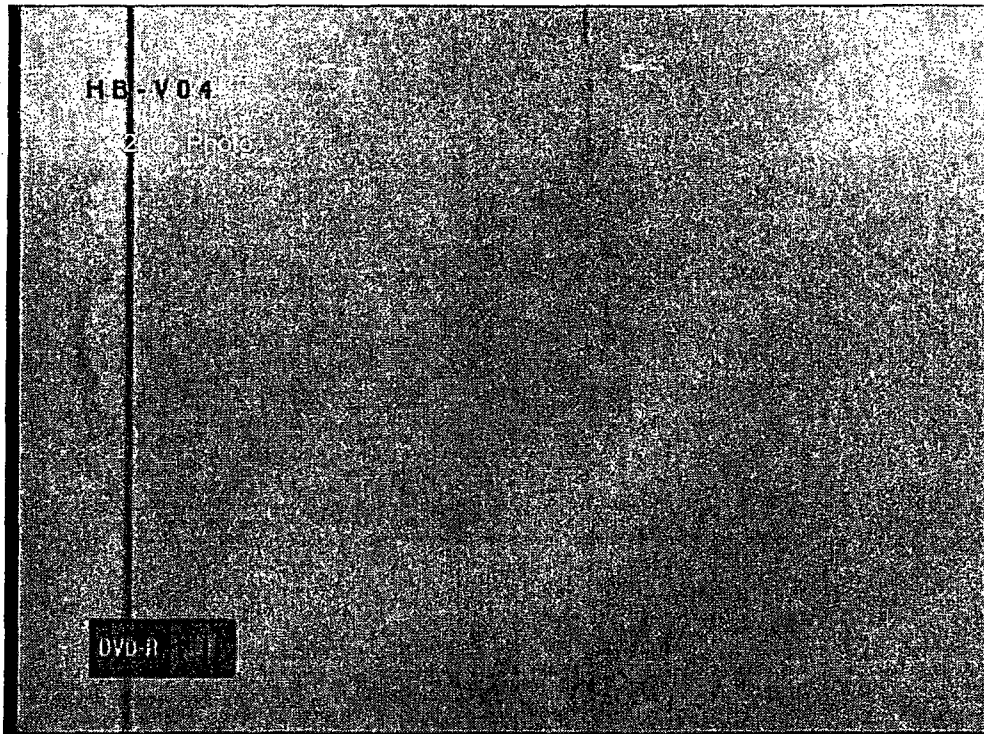
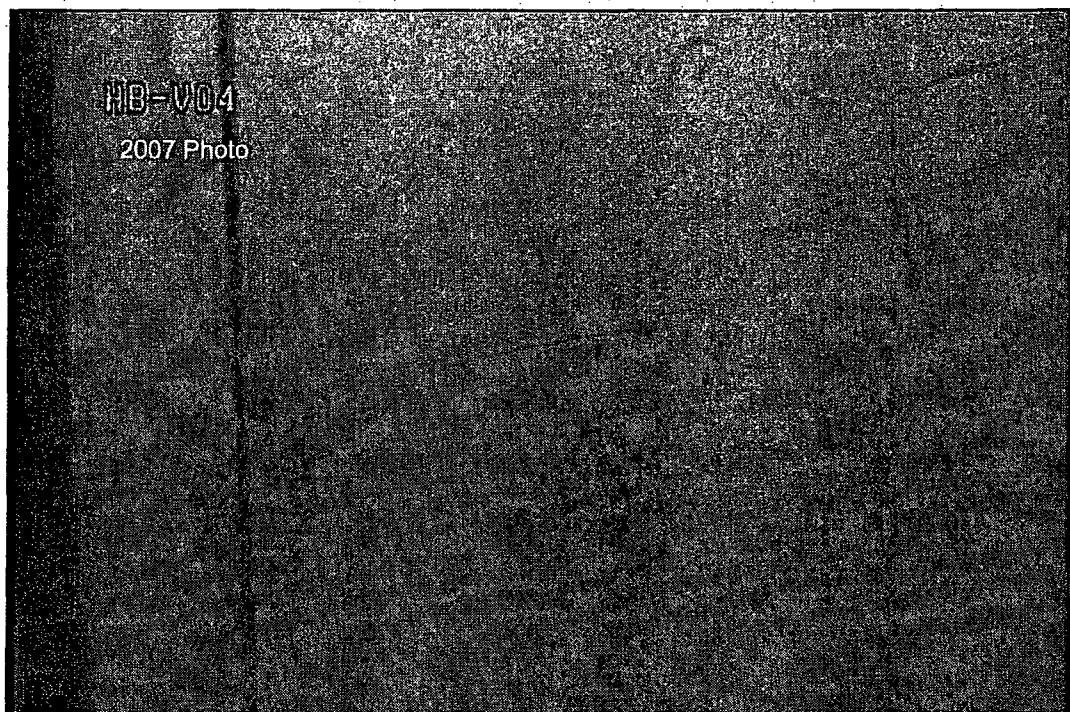
This is a 2007 photo of the 9<sup>th</sup> indication (Correlates to RFO25: 10th indication).

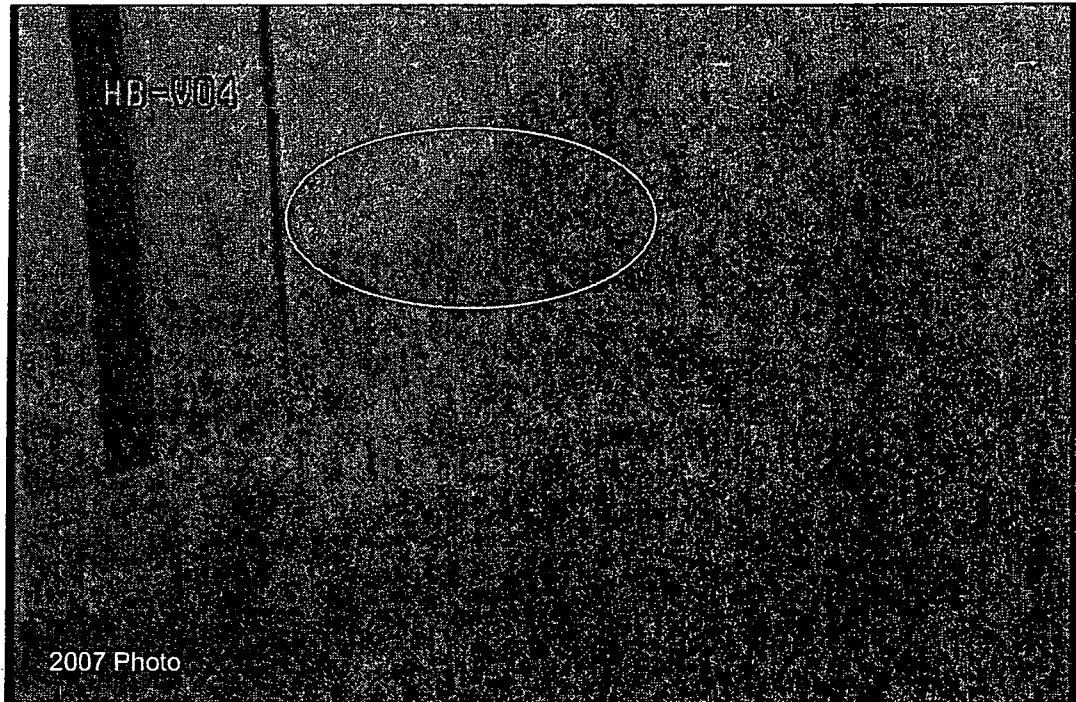
This is a 2007 photo of the bottom weld area and crud line.
