**NEW ENGLAND COALITION, INC.'S (NEC) SUPPLEMENT TO OPPOSITION
TO ENTERGY'S MOTION FOR SUMMARY DISPOSITION OF NEW
ENGLAND COALITION CONTENTION 3 (STEAM DRYER)**

SECOND DECLARATION OF ULRICH WITTE

INR-IVVI-VYR26-07-10- Steam Dryer Interior HB-V04 Indication Notification Report

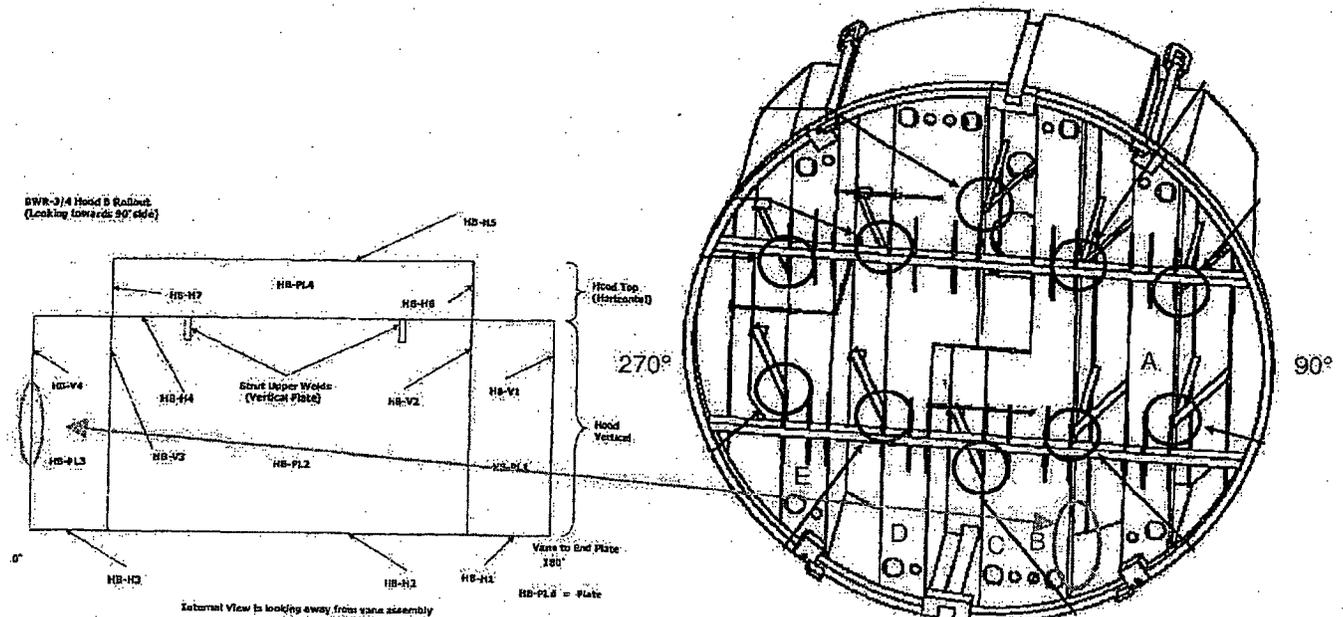
Sketch on the left shows the weld map rollout. The sketch on the right shows a bottom view of the dryer.

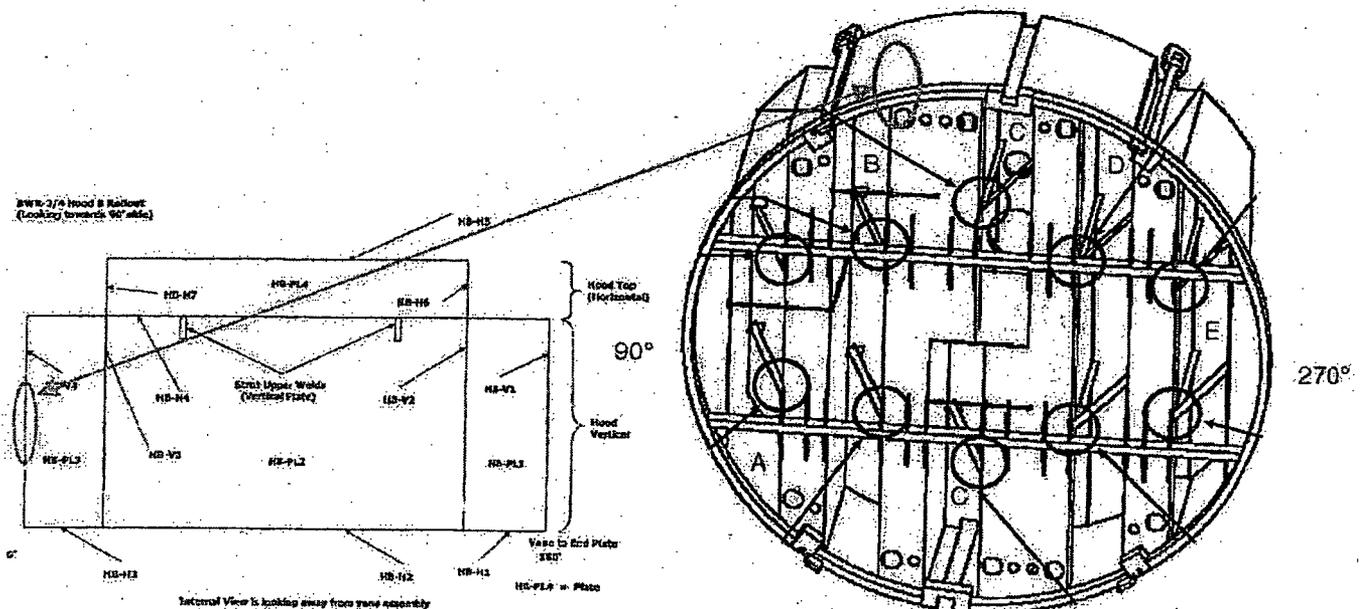
Sketch on the left shows the weld map rollout The sketch on the right shows a bottom view of the dryer.
