**2000 Annual Site Inspection and Monitoring
Compliance Report for Uranium Mill Tailings
Radiation Control Act Title II Disposal Sites**

September 2000

Prepared by
U.S. Department of Energy
Grand Junction Office
Grand Junction, Colorado

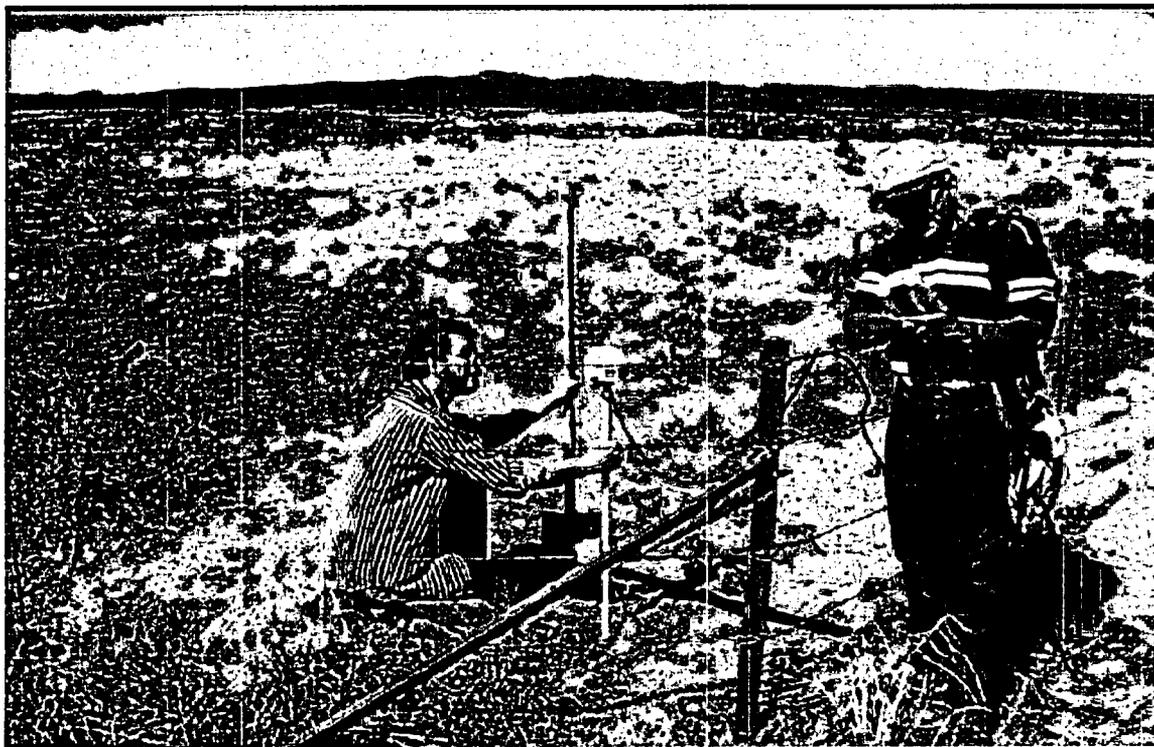
Twenty-four boundary monuments define the site boundary. These monuments are typically inside the perimeter fence, several feet inside the true corner or boundary line. Boundary monument BM-24 that was not located during the 1999 inspection was located during the 2000 inspection with the aid of the global positioning system unit (PL-1). The boundary monuments and the general area around the monuments were inspected for signs of disturbance. None was found.

BLU 5/2000. PL-1. Locating BM-24.

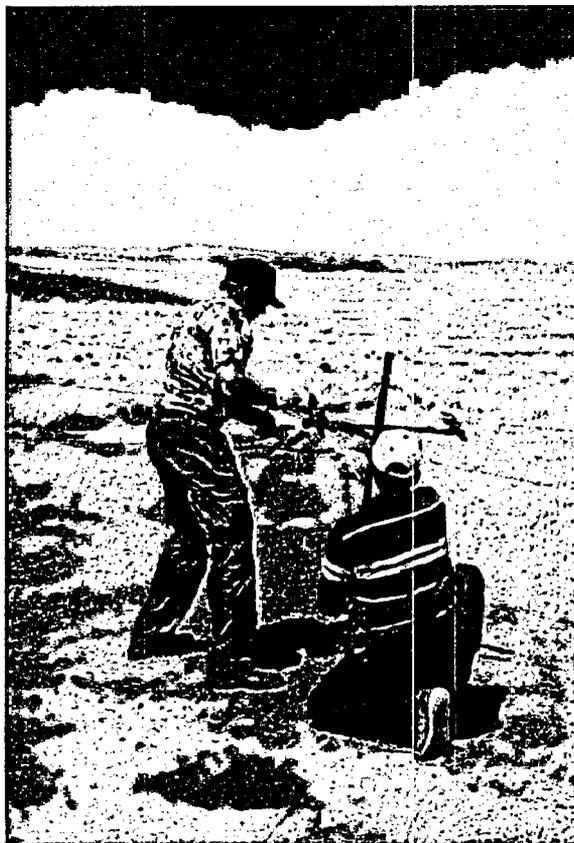
An electric power substation is enclosed by a security fence near the center of the site along the Plains Electric Company right-of-way (Figure 1-1). Fencing around this station is in good condition. Inspectors repaired the fence along the right-of-way northwest of the substation (PL-2).

BLU 5/2000. PL-2. Repairing the fence along the Plains Electric right-of-way.
