**Annual Site Inspection and Monitoring Report  
for Uranium Mill Tailings Radiation Control Act  
Title I Disposal Sites**

**Annual Report for the Period  
January 1, 1998, Through December 31, 1998**

**February 1999**

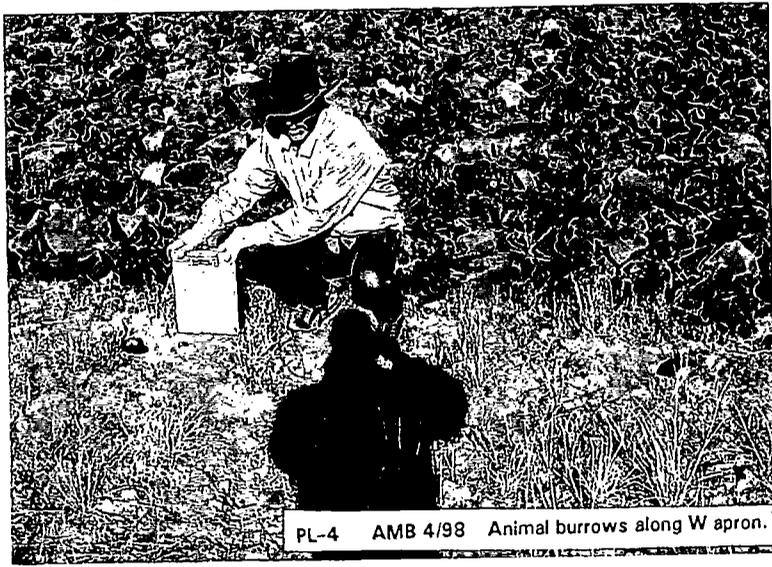
PL-4 AMB 4/98 Animal burrows along W apron.

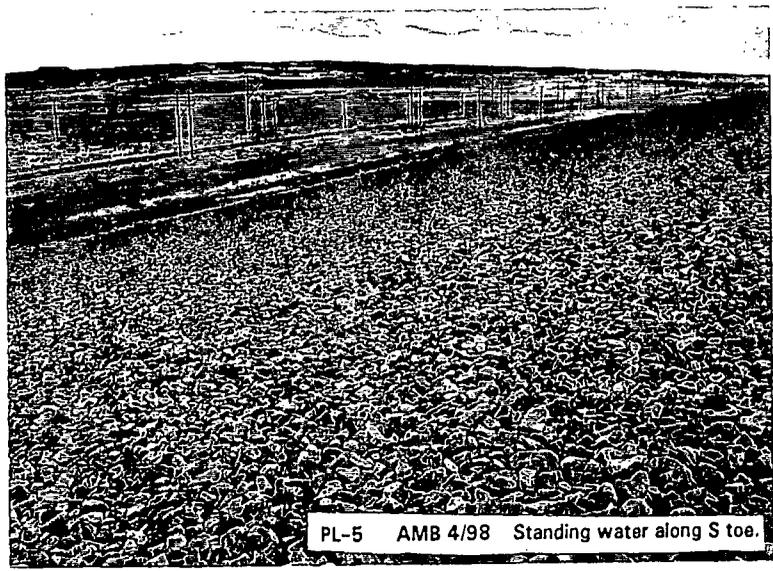
PL-5 AMB 4/98 Standing water along S toe.

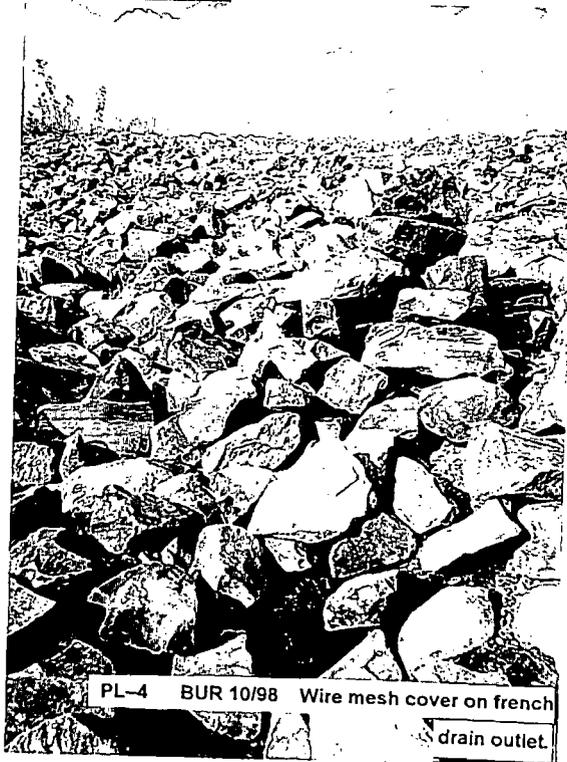
PL-4 BUR 10/98 Wire mesh cover on french drain outlet.

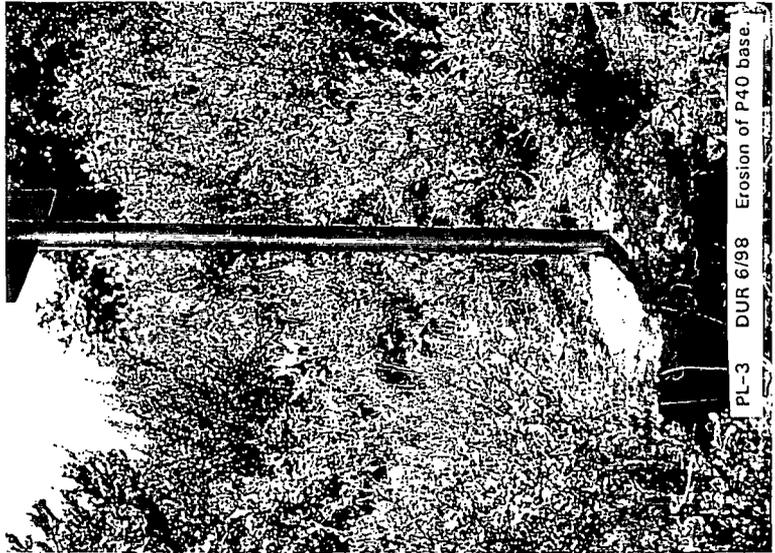
PL-3 DUR 6/98 Erosion of P40 Base.

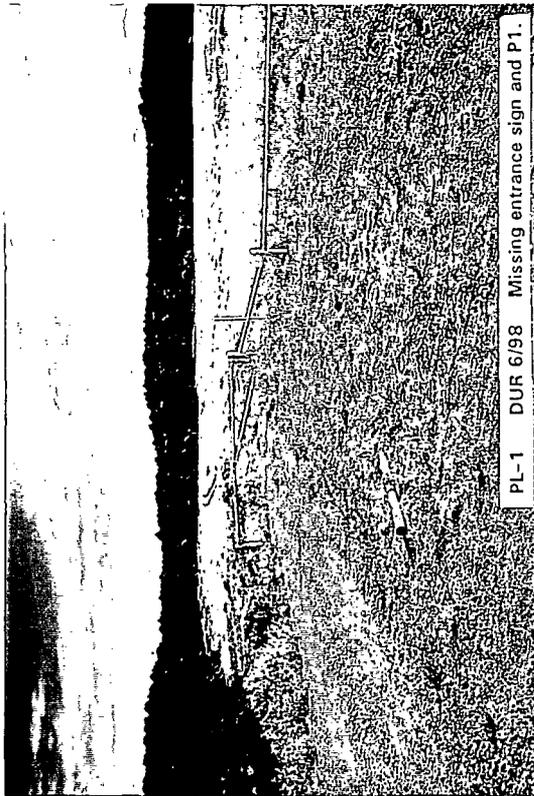
PL-1 DUR 6/98 Missing entrance sign and P1.

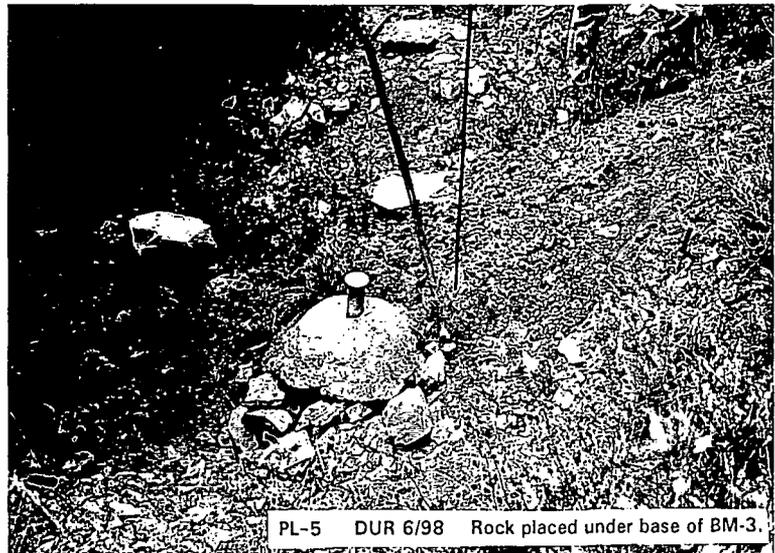
PL-5 DUR 6/98 Rock placed under base of BM-3.

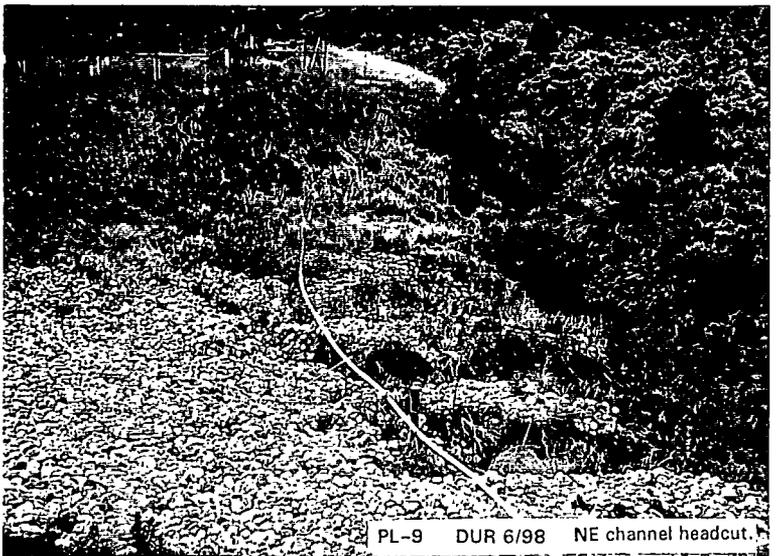
PL-9 DUR 6/98 NE channel headcut.

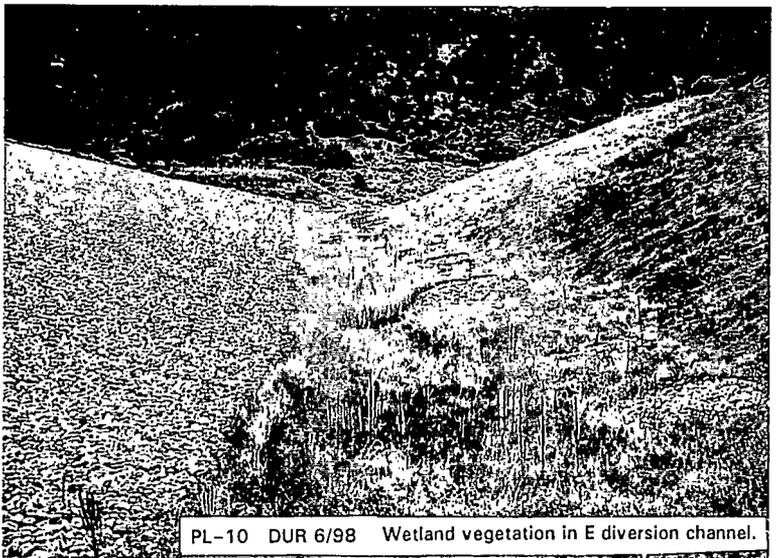
PL-10 DUR 6/98 Wetland vegetation in E diversion channel.

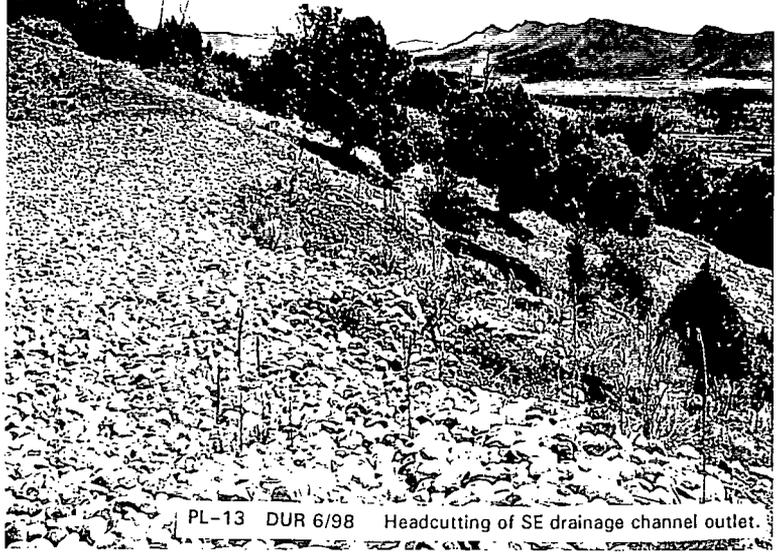
PL-13 DUR 6/98 Headcutting of SE drainage channel outlet.

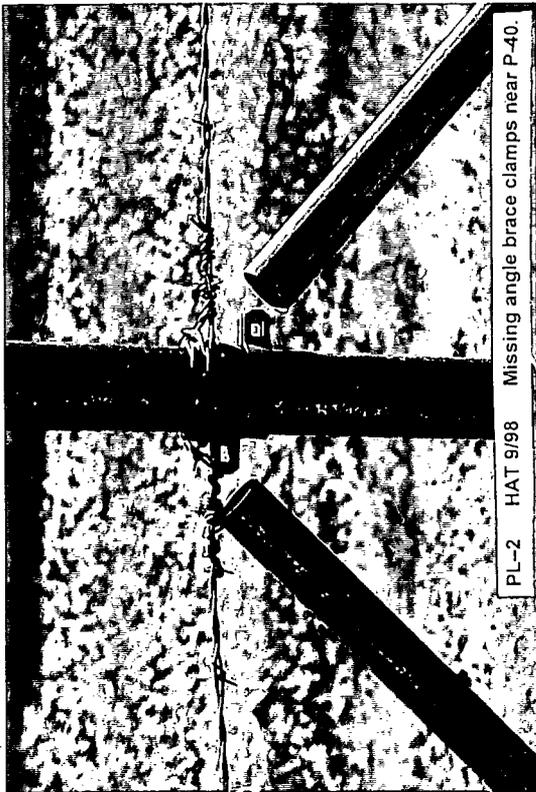
PL-2 HAT 9/98 Missing angle brace clamps near P-40.

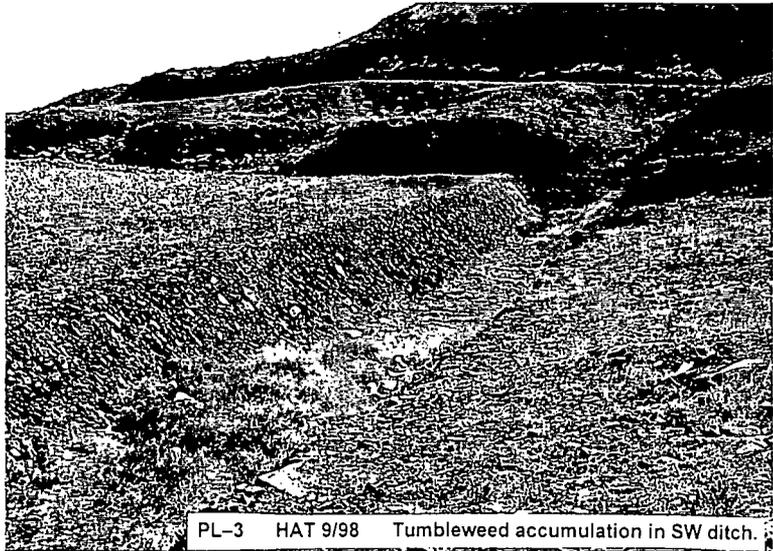
PL-3 HAT 9/98 Tumbleweed accumulation in SW ditch.

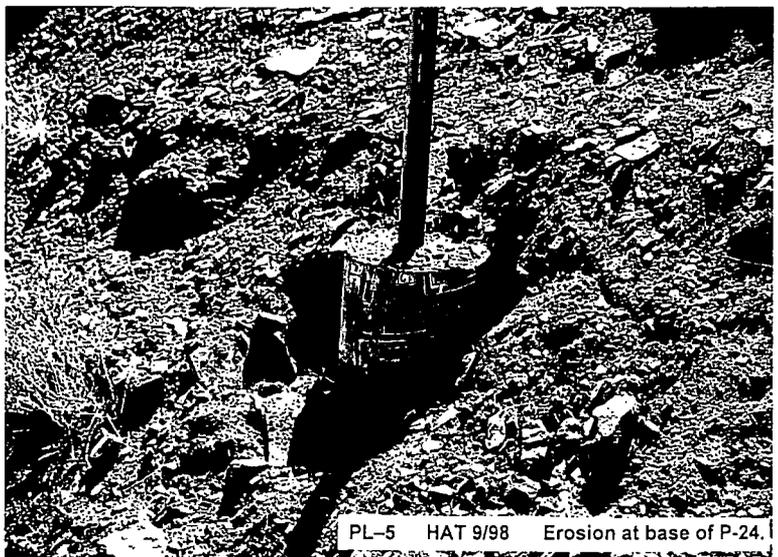
PL-5 HAT 9/98 Erosion at base of P-24.

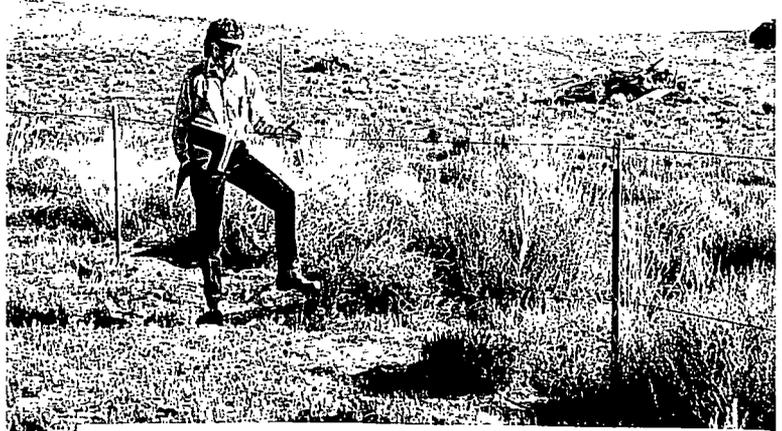
PL-13 SRK 7/98 Loose wire strands on stock fence, near entrance gate.
