**Long-Term Surveillance and Monitoring Program**

**1998 Annual Site Inspection  
and Monitoring Report for  
Uranium Mill Tailings Radiation  
Control Act Title II Disposal Sites**

**Edgemont, South Dakota, Disposal Site**

**1998 Annual Report**

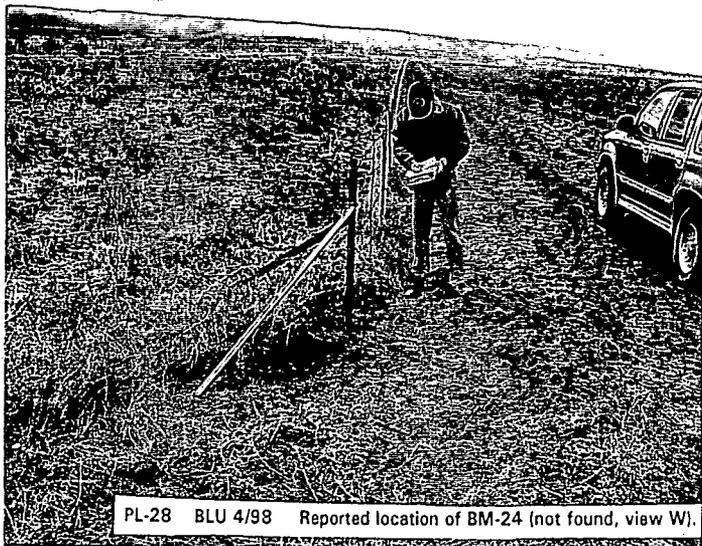
BM-15 in the northeast part of the site (Plate 1) could not be found. It is probably present but is buried by windblown sand and silt along the site perimeter road at this corner. BM-24 along the south boundary of the site also could not be found. It, likewise, is probably buried by windblown sand along the side of the site perimeter road (BLU PL-28). Both boundary monuments can be found by using construction diagrams that show the monuments in relation to the boundary fence. Attempts will be made to find both monuments during the next annual inspection.

PL-28 BLU 4/98 Reported location of BM-24 (not found, view W).

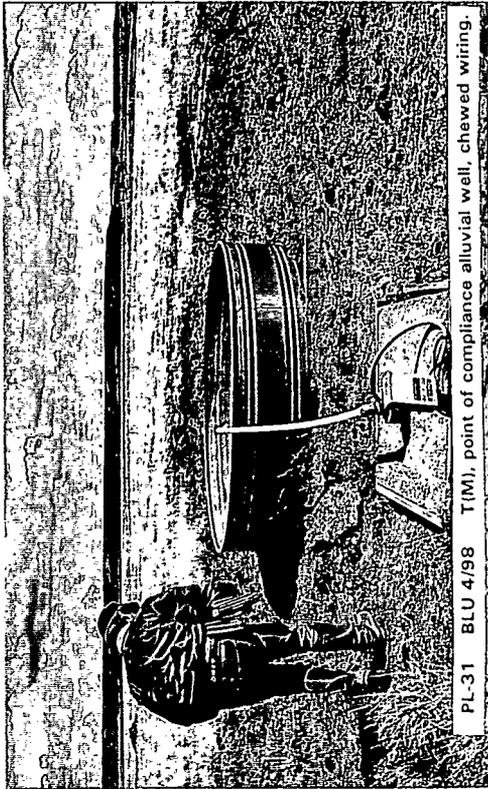
The five alluvial wells, E(M) in BLU PL-29, F(M) in BLU PL-30, T(M) in BLU PL-31, X(M) in BLU PL-32A and BLU PL-32B, and Y2(M) in BLU PL-33, are all in excellent condition except for minor damage caused by cattle to three of the wells. The damage consists of chewed wiring at wells T(M) and X(M), shown in BLU PL-31 and BLU PL-32B, respectively, and broken PVC pipe (BLU PL-33) that transmits pumped water from well Y2(M) to an evaporation tank.

PL-31 BLU 4/98 T(M), point of compliance alluvial well, chewed wiring.

Cattle grazing on the site and their resulting rubbing against and breaking of well piping as well as chewing exposed wiring will continue to damage the monitor wells until cattle are eliminated from the site or until fencing is placed around the wells. Damage to the wells should continue to be monitored during future inspections. Stock fencing should be placed around the wells to prevent damage.

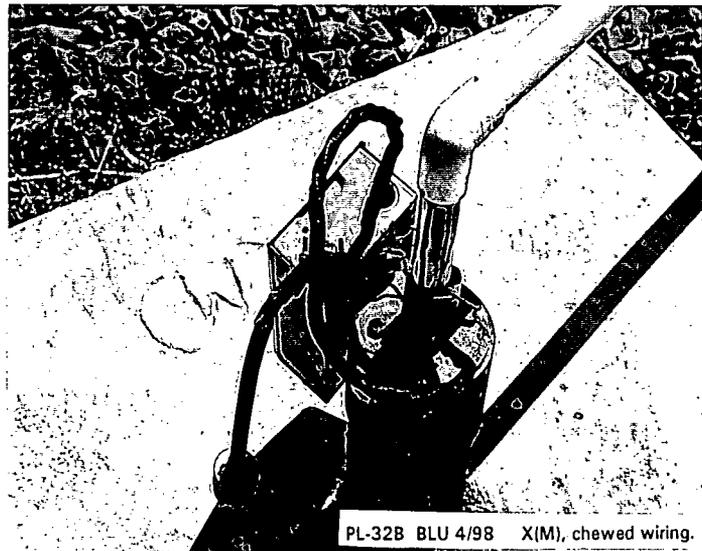
PL-32B BLU 4/98 X(M), chewed wiring.

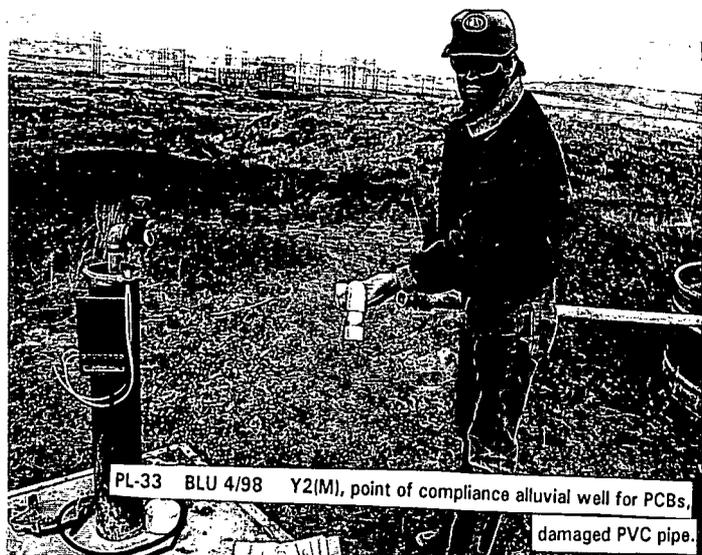
PL-33 BLU 4/98 Y2(M), point of compliance alluvial well for PCBs, damaged PVC pipe.

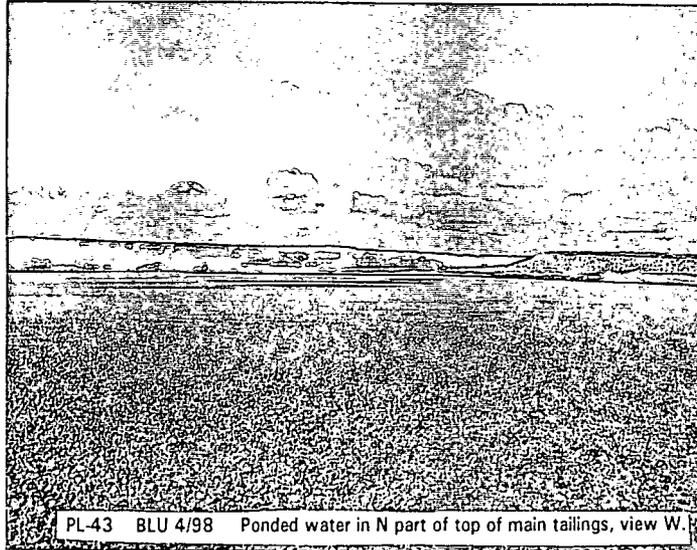
Water has accumulated in a small area at the north end of the top of the main tailings pile (BLU PL-43 and BLU PL-44). At the time of the inspection, ponded water several inches deep covered an area less than 0.5 acre. A water line on the rock surface indicated that the recent extent of ponded water extended over an area of 4 to 5 acres (Plate 1). This water accumulation may be an indication of settling of the north end of the tailings pile where the slimes were placed, or it may be an artifact of site construction. The slope specification for this portion of the main tailings pile is a maximum of 0.5 percent. Because the recent winter in this area was much wetter than normal, it is not known if the presence of ponded water will be a yearly occurrence. This area will be carefully inspected during future inspections.

PL-43 BLU 4/98 Ponded water in N part of top of main tailings, view W.

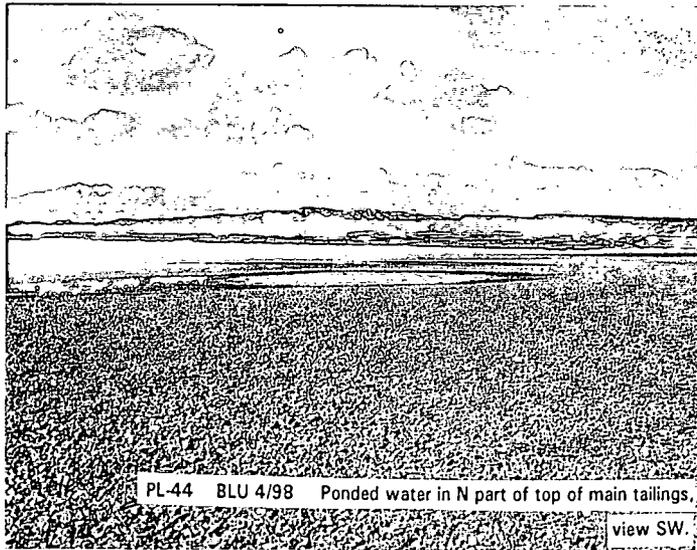
PL-44 BLU 4/98 Ponded water in N part of top of main tailings, view SW.

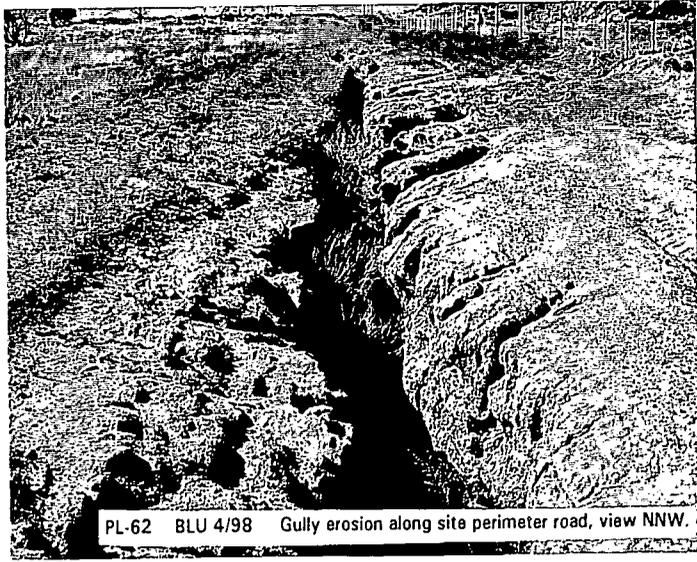
The site perimeter road is mainly dirt-surfaced, but is covered by crushed basalt (BLU PL-61) in a few places. The road inside the site stays close to the site boundary in part of the south and most of the north and east parts of the site. The road is in good to excellent condition, but may require periodic maintenance in places to remain passable. Most notable is the gully erosion (BLU PL-62), up to 3 feet deep along a short section of the road in the northeast part of the site. The progress of this erosion area and others along the road will be noted during future site inspections. These erosion areas are not a threat to disposal site integrity.

PL-62 BLU 4/98 Gully erosion along site perimeter road, view NNW.

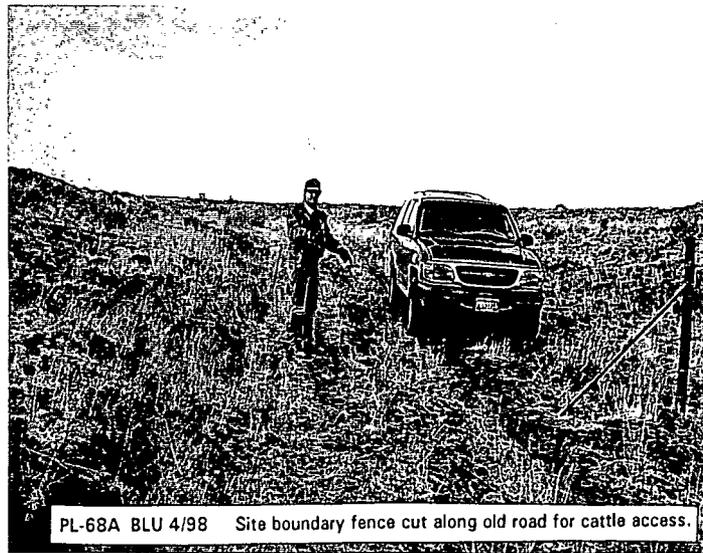
During the inspection of the site perimeter, evidence of unauthorized cattle grazing was obvious. Ten to fifteen cows were seen in the southwest (BLU PL-66) and east (BLU PL-67) parts of the site. The main entry point for the cattle was found in the southwest part of the site where the fence had been cut along an old road from the south (BLU PL-68A). The fence was repaired by the inspectors (BLU PL-68B) and a warning (perimeter) sign placard (P13) was placed on the fence. Along the north site boundary, another section of stock fence along a utility company right-of-way was open (BLU PL-69). This open section about 4 feet wide was adjacent to the gate for the site perimeter road to cross the El Paso Natural Gas Pipeline right-of-way. The fence was repaired. Also noted was the absence of a lock on the right-of-way gate just to the north at the site boundary (Plate 1). As a result of this inspection, the DOE has notified adjacent private landowners that cattle grazing on the site is not authorized. Also, DOE may request that a lock be placed on the El-Paso-Transwestern right-of-way gate along the north site property boundary.

PL-68A BLU 4/98 Site boundary fence cut along old road for cattle access.

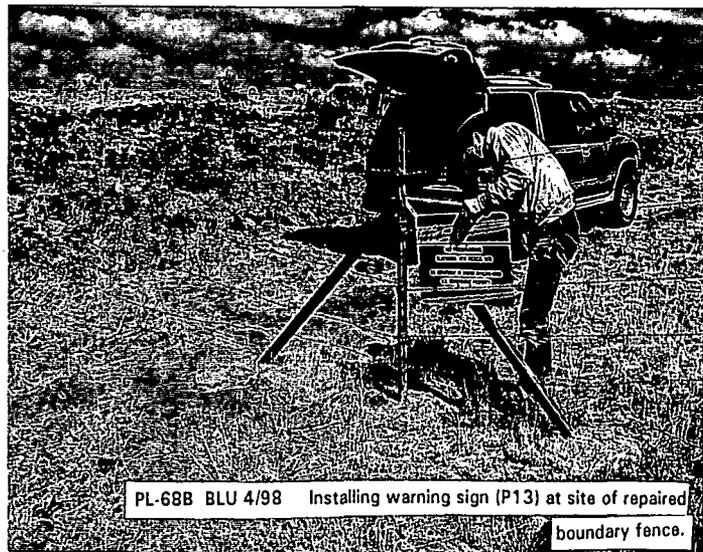
PL-68B BLU 4/98 Installing warning sign (P13) at site of repaired boundary fence.

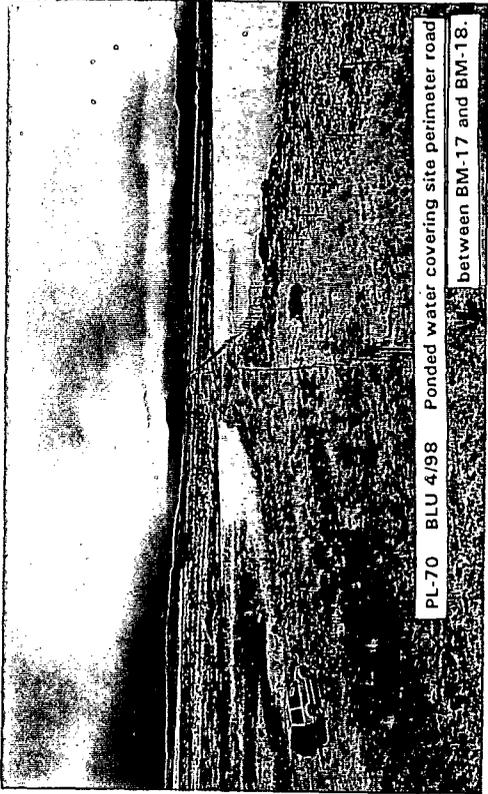
Most of the site drains to the east and an area of ponded water occurs along the site boundary fence (BLU PL-70). A short section of the boundary fence is down in this flooded area. The presence of water here is intermittent, but was particularly high after the wet winter experienced in the area. The high water also covers the site perimeter road and closes it. The site fence in this area should be repaired when the water recedes. This water does not threaten disposal site integrity.

PL-70 BLU 4/98 Ponded water covering site perimeter road between BM-17 and BM-18.
