FPL

Re: Turkey Point Unit 3
Docket No. 50-250
Reportable Event: 2007-002-00
Date of Event: June 6, 2007
Completion of Shutdown Required by Technical Specifications due to Inoperable Rod
Position Indication for Two Control Rods in the Same Control Bank

1. FACILITY NAME Turkey Point Unit 3				2. DOCKET NUMBER 05000250		3. PAGE 1 OF 5																																					
4. TITLE Completion of Shutdown Required by Technical Specifications due to Inoperable Rod Position Indication for Two Control Rods in the Same Control Bank

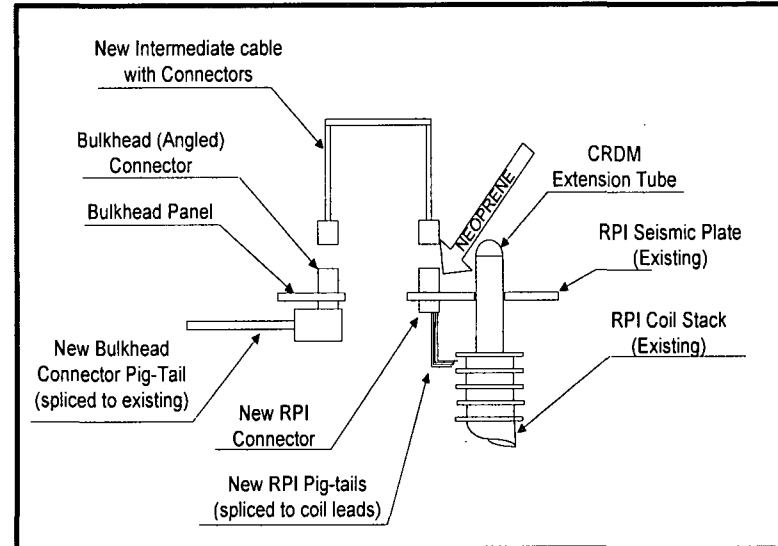
Figure 1: RPI Coil Stack Cable Connectors

The RPI cable replacement included the following: a) replacement of cables surrounding the reactor cavity with new cable spliced into the existing cable, b) new bulkhead connector and panel on the refueling floor on the west end of the reactor cavity, c) new intermediate cables with connectors from the bulkhead connector panel to the RPI Seismic Plate Coil stack connectors. The existing Rod Position Indicator (RPI) coils were reused. The RPI coil stack seismic plate connectors were also replaced. Refer to Figure 1.

The identified RPI failures were at the RPI coil stack seismic plate connection with the coil stack seismic plate-mounted male connector being the failure initiator/propagator. The RPI coil stack seismic plate connectors have been determined to have neoprene inserts based on part numbers, vendor documentation, insert material color, and laboratory testing of the failed dielectric from the M-6 RPI coil stack connector.

The cables and connectors installed in the vicinity of the reactor vessel must be able to maintain their physical and electrical insulation properties over many years under high temperature environmental conditions. The RPI coil stack seismic plate connector utilized neoprene rubber insert, instead of silicone rubber. The degradation of the neoprene rubber insert from the pigtail assembly connector contaminated and permeated the silicon rubber insert of the intermediate cable mating connector. The contamination of the intermediate cable connector resulted in a breakdown of its silicon rubber insert and caused it to become conductive. This conductivity resulted in shorting of conductor dielectric and caused the erratic RPI detector oscillations.

The cause of the failed RPIs is the incorrect application of the connector insert material (neoprene) for the required environment (high temperatures). A root cause evaluation including the human performance causes and circumstances that led to the use of the incorrect RPI pigtail assembly connector insert is ongoing. A supplement to this LER will be submitted following completion of the final root cause evaluation.

Turkey Point Unit 3 was shutdown and the RPI seismic plate coil stack connectors were removed. Because of parts unavailability and the long lead time to procure new connectors, the RPI coil stack pigtail assembly wires have been spliced to the RPI intermediate head cables as a corrective action which eliminates the failure mode by eliminating the unqualified portion of the RPI system.

Turkey Point Unit 4 was proactively shutdown on July 22, 2007 to remove these connectors and splice the RPI coil stack pigtail assembly wires to the RPI intermediate head cables.
