NL-07-1547

Joseph M. Farley Nuclear Plant – Unit 2  
Proposed Alternative for Continued Operation With Pinhole Leaks  
in Class 2 Valve Q2N11V003B

**SOUTHERN NUCLEAR OPERATING COMPANY  
FNP-ISI-ALT-07-02, VERSION 1.0  
PROPOSED ALTERNATIVE IN ACCORDANCE WITH 10 CFR 50.55a(a)(3)(ii)  
FOR CONTINUED OPERATION WITH PINHOLE LEAKS IN CLASS 2 VALVE Q2N11V003B**

Farley Nuclear Plant Unit 2 (FNP-2)

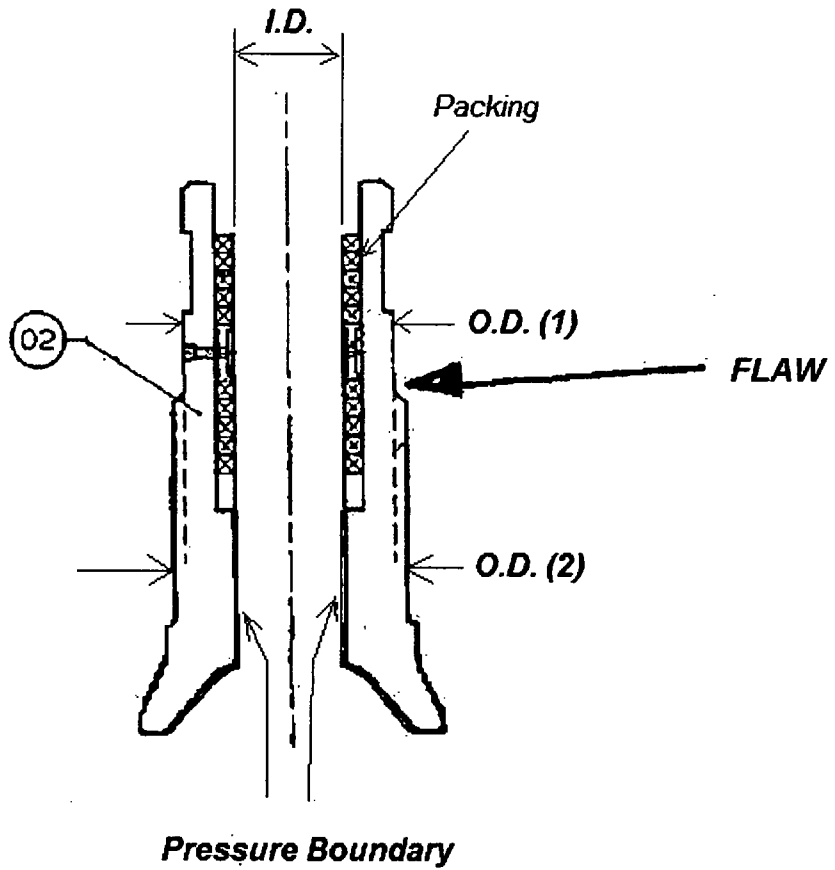
Figure 1-1. Approximate Location of Flaw in Valve Q2N11V003B

A small pinhole leak was discovered in Class 2 valve Q2N11V003B as shown in Figures 1-1, 1-2, and 1-3. Upon visual examination, the steam leakage was determined to be originating from the valve bonnet at a location just above the threaded area of this valve part. This leakage was conservatively considered to be the result of a through-wall defect in a pressure retaining part and was therefore an unacceptable condition.

Attempts to characterize the defect through the use of radiography (RT) and ultrasonic (UT) techniques were not definitive in determining the size and shape of the flaw or where the flaw originates on the inside diameter of the bonnet. UT straight beam confirmed the presence of an internal void, which was bounded by a rectangle 0.25 inch wide by 0.625 inch high.

The leaking flaw was initially visually characterized as a single rounded flaw. After surface preparation for UT, the initial leaking flaw was measured to be approximately 0.1 inch long and two other leaks surfaced nearby.

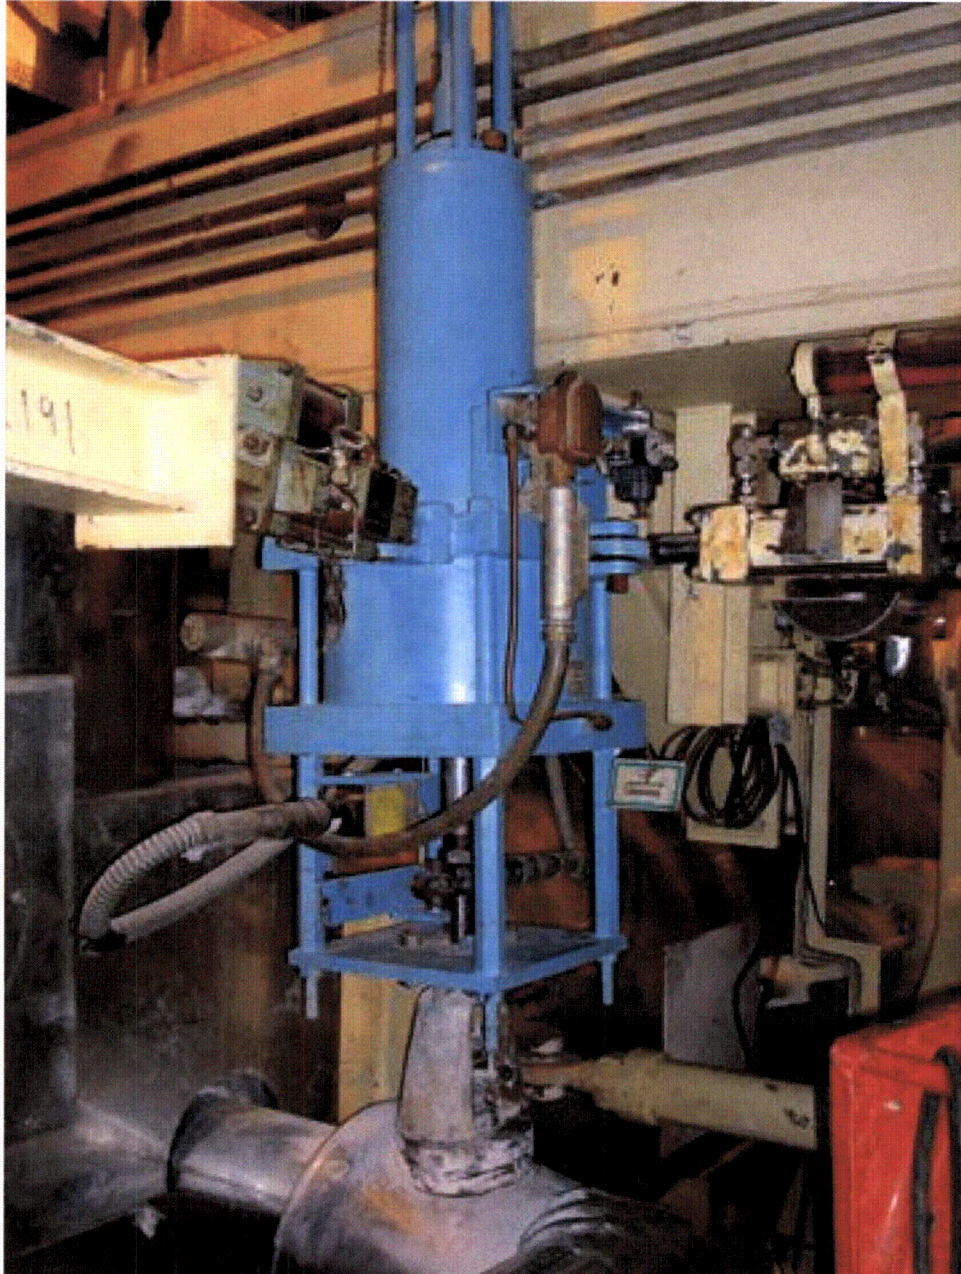
Figure 1-3. Picture of Entire Valve Body and Actuator

This valve is located on the bypass line around the "B" inboard main steam line isolation valve (MSIV). It is a 3-inch, Class 600 lb, flexible wedge, gate valve with pneumatic actuator. The valve body and bonnet material are SA-105 carbon steel.

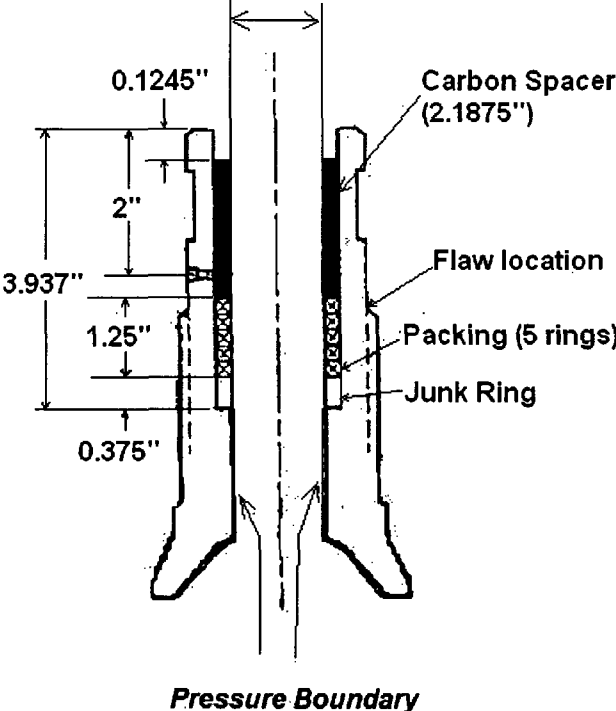
**Figure 2-1: Packing Configuration Prior to November 2005**

The hypothesis is that a subsurface flaw existed in the forging that escaped detection during original valve manufacture. Due to the packing configuration shown in Figure 2-1, this flaw was not exposed to significant thermal or pressure loads for the majority of its operating history. During 2R17 (Fall 2005), the packing configuration was changed to that shown in Figure 2-2 and packing stud torque was increased. These changes resulted in a higher radial load in the area of the flaw, where there was a stress concentration due to the different diameter. These stresses, in combination with a pre-existing fabrication defect, may have resulted in a small crack on the inside surface. After the leak was detected, it was determined that the packing loading was less than the target value. This reduction was attributed to vibration causing the packing loading to relax. Subsequently, this allowed the system pressure to place additional stress at the flaw location, and the additional stress eventually drove the flaw to the surface.

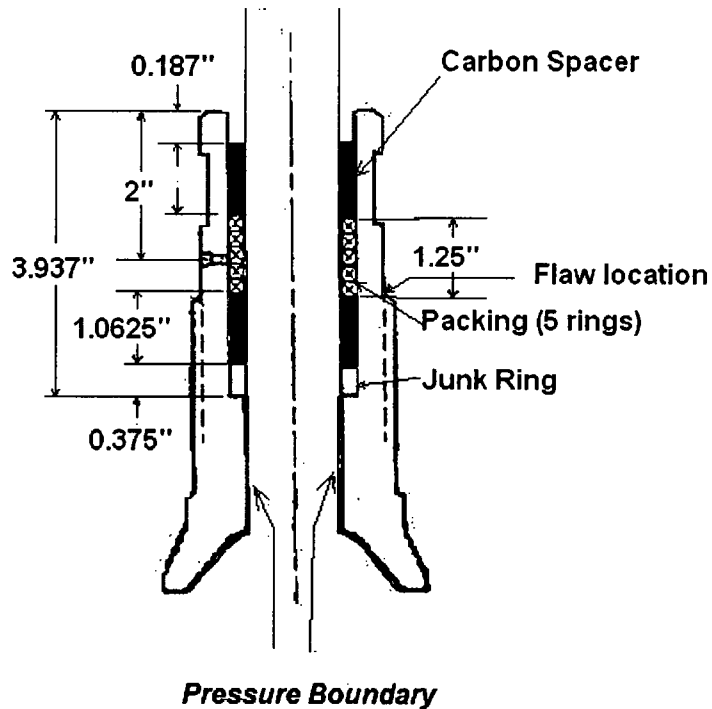
**Figure 2-2: Packing Configuration After November 2005**

The most likely cause of the leakage was determined to be a latent manufacturing defect that, over time, resulted in leakage due to a combination of mechanical and pressure stresses from radial packing load and system pressure. This is supported by the lack of observed leakage on other valves of the same design, application, environment and manufacture as Q2N11V003B. The timing of the observed leakage can be explained by the changes to the valve packing configuration and applied loads at the flaw location.
