Report No.: SIR-07-221-NPS
Revision No.: 0
Project No.: FNP-08Q
File No.: FNP-08Q-401
August 2007

**DEGRADATION MECHANISMS AND
FLAW EVALUATION ASSOCIATED
WITH A LEAK IDENTIFIED IN MAIN
STEAM SYSTEM BYPASS VALVE
Q2N11V0003B AT FARLEY UNIT 2**

Structural Integrity Associates, Inc.
San Jose, California

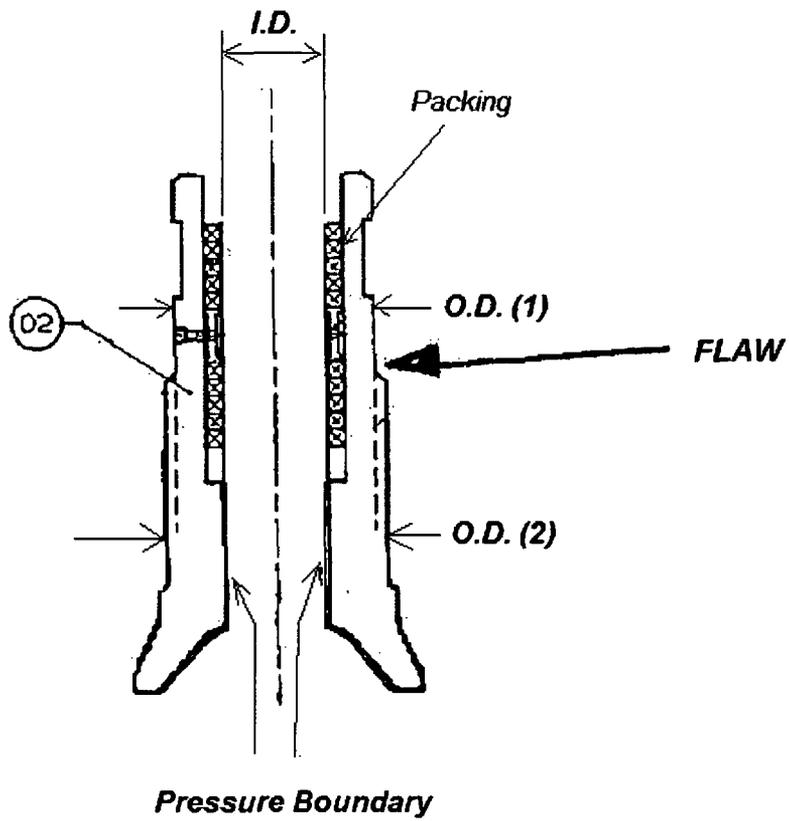
Figure 1-1. Approximate Location of Flaw in Valve Q2N11V0003B [1.2]

The leak is located above the threaded section of the bonnet as shown in Figure 1-1 [1.2]. The valve is located on a horizontal line with the valve bonnet pointing upwards. Pictures of the affected valve are shown in Figures 1-2 and 1-3 [1.3].

Bonnet Showing Location of Flaw

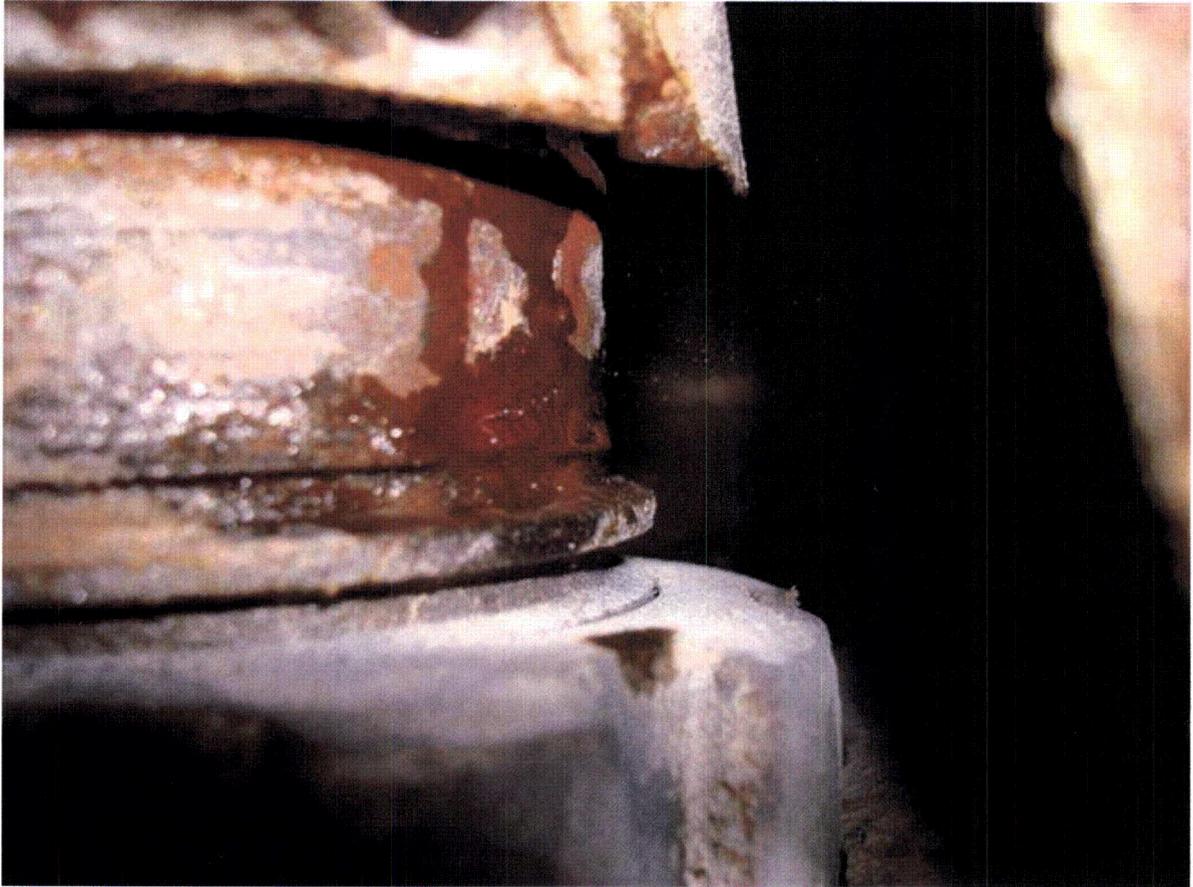
Figure 1-2. Picture of Leak in Valve Bonnet [1.3]

A small pinhole leak was discovered in the bonnet of a small bore main steam system isolation valve (Q2N11V0003B) at Farley Nuclear Plant (FNP), Unit 2. This valve is the upstream Main Steam Isolation Valve (MSIV) bypass line isolation valve for the “B” main steam line. Valve Q2N11V0003B is a 3-inch, Class 600 lb, pressure seal, flexible wedge, gate valve with pneumatic actuator. This safety-related, ASME Section III, Class 2 valve, was manufactured by Velan Valve Company for FNP. The valve body and bonnet material are SA-105 Gr. II carbon steel [1.1].

Further support for a pre-existing flaw is supported by the NDE report that notes a loss of signal 1/3 of the way through the bonnet wall and that light sanding opened up two additional leaks (reported as “pinhole leaks” by station personnel [2.17]) in the vicinity of the original location.

It is recommended that the following actions be taken to monitor the leakage from the pinhole in Valve Q2N11V0003B:

- Walk down the line on a regular basis (possibly daily) to monitor leakage
- Perform periodic UT examination of the flaw region to verify no significant changes in the flaw characterization at intervals of no more than 90 days.
- Confirm there is rigid body motion between the valve and actuator as discussed in Section 2.2.6.1.

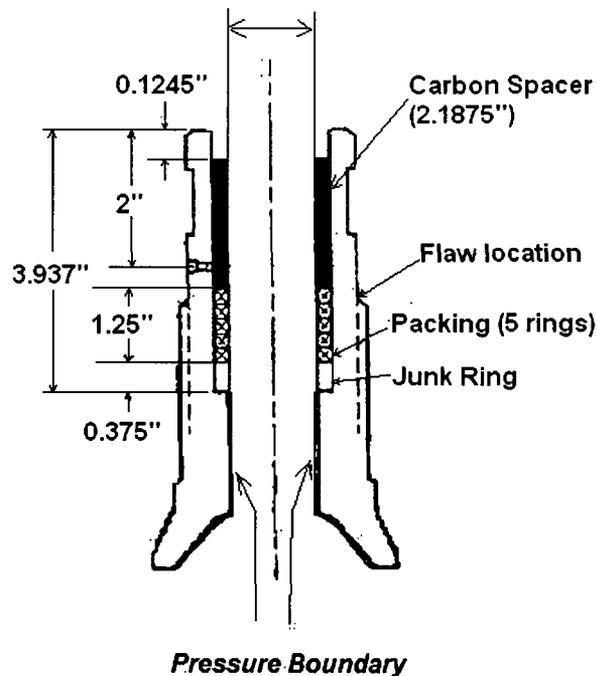
Figure 2-1: Packing Configuration Prior to 2R17

Q2N11V0003B has a history of steam leaks going back at least 3 operating cycles [2.8 through 2.10, 2.12, and 2.13]. Prior to 2R17, the packing arrangement (shown in Figure 2-1) isolated the flaw location from the system pressure [2.8]. Leakage identified in October 2002 was due to loose bonnet bolts. Immediately following startup from 2R16 in April 2004, the valve was observed to be leaking in the body to bonnet area and no leakage was observed in the area of the packing [2.9]. The bonnet clamp was confirmed to be tight. The leakage gradually worsened during the operating cycle. In addition, damage was observed in the area where the actuator and valve stem are connected and the condition report notes that this is a recurring issue [2.9]. The combination of loose bolting prior to 2R16 and the actuator to valve stem damage [2.11] suggests vibration as a possible contributor to the observed problems to this point. However, there is no evidence to suggest that vibration could have been the cause of crack initiation or crack growth at the location of the observed flaw.

The hypothesis is that there was a subsurface flaw in the forging that escaped detection during original valve manufacture. Due to the packing configuration shown in Figure 2-1, this flaw was not exposed to significant thermal or pressure loads for the majority of its operating history. Following 2R17, the change in packing configuration to that shown in Figure 2-2 and increase in packing stud torque resulted in a higher radial load in the area of the flaw, where there is a stress concentration. This, in combination with a pre-existing fabrication defect, may have resulted in a small crack on the inside surface. The load on the bonnet that would result from a flaw connected to the inside surface would produce additional stress at the location of the flaw and eventually drive the flaw to the outer surface.

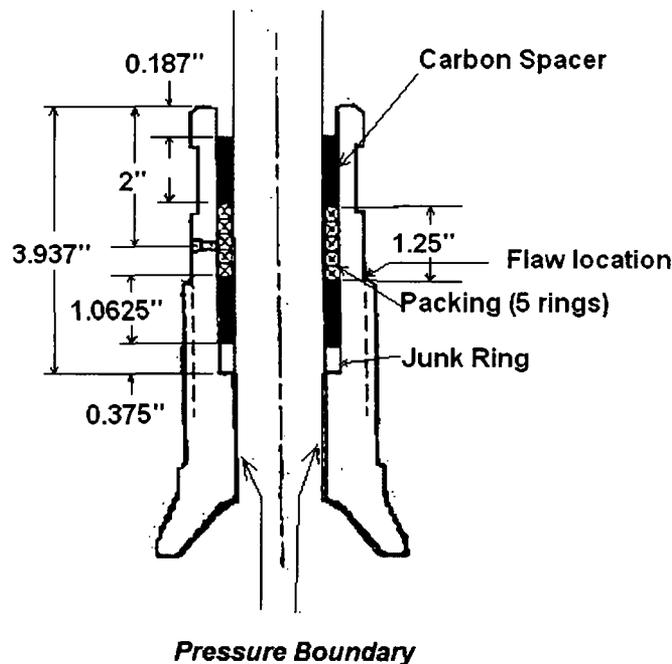
Figure 2-2: Packing Configuration Following 2R17

The loads produced by packing or internal pressure are accounted for in the design of the component and could not have initiated a crack alone. Since increasing the torque from 9 ft-lbs to 12.5 ft-lbs significantly reduced the leakage at the flaw location on 7/5/2007, it is likely that the packing extends below the location of the flaw. Following 2R18, the leak was not immediately observed, as occurred following 2R16 and 2R17. This suggests the packing was originally performing its intended function until it loosened up, most likely due to system vibration given the previous history, and allowed the system pressure to place additional stress at the flaw location.

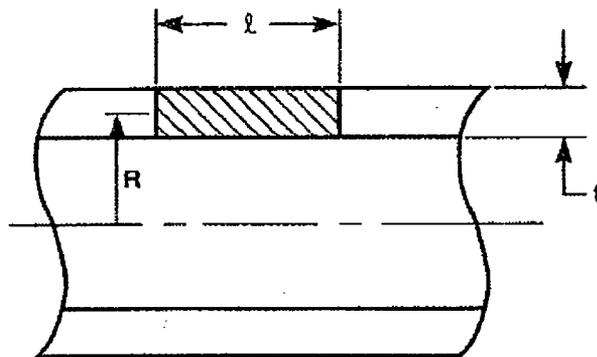
Figure 3-1. Assumed Axial Flaw Geometry in a Pipe

For comparison, a conservative linear elastic fracture mechanics (LEFM) analysis for the axial flaw was also performed using the **pc-CRACK** program [4.1]. The results showed an allowable flaw size of 5.6 inches would be required to exceed the criterion for initiation ($K_I > K_{IC}$), including the code defined safety factor of $\sqrt{10}$ [3.6]. The results using LEFM are more conservative even though the Code Case N-513-1 method allows the use of limit load. Both the limit load and LEFM produce an allowable flaw size that is larger than the maximum height of the observed indications from the NDE report of 0.625 inches [2.15].

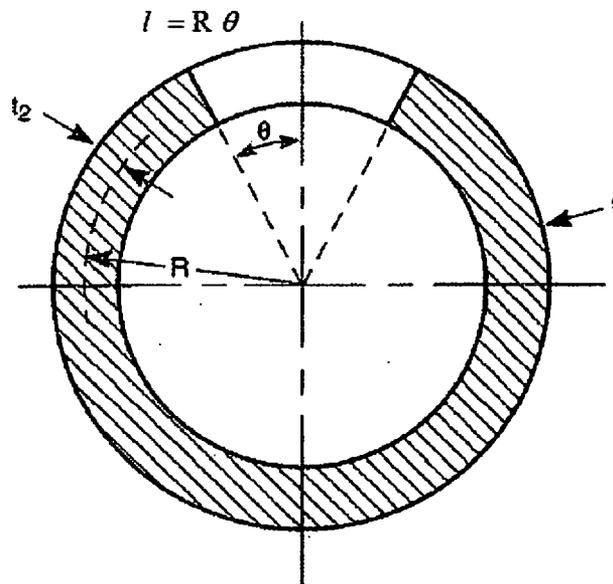
Figure 3-2. Assumed Circumferential Flaw Geometry in a Pipe

The **pc-CRACK** program [4.1] was used to solve for the maximum allowable circumferential flaw length based on linear elastic fracture mechanics (LEFM). The results show that a maximum flaw length of 3.8 inches would be required to exceed the criterion for initiation ($K_I > K_{IC}$), including the Code defined safety factor of $\sqrt{10}$ [3.6]. This is compared to the maximum width of indications from the NDE report of 0.25 inches [2.15].

Accident conditions with pressure reaching a maximum of 1194 psi were also evaluated using **pc-CRACK** with the appropriate Code safety factors for service level C&D Conditions. The results show that, for service levels C&D, the maximum allowable flaw size for an axial flaw is 7.09 inches [3.6]. Also, the maximum allowable flaw size for a circumferential flaw under service levels C&D conditions is 4.46 inches [3.6]. The circumferential flaw is bounded by the maximum circumferential flaw length of 3.8 inches for service level A&B conditions.
