**UNITED STATES OF AMERICA  
NUCLEAR REGULATORY COMMISSION  
ATOMIC SAFETY AND LICENSING BOARD**

In the Matter of:	)	
	)	August 17, 2007
AmerGen Energy Company, LLC	)	
(License Renewal for Oyster Creek Nuclear Generating Station)	)	Docket No. 50-219
	)	
	)

**AMERGEN ENERGY COMPANY, LLC  
REBUTTAL STATEMENT OF POSITION**

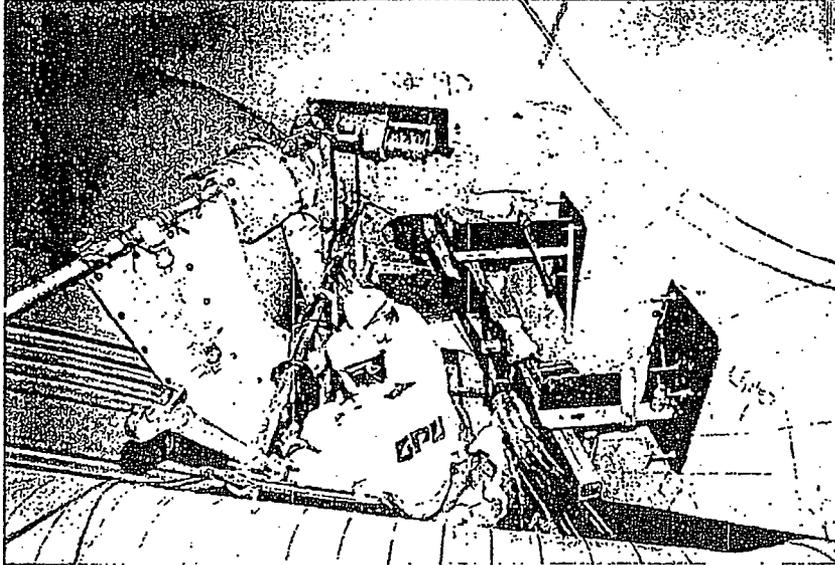
Figure 1

Access hole drilling set up view from the top of the Torus.

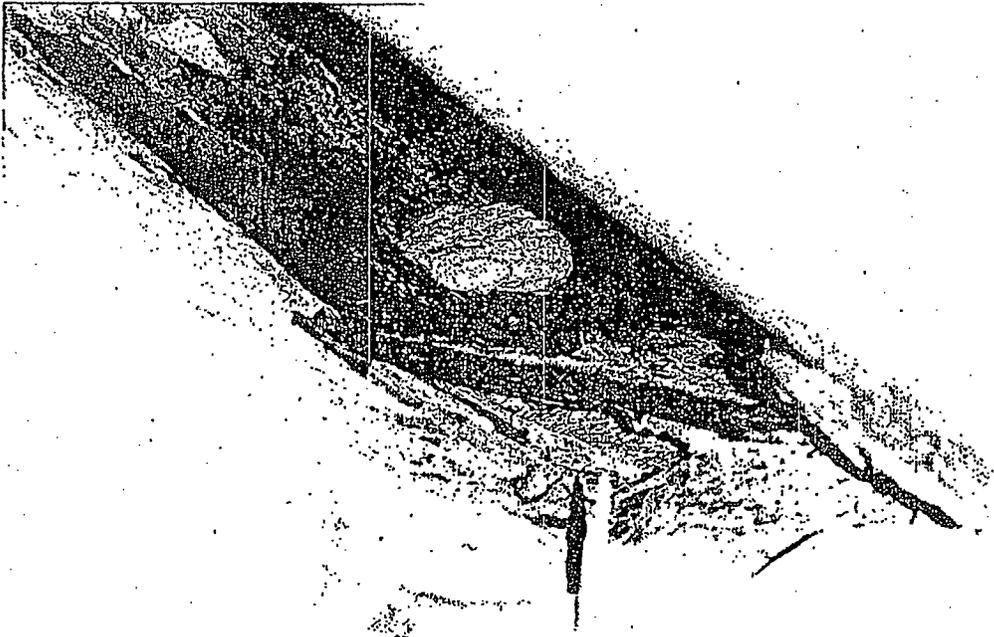
Figure 2

There were thick crusts of corrosion product laying on top of the sand. (See Fig. 2). It was necessary to remove this material before the task of removing sand could begin. In most bays, very little corrosion product was left on the vessel. (See Fig. 3). The oxide crusts may have spalled off the vessel as the plant went to cold shutdown in preparation for the 14R outage. The last video views taken during the operating cycle 13 sand removal effort showed that some material had fallen off the vessel, but not to the extent found. The corrosion product pieces were removed and bagged. The sand was then removed using an electric VecLoader vacuum. Appendix A contains

Sand Bed Region - Typical condition found on initial entry.

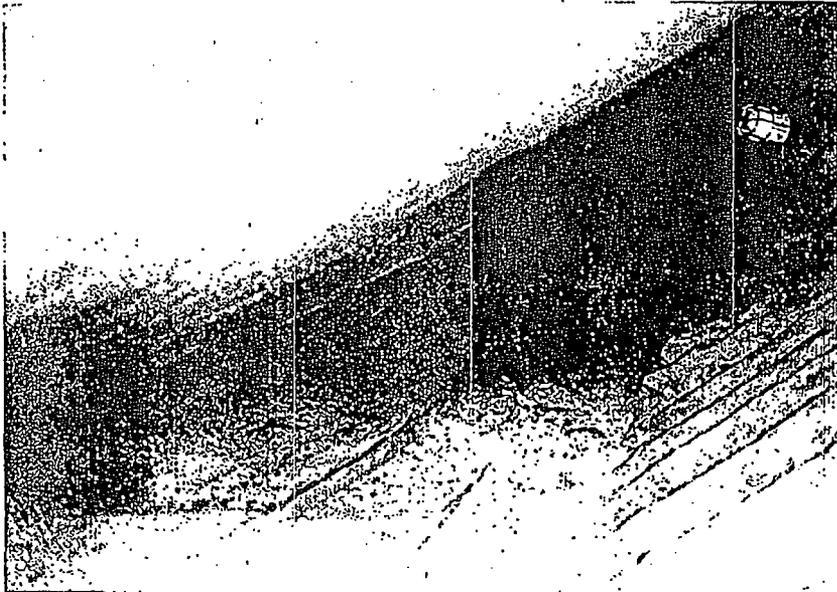
Figure 4

A more serious finding was the condition of the floor in the sand bed. The concrete was not finished, there were holes and craters along side the vessel, there was no evidence of a drainage ditch as shown on the drawings and in most cases the drain pipes were higher than the floor. (See Figs. 4 and 5). This was a general condition in all bays, however some were worse than others. Apparently the finish pour of concrete was not installed. This condition had a significant effect on the project's schedule and cost. To make the drain system effective the holes and craters needed to be filled, and the floor leveled using a suitable material compatible with both concrete and the steel shell. (See Figs. 6 and 7). The Devoe epoxy product 184 was used to refurbish the floor. This was done after evaluation of the suitability of the material in the sand bed environment. This condition was documented using a MNCR (see reference 2.17). As a part of the floor refurbishment, a wedge of Devoe 140S caulking material was placed at the intersection of the vessel shell and the floor. The caulking material will keep water away from the vessel in the event a volume of water greater than the drains capacity is introduced into the area. (See Figs. 8 and 9).

As found condition of floor bed.

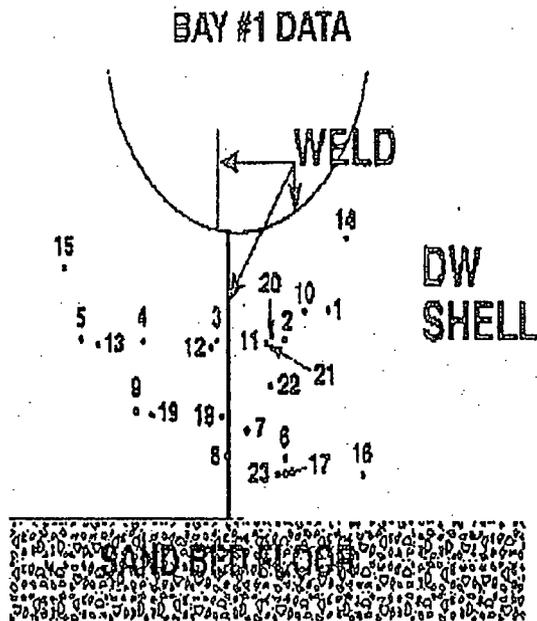
Figure 10

Bay 1 Data - Table 1

Location	UT Measurement (1)	Avg Micrometer (2)	Mean Depth/Valley (3)	T (Evaluation) (4)=(1)+(2)-(3)	Remarks
1	0.720"	0.218"	0.200"	0.738"	Acceptable
2	0.716"	0.143"	0.200"	0.659"	Acceptable
3	0.705"	0.347"	0.200"	0.852"	Acceptable
5	0.710"	0.313"	0.200"	0.823"	Acceptable
7	0.700"	0.266"	0.200"	0.766"	Acceptable
11	0.714"	0.212"	0.200"	0.726"	Acceptable
12	0.724"	0.301"	0.200"	0.825"	Acceptable
21	0.726"	0.211"	0.200"	0.737"	Acceptable

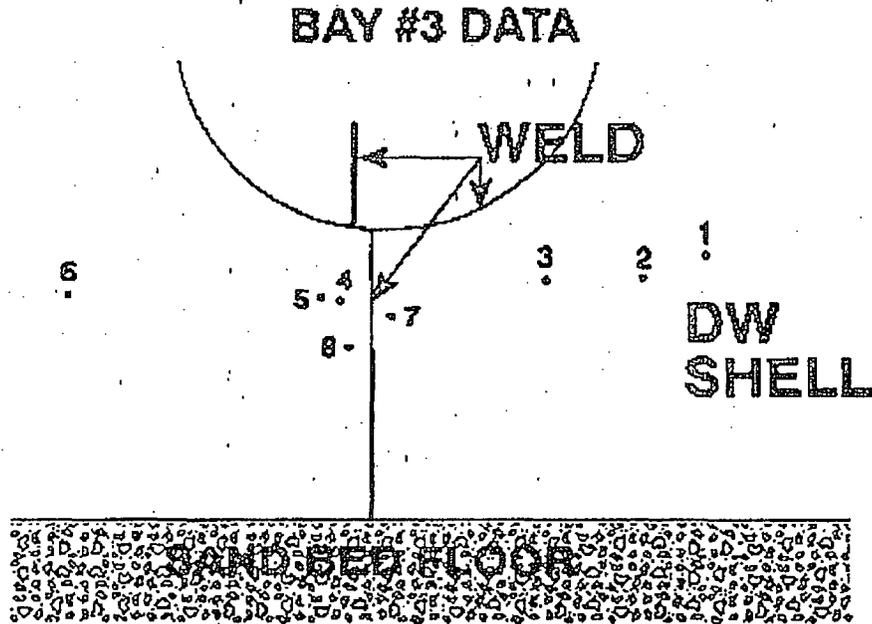
Figure 11

Bay 3 Data - Table 3

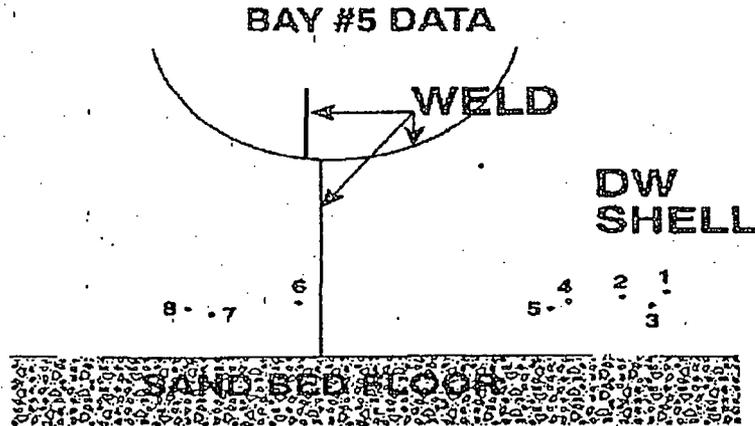
Figure 12

Bay 5 Data - Table 4

Given the UT measurements, a conservative mean evaluation thickness of 0.950 inches is estimated for this bay and therefore, it is concluded that the bay is acceptable.

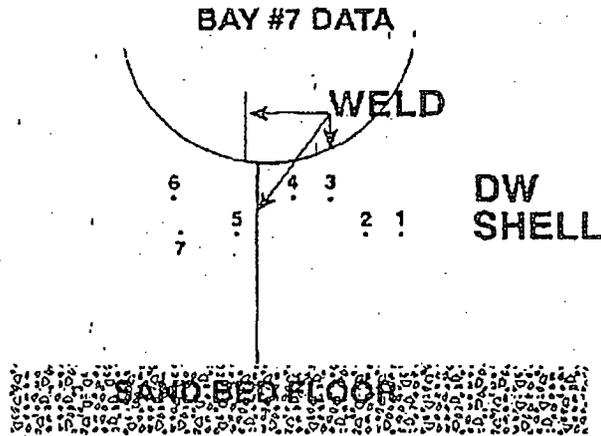
Figure 13

Bay 7 Data - Table 5

Given the UT measurements, a conservative mean evaluation thickness of 1 inch is estimated for this bay and therefore, it is concluded that the bay is acceptable.

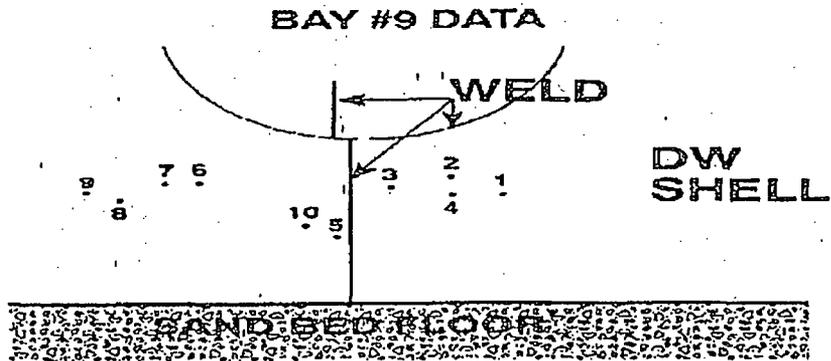
Figure 14

Bay 9 Data - Table 6

Given the UT measurements, a conservative mean evaluation thickness of 0.900 inches is estimated for this bay and therefore, it is concluded that the bay is acceptable.

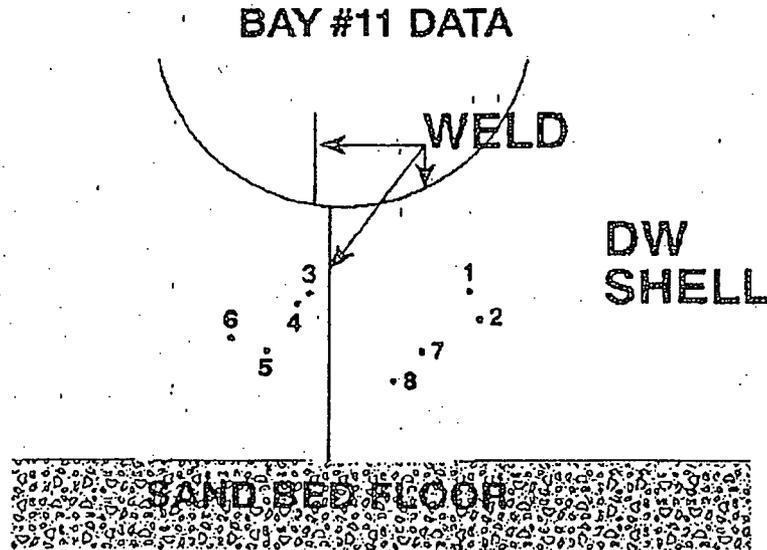
Figure 15

Bay 11 Data - Table 7

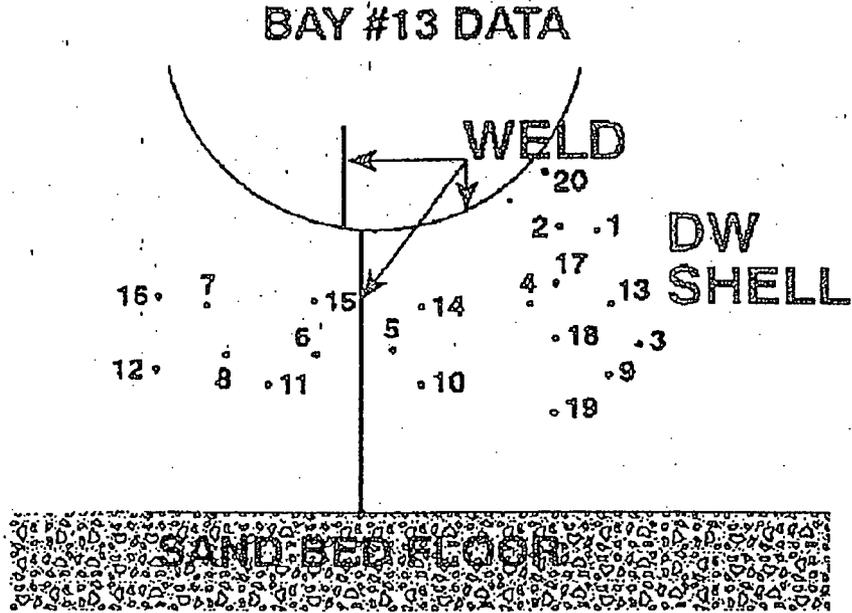
Figure 16

Bay 13 Data - Table 9

Location	UT Measurement (1)	Avg Micrometer (2)	Mean Depth/Valley (3)	T (Evaluation) (4)-(1)+(2)-(3)	Remarks
1	0.672"	0.351"	0.200"	0.823"	Acceptable
2	0.722"	0.360"	0.200"	0.882"	Acceptable
5	0.718"	0.217"	0.200"	0.735"	Acceptable
6	0.655"	0.301"	0.200"	0.756"	Acceptable
7	0.618"	0.257"	0.200"	0.675"	Acceptable
8	0.718"	0.278"	0.200"	0.796"	Acceptable
10	0.728"	0.211"	0.200"	0.739"	Acceptable
11	0.685"	0.256"	0.200"	0.741"	Acceptable
15	0.683"	0.273"	0.200"	0.756"	Acceptable

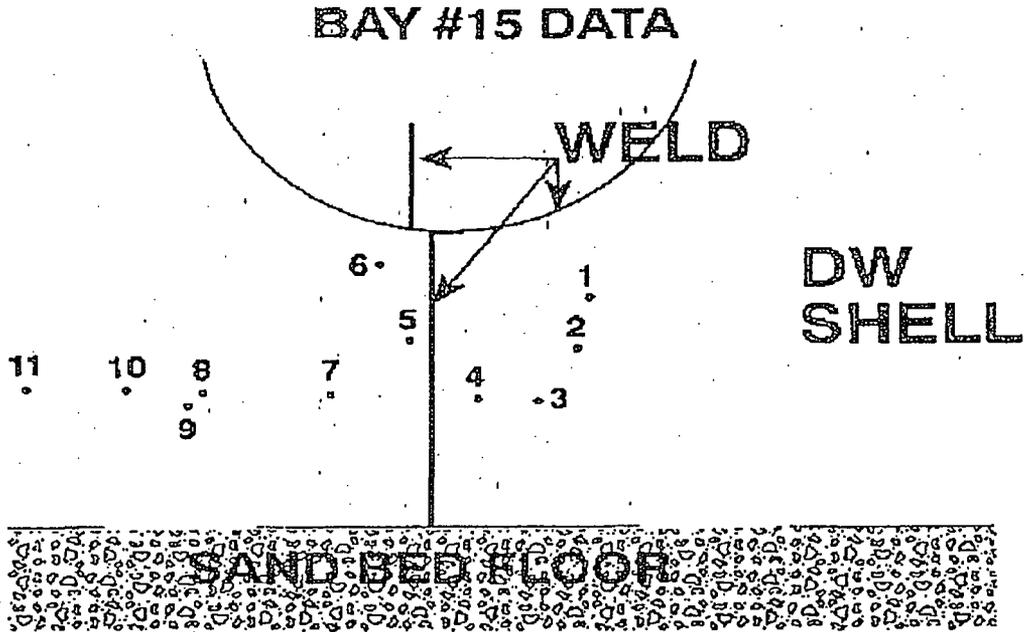
Figure 17

Bay 15 Data - Table 11

Location	UT Measurement (1)	Avg Micrometer (2)	Mean Depth/Valley (3)	T (Evaluation) (4)=(1)+(2)-(3)	Remarks
9	0.722"	0.337"	0.200"	0.859"	Acceptable

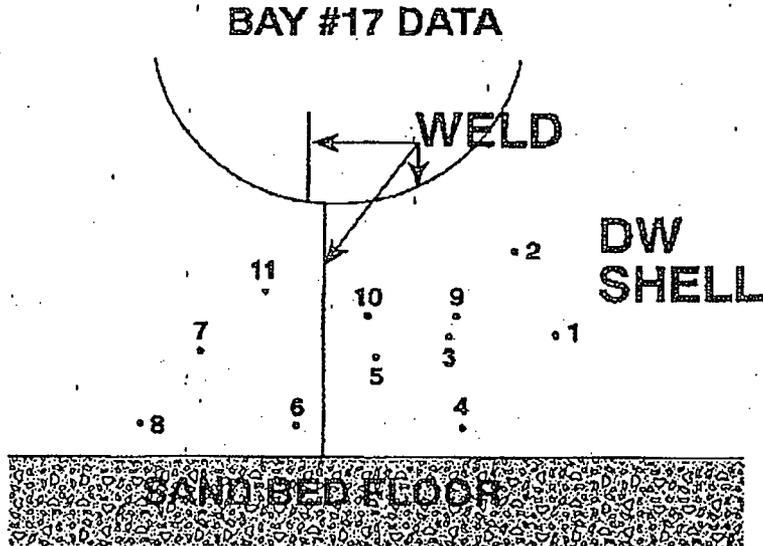
Figure 18

Bay 17 Data - Table 13

Location	UT Measurement (1)	Avg Micrometer (2)	Mean Depth/Valley (3)	T (Evaluation) (4)=(1)+(2)-(3)	Remarks
9	0.720"	0.351"	0.200"	0.871"	Acceptable

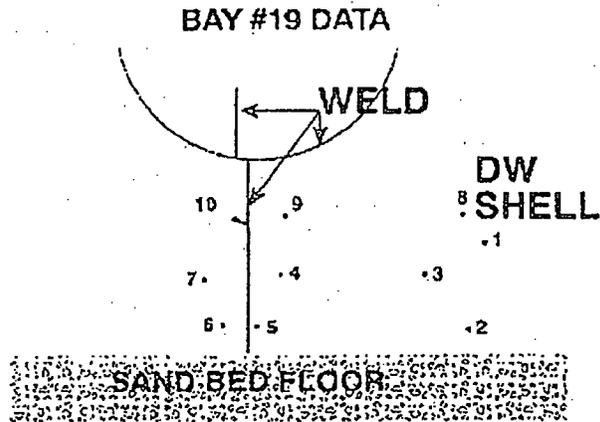
Figure 19

Bay 19 Data - Table 15
