NDE and DE of PWSCC found in the J-Groove Weld of a Removed-From-Service Control Rod Drive Mechanism

**6th International Conference on NDE in Relation to
Structural Integrity for Nuclear and Pressurised
Components**

**October 8-10, 2007
Budapest, Hungary**

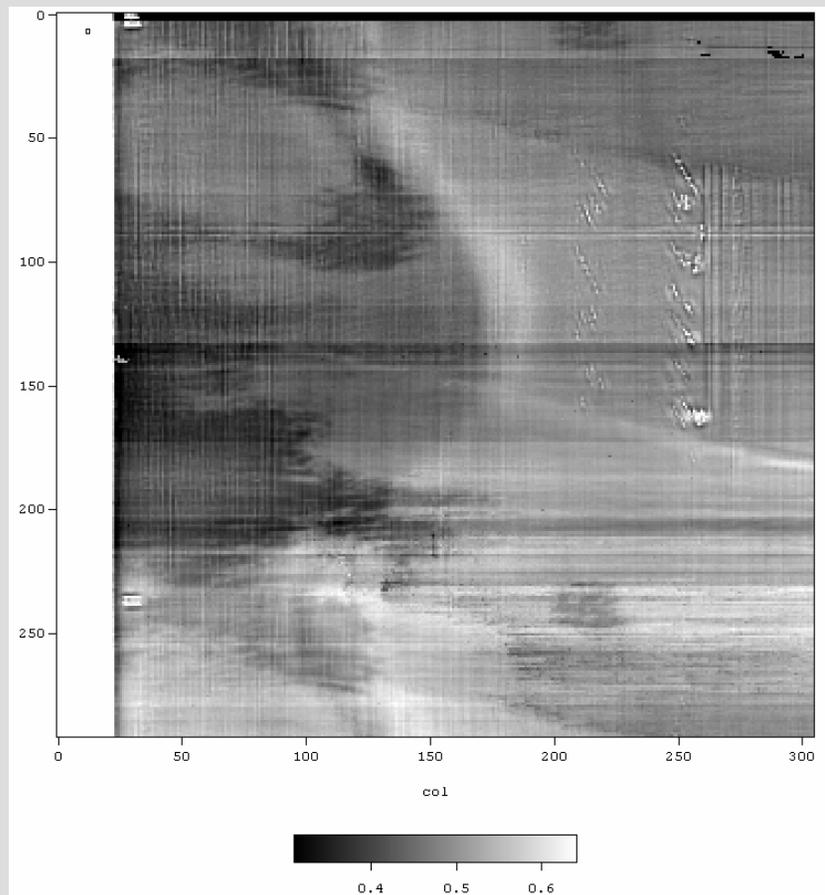
Nozzle #31- Penetration Tube ID ET exam

- ▶ No crack-like indications found.
- ▶ Indications consistent with shallow scratches discovered.
- ▶ J-groove weld clearly visible in data.

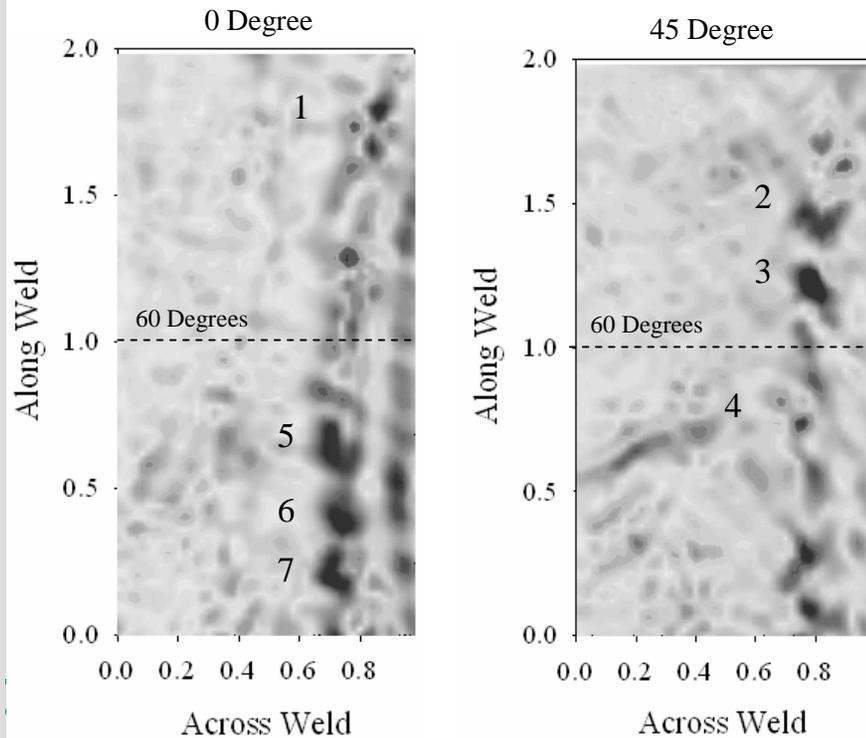
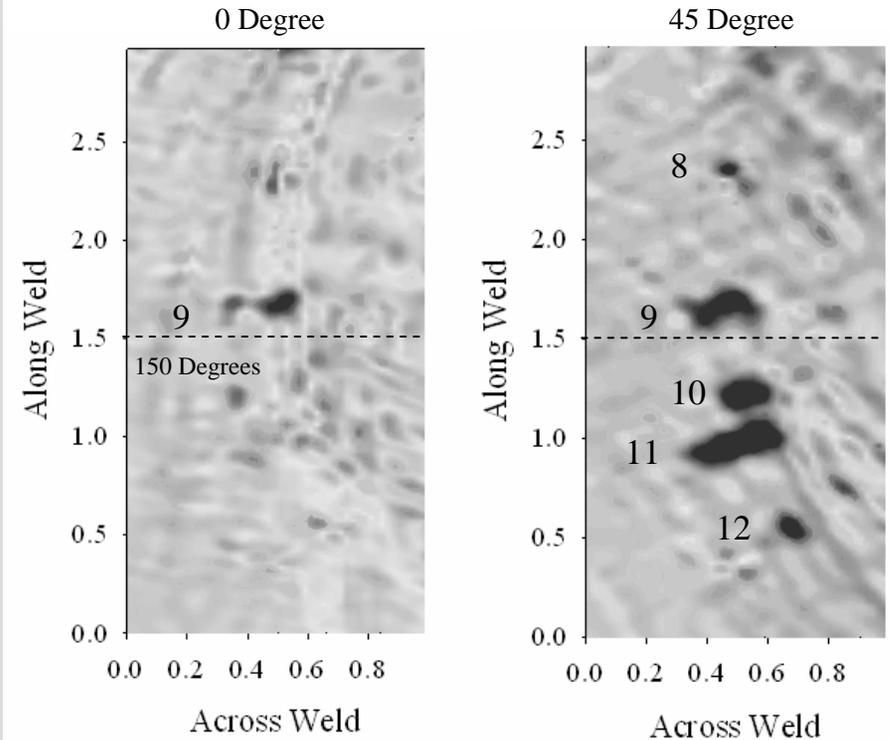
Centered on 60°

Indication	Length	Max Voltage
1	5 mm	2.1
2	3 mm	1.9
3	4 mm	3.3
4	2 mm	1.8
5	5 mm	2.2
6	3 mm	2.5
7	4 mm	2.3

Centered on 150°

Indication	Length	Max Voltage
8	3	2.3
9	8	3.2
10	6	3.3
11	10	4.1
12	4	2.6

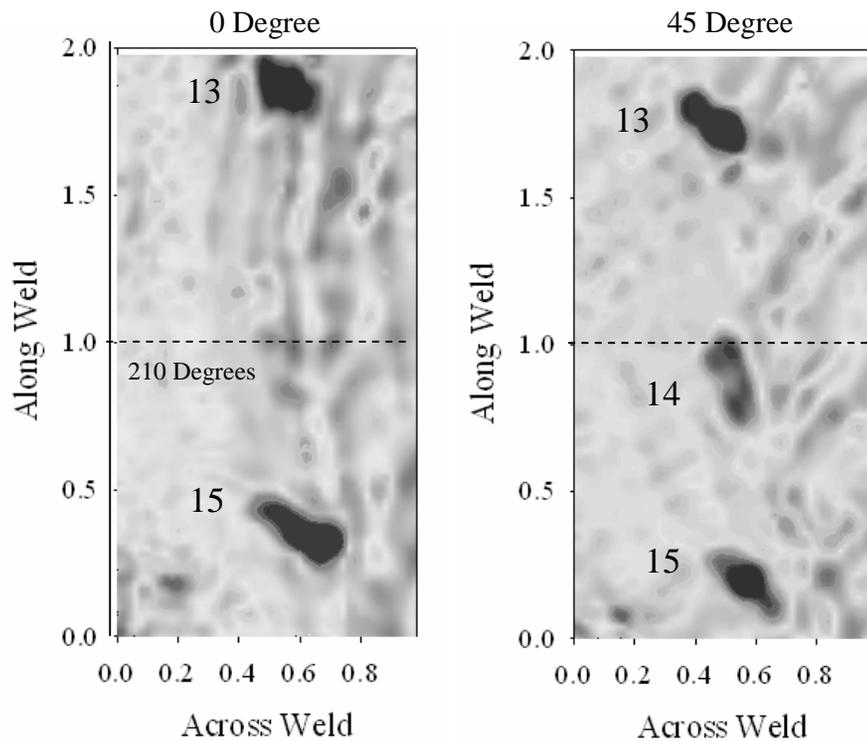
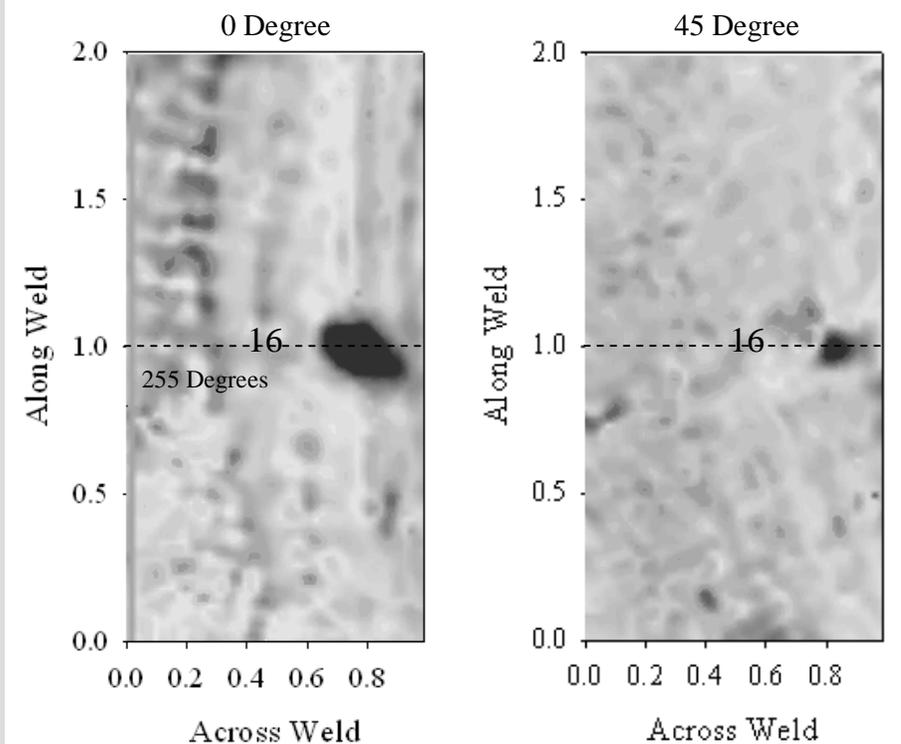
Centered on 210°

Indication	Length	Max Voltage
13	7	4.6
14	7	1.8
15	8	4.6

Centered on 255°

Indication	Length	Max Voltage
16	8	4.2

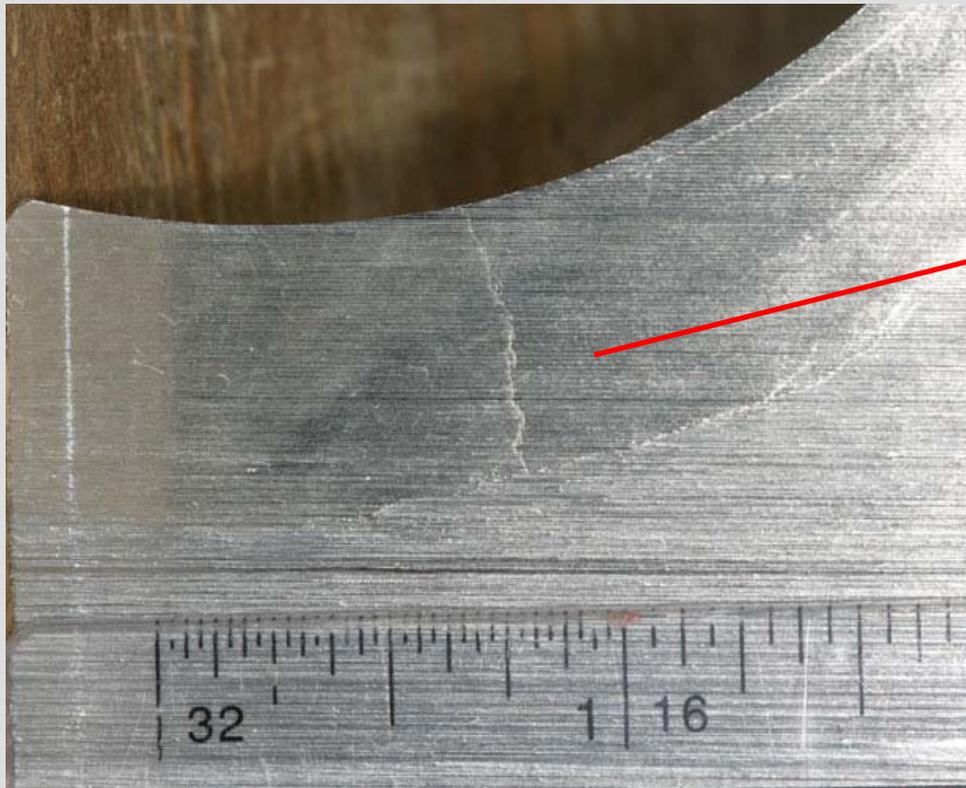
Located at 135 degrees

Crack Confirmed Through NDE

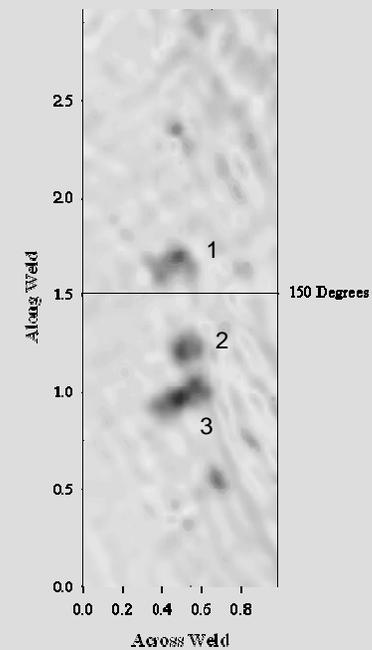
Indications near 150 degrees

No PT indications

#1: 146 degrees Max 3.1 V, 5 mm

#2: 153 degrees Max 3.3 V, 4 mm

#3: 157 degrees Max 4.1 V, 8 mm

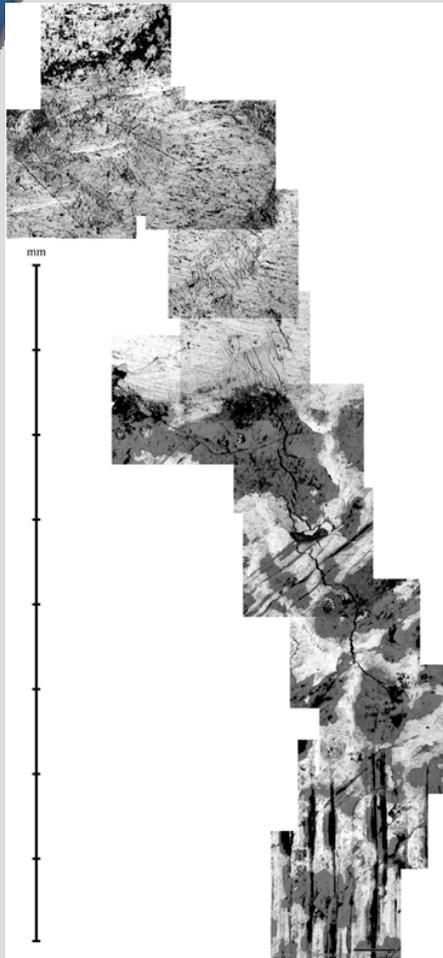
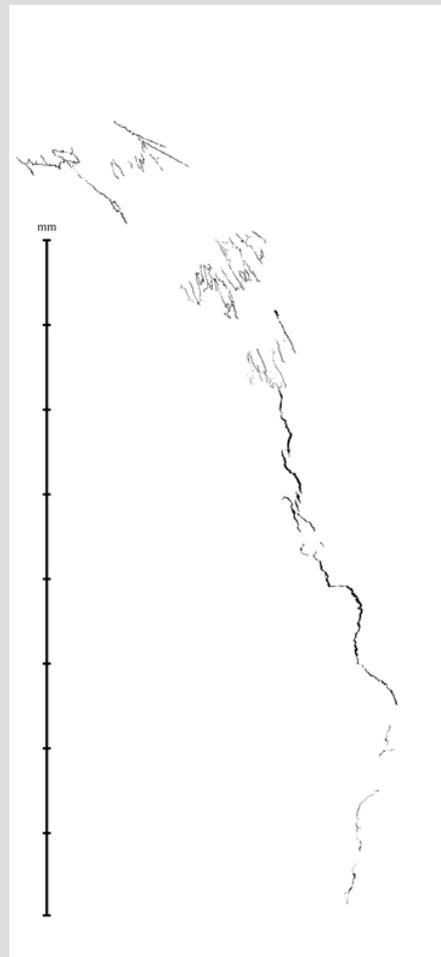
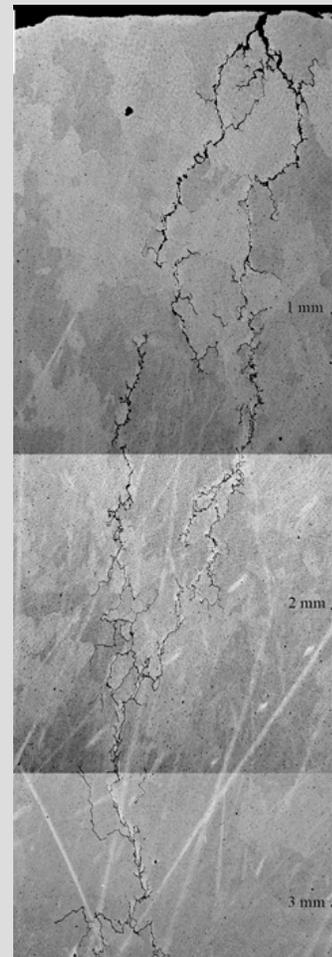
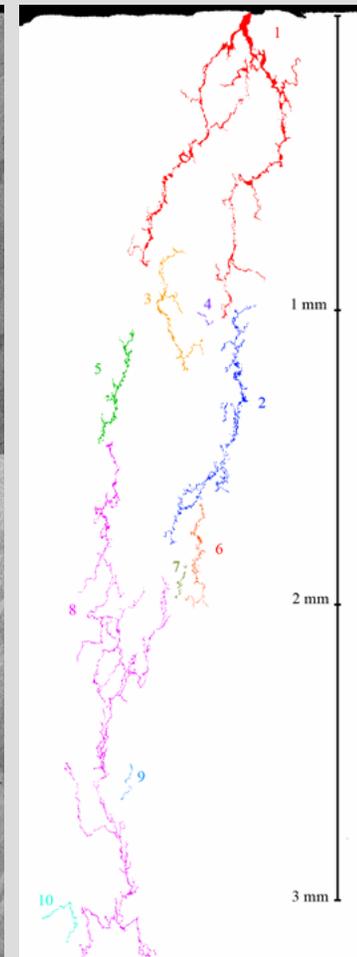
Microscopy of Crack #2

SEM of Surface

Side view of first three mm

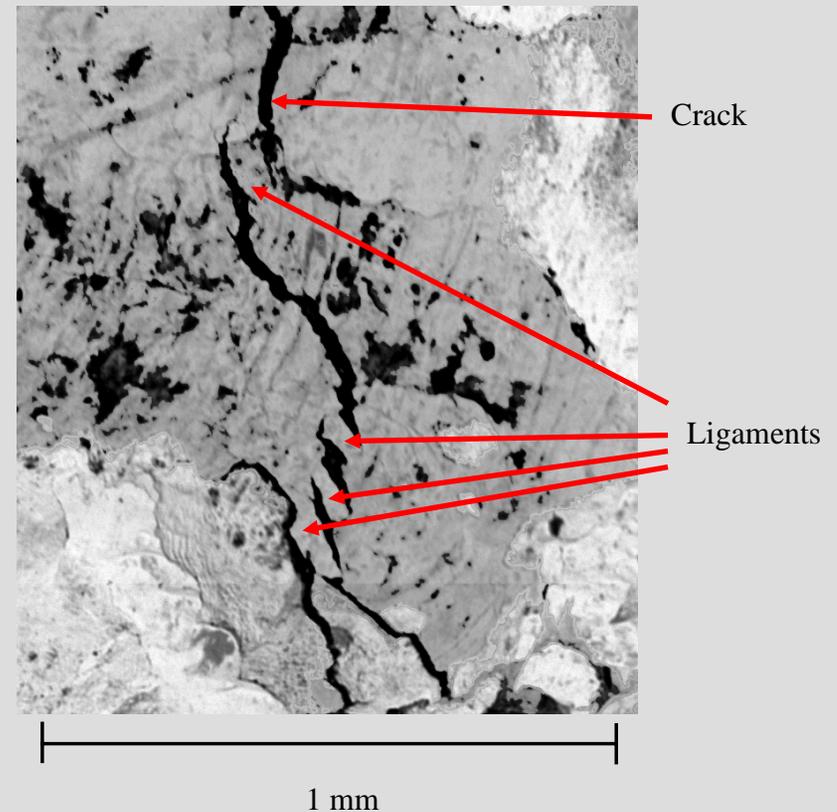
Expanded View of Through-Weld Crack

The through-weld crack has ligaments of metal crossing the crack in several places

The meandering nature of the crack below the surface also allows for electrical contact between the crack faces.

This electrical contact between the crack faces is likely responsible for the reduced ET response.

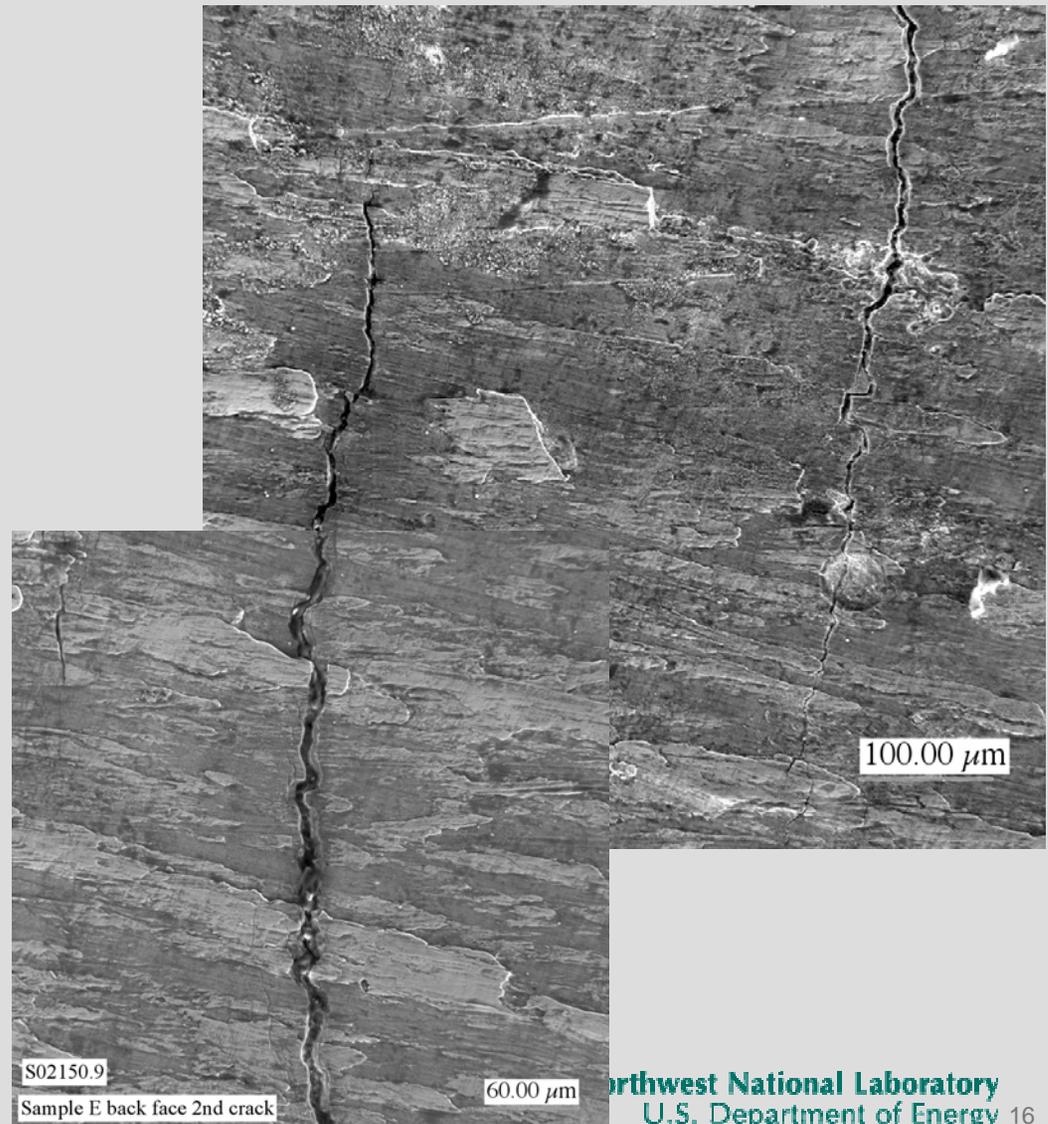
Exit Point into Annulus

The crack was tracked from the wetted surface to the annulus.
