Beaver Valley Power Station, Unit No. 1 Docket No. 50-334 License No. DPR-66 LER 2007-001-00

Enclosed is Licensee Event Report (LER) 2007-001, "Valve Testing Program Change Inadvertently Leads to Condition Beyond Design Basis During Test."

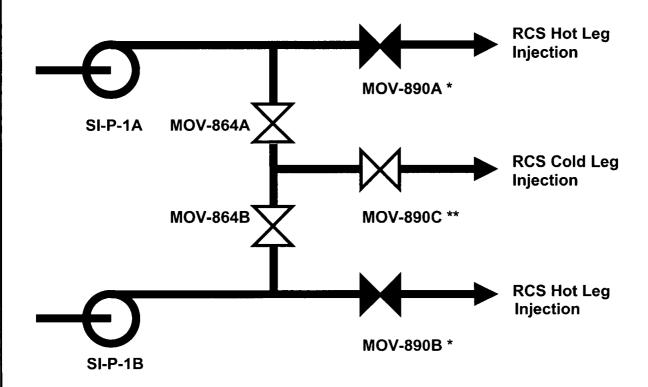
Simplified BVPS Unit 1 Low Head Safety Injection System Piping Arrangement (Normal System Arrangement Shown)

BVPS Unit 1 Technical Specification Surveillance Requirement 3.5.2.1 requires that valve MOV-1SI-890B be verified closed with power to the valve operator control circuit removed every 12 hours. If MOV-1SI-890B were opened, then the discharge from both LHSI pumps would be aligned to simultaneously inject into the Reactor Coolant System (RCS) Hot Legs and the Cold Legs. [See simplified piping diagram on last page.]

Subsequent review confirmed that simultaneously injecting through both the RCS Hot Legs and Cold Legs immediately following a design basis accident Loss of Coolant Accident (LOCA) was not analyzed. It also could not be confirmed that while in this abnormal arrangement (i.e., MOV-1SI-890B energized/open), all design basis accident safety analyses conclusions described in the BVPS Unit 1 Updated Final Safety Analysis Report (UFSAR) could be maintained valid if a LOCA were postulated to occur, resulting in an indeterminate safety analysis conclusion for operation in this abnormal configuration. This concern also applied to the other train for MOV-1SI-890A.

- 1. The subject valve stroke surveillance was revised and MOV-1SI-890B was subsequently properly valve stroke tested with the plant in Mode 1 on July 16, 2007. The procedure was revised to declare Train B of LHSI System inoperable and closed MOV-1SI-864B prior to energizing and opening MOV-1SI-890B. This ensures that the remaining train (A) of LHSI flow will inject only into the RCS Cold Legs immediately following a postulated design basis accident, as credited in the safety analyses. Similar changes were made to the surveillance procedures addressing the opposite train (which included MOV-1SI-890A) to address this issue.
