TENNESSEE VALLEY AUTHORITY

WATTS BAR NUCLEAR PLANT (WBN) - NRC INSPECTION REPORT NO. 390, 391/90-14 -
REPLY TO NOTICE OF VIOLATIONS 390/90-14-01 AND 390/90-14-02

RESPONSE TO NRC NOTICE OF VIOLATION
390/90-14-01

RESPONSE TO NRC NOTICE OF VIOLATION
390/90-14-02Description of Violation

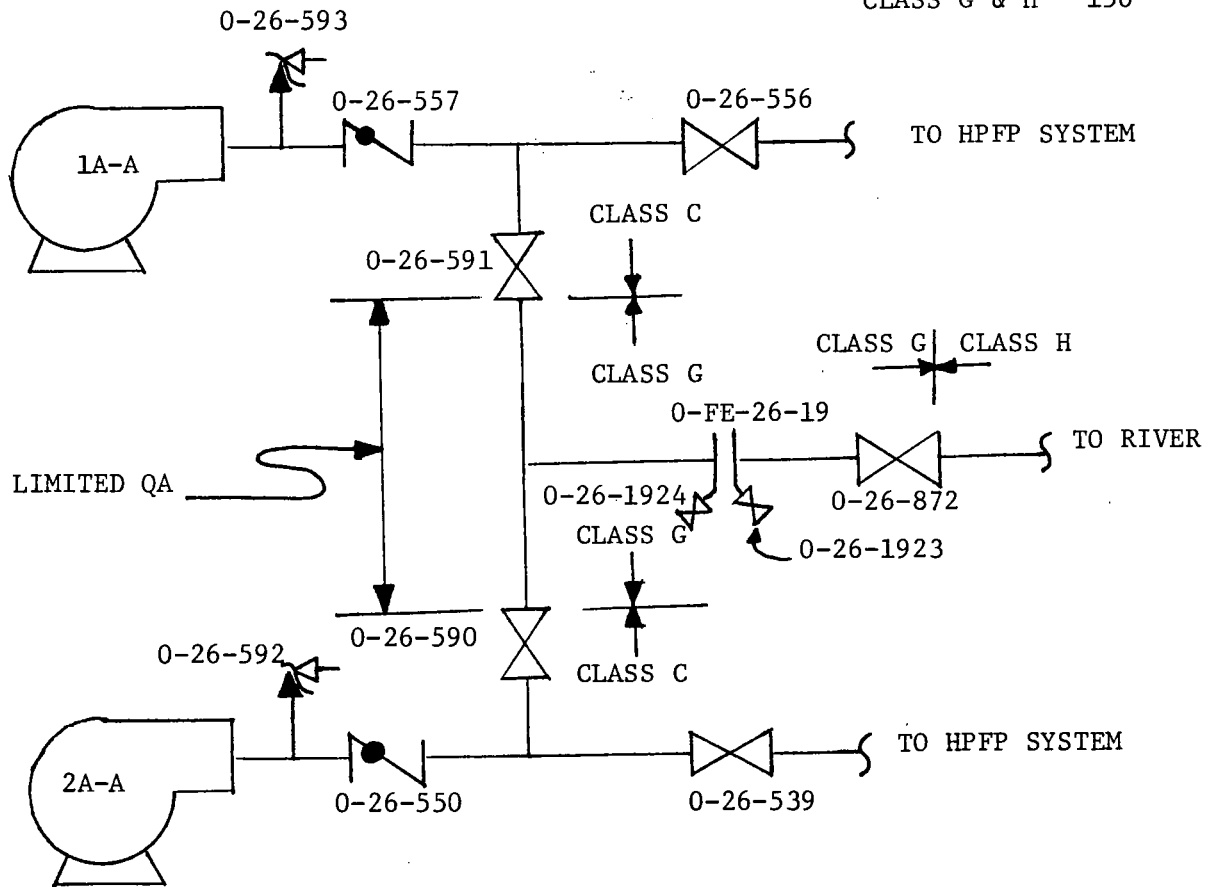
WBN INTAKE PUMPING STATION - FIRE PROTECTION PUMP DISCHARGE (TRAIN A)

Contrary to the above, Instruction Change 90-200 to Surveillance Instruction (SI)-7.50 was technically inadequate in that it instructed gagging of the "A" train high pressure fire system relief valve which resulted in a portion of the system piping between the pump discharge and the flow line test throttle valve 0-26-871 exceeding the design pressure.

TVA admits the violation occurred, but would like to provide the following clarification. The portion of the piping system for which the design pressure was exceeded is Class G (non-ASME) and is bounded by valves 0-26-590, 0-26-591, and 0-26-872 (see attachment). The piping from the pumps to valves 0-26-590 and 0-26-591 has a rated design pressure of 200 psig. The only piping affected by the excessive pressure was the test header, not the high pressure fire protection header.

DESIGN PRESS	HYDRO PRESS
CLASS C	200	250
CLASS G & H	150	225

Under the corrective action for Condition Adverse to Quality Report (CAQR) WBP 900290P, the design organization will revise the design pressure of the subject fire protection test line to meet testing requirements.

The design pressure of the fire protection test line will be revised by October 31, 1990.
