UNITED STATES
NUCLEAR REGULATORY COMMISSION

SUBJECT: NRC INSPECTION REPORT NO. 70-143/2006-006

Report No.: 70-143/2006-006

Nuclear Fuel Services, Inc.
NRC Inspection Report 70-143/2006-006

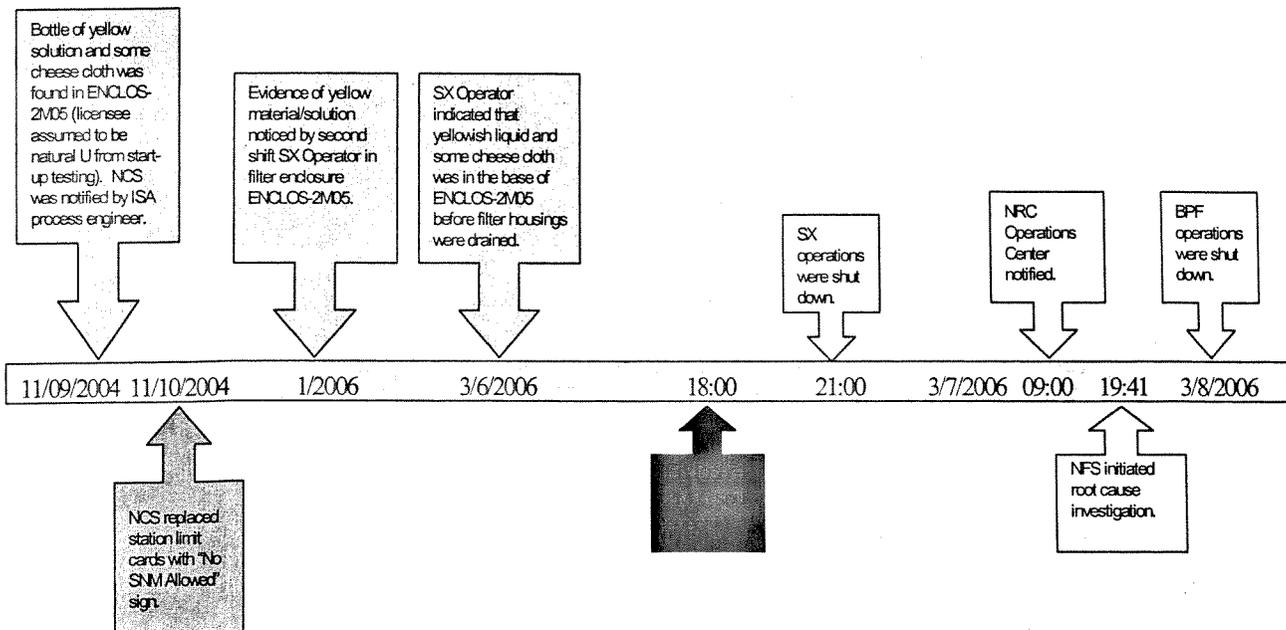
The inspectors noted that there were three previous occasions where either a small amount of yellow solution or evidence of yellow solution was found in the enclosure (see Figure 1). The operators involved reported their observations to their supervisor. The personnel involved thought the material was depleted uranium solution from start-up testing. None of the observed events were reported in the licensee's problem identification, resolution, and correction system (PIRCS).

Figure 1: Event time line showing three previous occasions where either a small amount yellow solution or evidence of yellow solution was found in the bag filter enclosure (ENCLOS-2M05).

The inspectors identified three examples, prior to the event, where yellow solution was found in the 2M05 enclosure. Since the enclosure was not approved for use, the presence of yellow solution, possibly uranyl nitrate, was not authorized. In two cases, area supervision was notified, but the issue was not entered into the PIRCS system for formal safety review and was not reported to the Nuclear Criticality Safety function as required by NFS-HS-CL-26. As such, the inspectors concluded that the less-than-rigorous followup to the discovery of yellow solution in three different instances represented lost opportunities to possibly identify and correct the problem before the March 6 spill. The failure to report the events concerning the yellow solution in the 2M05 enclosure in accordance with the requirements of Section 5.1 of NFS-GH-65 is identified as an apparent violation (APV 70-143/2006-006-08).

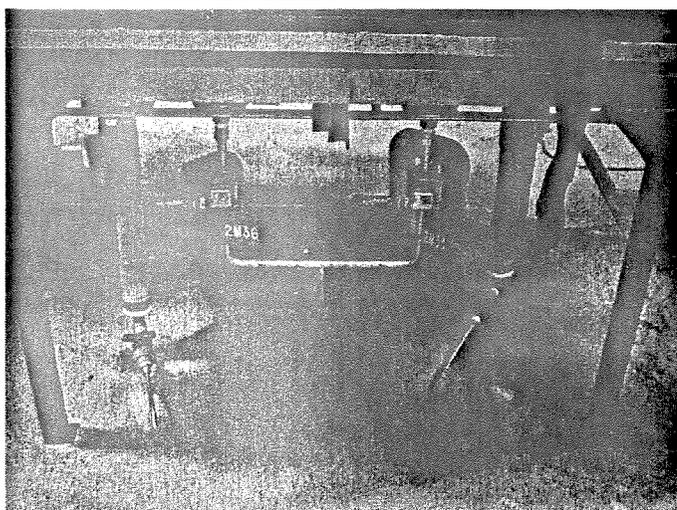
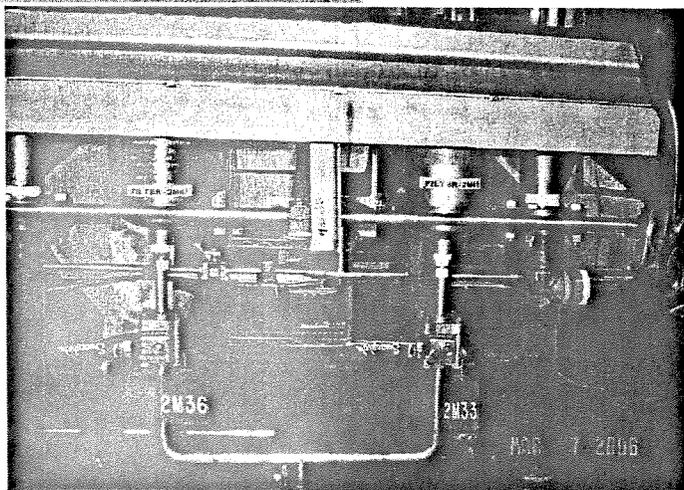
The tray dissolver filter enclosure had two engineered NCS controls consisting of two drains which each had a diameter of two inches. There were no management measures in place to ensure that the drains could adequately perform their safety function. Items such as cheesecloth and poly-bottles which could block the drains were observed in the enclosure prior to the event (see Figure 1). The filter enclosure was considered out of service, and there were no approved procedures for enclosure operations including maintenance operations. No station limit card was in place, and operators were not trained on the unit. The licensee intended to use the enclosure drains as IROFS, and the drains would have been procedurally checked for obstructions prior to each use of the equipment. Other management measures on the drains would have included installation checks and preventive maintenance which were also not performed. The inspectors determined that the filter enclosure was uncontrolled for the accident sequence of a spill into the enclosure because these controls and measures were not implemented. In addition, a spill contained in the enclosure would not be easily noticed such that multiple spills to the enclosure could result in accumulation of fissile solution if the drains were blocked.

The licensee had performed an NCS analysis for the tray dissolver equipment and had prepared an operating procedure. The inspectors observed that the completed and approved NCS analysis for the tray dissolver process had reviewed the potential for accumulation of fissile solution in the enclosure and established appropriate NCS controls for that accident sequence which consisted of two 2-inch drains which were intended to be designated as IROFS. Because the system was considered out of service, the drains required by the analysis were not completely implemented, and double contingency was not established for the accident sequence of fissile solution spill into the tray dissolver filter enclosure. Specifically, verification of proper installation of the drains was not completed. License application Section 4.1.1.1.3 states, in part, that engineered controls must be verified as being properly installed prior to first use with fissile material. Failure to verify proper installation of the tray dissolver filter enclosure drains prior to use of the system with fissile material is identified as an apparent violation (APV 70-143/2006-006-02).

Figure 2: BPF Tray Dissolver 2M05 Enclosure, Piping and Drains

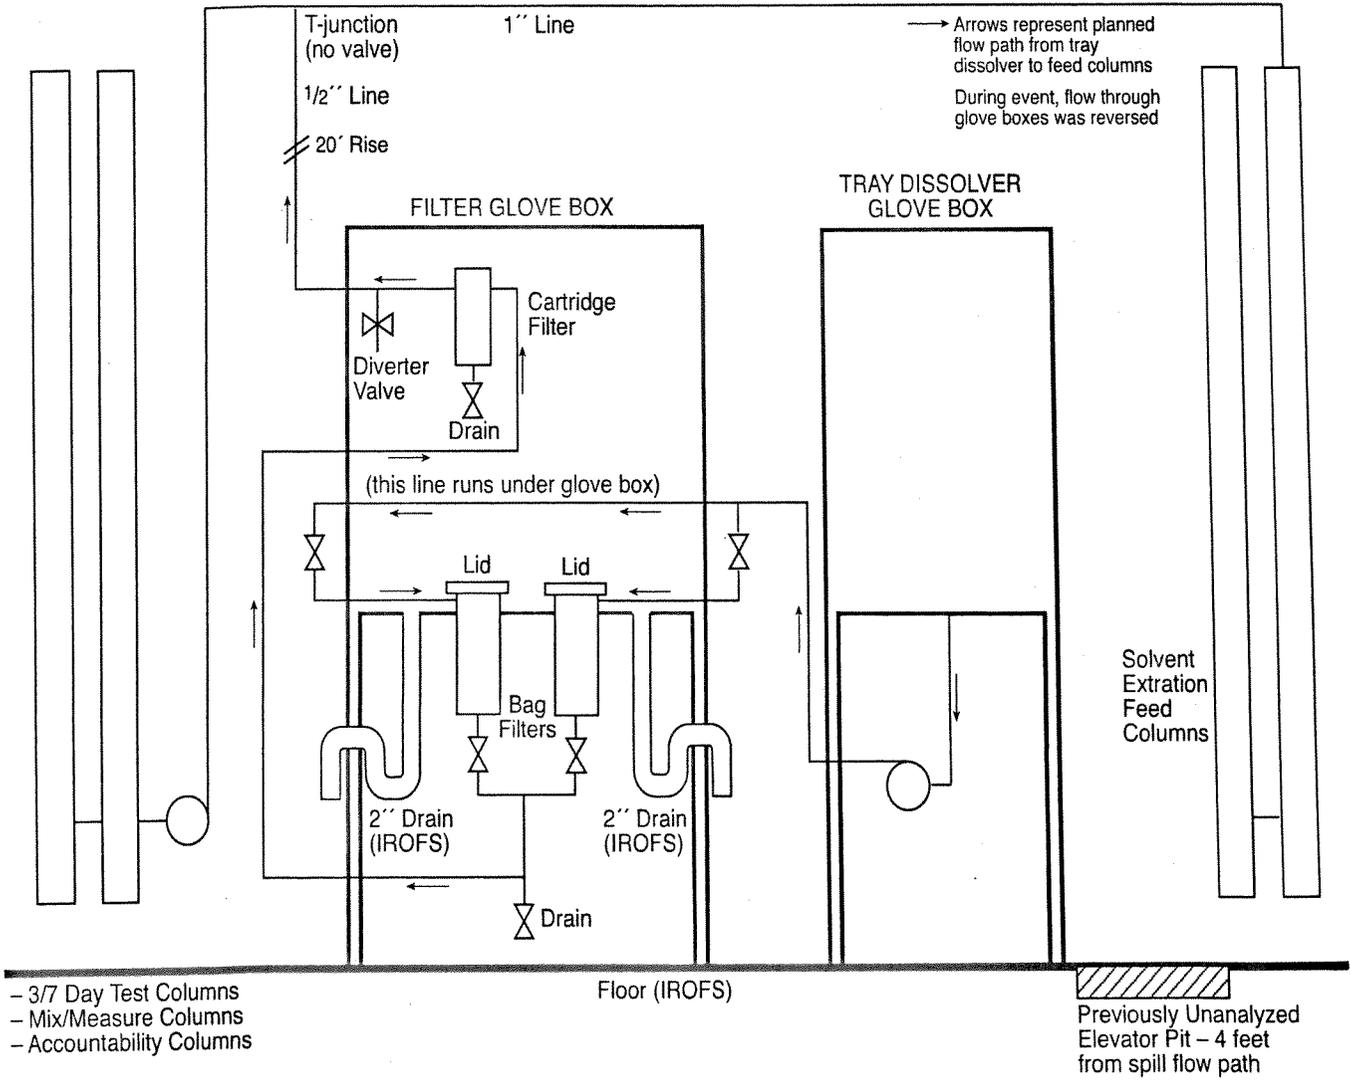
Figure 3: Tray Dissolver and Filter Enclosure Equipment Layout

The inspectors noted that the tray dissolver filter enclosure was installed without isolation valves and was connected to fissile process lines, utilities, and ventilation as if the tray dissolver system was in service and would therefore be required to meet the performance requirement of 10 CFR 70.61(d) for accident sequences leading to criticality due to handling fissile material with the tray dissolver equipment. The inspectors determined that because management measures were not implemented for the enclosure drain system, the enclosure did not meet performance requirements for criticality safety relative to accumulation of fissile material in the enclosure or on the floor of the solvent extraction room. Failure to meet the performance requirements of 10 CFR 70.61(d) for accident sequences related to handling fissile material in the tray dissolver system is identified as an apparent violation **(APV 70-143/2006-006-03)**. The inspectors reviewed similar filter enclosures in the plant and observed that they had isolation valves on both sides and an uninterrupted transfer line to the discharge point. No generic issue was identified relative to similar enclosures and equipment in the facility.

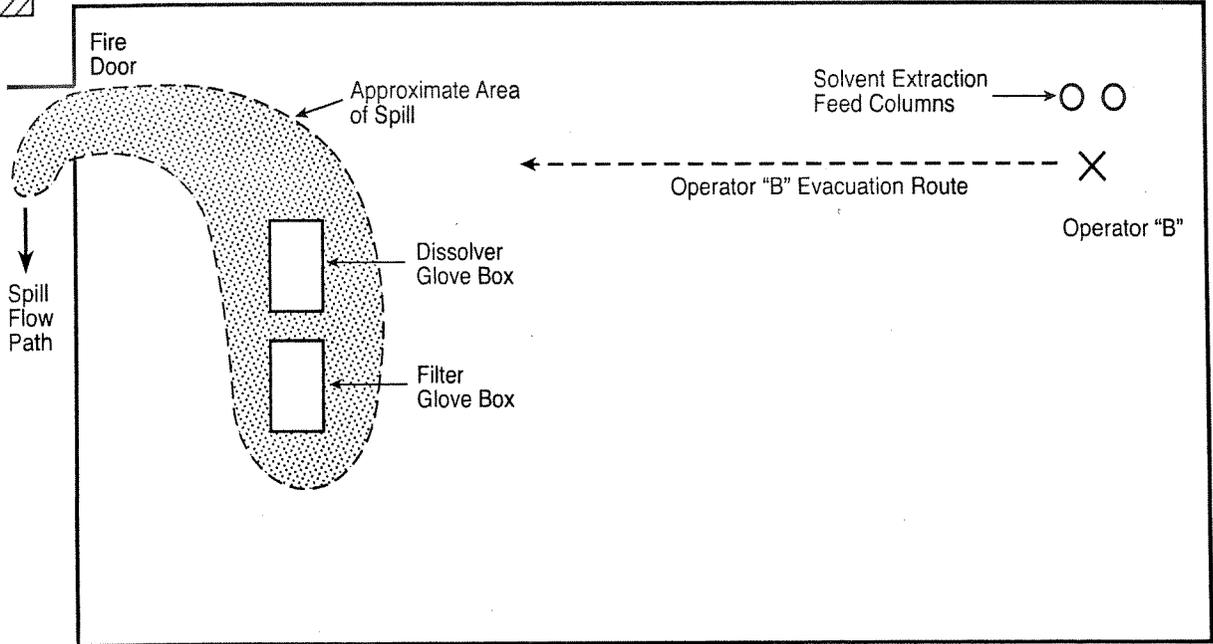
BPF Solvent Extraction Layout

The licensee identified that the floor of the solvent extraction room was compromised by an elevator pit that was not considered in previous analysis of the facility floor. The inspectors analyzed the elevator pit to determine how much solution would be required for a critical system. The inspectors performed the analysis using KENO IVa and used a model involving a nominal reflection condition on top of the fissile slab. The inspectors determined that a slab of the spilled solution in the shape of the elevator pit with full reflection on the sides and bottom and nominal reflection on the top will become critical at 8 centimeters (3.15 inches) with a volume of 100 liters (26.4 gallons).
