UNITED STATES
NUCLEAR REGULATORY COMMISSION

SUBJECT: NRC INSPECTION REPORT NO. 70-143/2006-006

SUBJECT: SPECIAL INSPECTION TEAM CHARTER FOR NUCLEAR FUEL
SERVICES (NFS) - DOCKET NO. 70-143 (INSPECTION REPORT
NUMBER 70-143/2006-006)

Nuclear Fuel Services, Inc.
NRC Inspection Report 70-143/2006-006

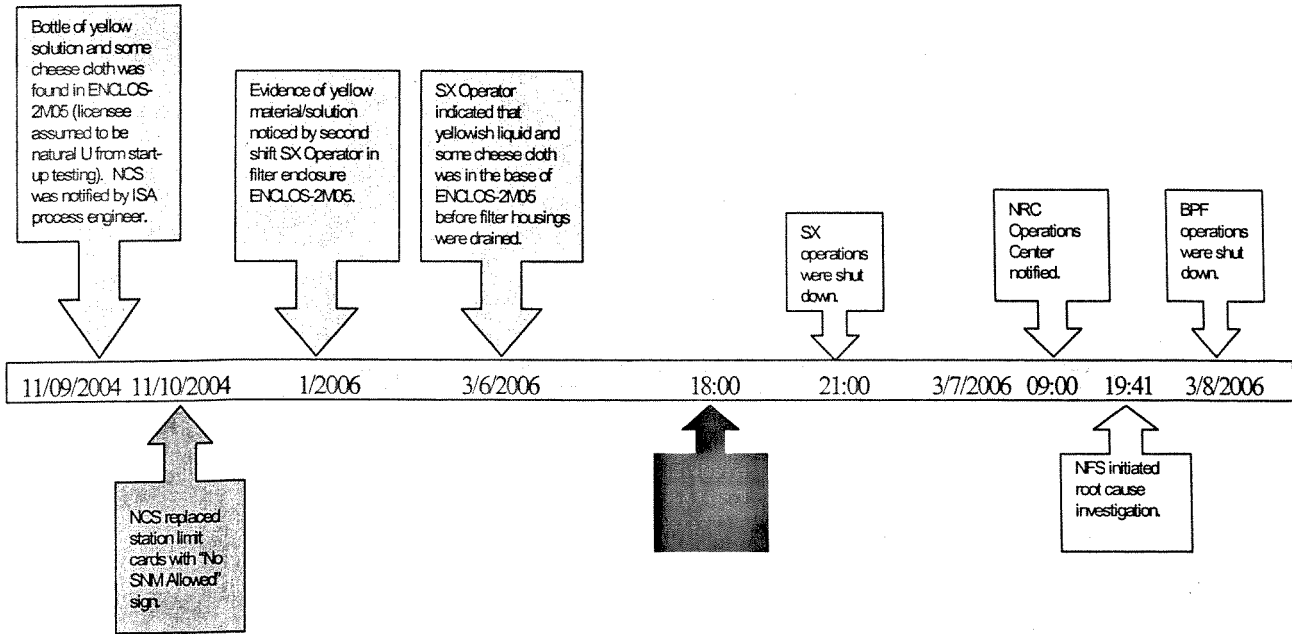
The inspectors noted that there were three previous occasions where either a small amount of yellow solution or evidence of yellow solution was found in the enclosure (see Figure 1). The operators involved reported their observations to their supervisor. The personnel involved thought the material was depleted uranium solution from start-up testing. None of the observed events were reported in the licensee's problem identification, resolution, and correction system (PIRCS).

Figure 1: Event time line showing three previous occasions where either a small amount yellow solution or evidence of yellow solution was found in the bag filter enclosure (ENCLOS-2M05).

The inspectors identified three examples, prior to the event, where yellow solution was found in the 2M05 enclosure. Since the enclosure was not approved for use, the presence of yellow solution, possibly uranyl nitrate, was not authorized. In two cases, area supervision was notified, but the issue was not entered into the PIRCS system for formal safety review and was not reported to the Nuclear Criticality Safety function as required by NFS-HS-CL-26. As such, the inspectors concluded that the less-than-rigorous followup to the discovery of yellow solution in three different instances represented lost opportunities to possibly identify and correct the problem before the March 6 spill. The failure to report the events concerning the yellow solution in the 2M05 enclosure in accordance with the requirements of Section 5.1 of NFS-GH-65 is identified as an apparent violation (APV 70-143/2006-006-08).

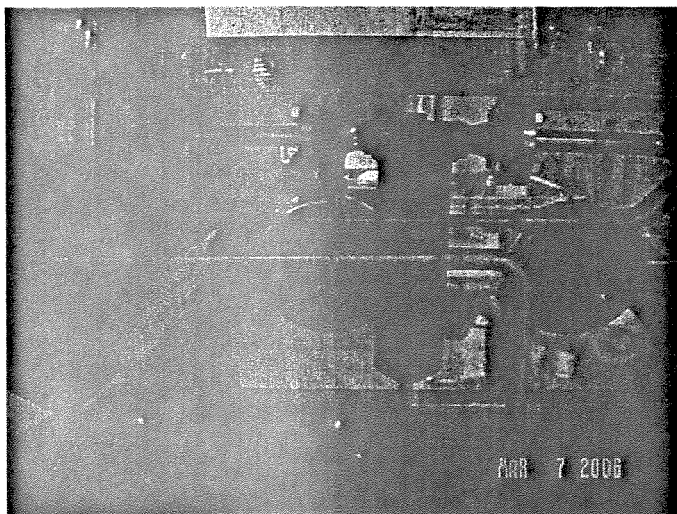
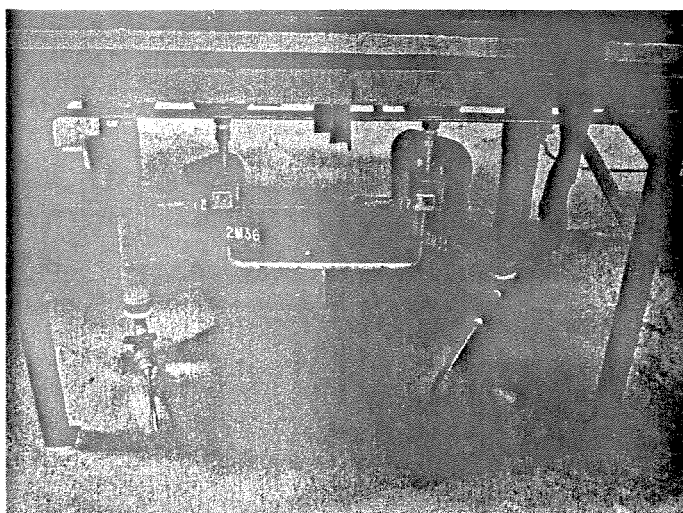
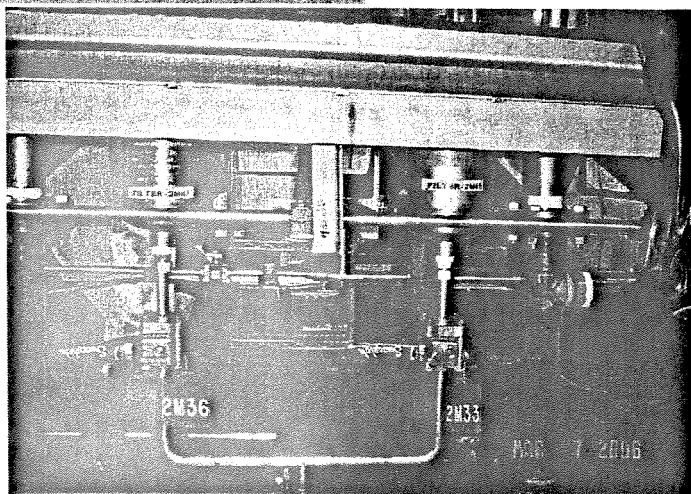
The tray dissolver filter enclosure had two engineered NCS controls consisting of two drains which each had a diameter of two inches. There were no management measures in place to ensure that the drains could adequately perform their safety function. Items such as cheesecloth and poly-bottles which could block the drains were observed in the enclosure prior to the event (see Figure 1). The filter enclosure was considered out of service, and there were no approved procedures for enclosure operations including maintenance operations. No station limit card was in place, and operators were not trained on the unit. The licensee intended to use the enclosure drains as IROFS, and the drains would have been procedurally checked for obstructions prior to each use of the equipment. Other management measures on the drains would have included installation checks and preventive maintenance which were also not performed. The inspectors determined that the filter enclosure was uncontrolled for the accident sequence of a spill into the enclosure because these controls and measures were not implemented. In addition, a spill contained in the enclosure would not be easily noticed such that multiple spills to the enclosure could result in accumulation of fissile solution if the drains were blocked.

The licensee had performed an NCS analysis for the tray dissolver equipment and had prepared an operating procedure. The inspectors observed that the completed and approved NCS analysis for the tray dissolver process had reviewed the potential for accumulation of fissile solution in the enclosure and established appropriate NCS controls for that accident sequence which consisted of two 2-inch drains which were intended to be designated as IROFS. Because the system was considered out of service, the drains required by the analysis were not completely implemented, and double contingency was not established for the accident sequence of fissile solution spill into the tray dissolver filter enclosure. Specifically, verification of proper installation of the drains was not completed. License application Section 4.1.1.1.3 states, in part, that engineered controls must be verified as being properly installed prior to first use with fissile material. Failure to verify proper installation of the tray dissolver filter enclosure drains prior to use of the system with fissile material is identified as an apparent violation (APV 70-143/2006-006-02).

Figure 2: BPF Tray Dissolver 2M05 Enclosure, Piping and Drains

The inspectors noted that the tray dissolver filter enclosure was installed without isolation valves and was connected to fissile process lines, utilities, and ventilation as if the tray dissolver system was in service and would therefore be required to meet the performance requirement of 10 CFR 70.61(d) for accident sequences leading to criticality due to handling fissile material with the tray dissolver equipment. The inspectors determined that because management measures were not implemented for the enclosure drain system, the enclosure did not meet performance requirements for criticality safety relative to accumulation of fissile material in the enclosure or on the floor of the solvent extraction room. Failure to meet the performance requirements of 10 CFR 70.61(d) for accident sequences related to handling fissile material in the tray dissolver system is identified as an apparent violation **(APV 70-143/2006-006-03)**. The inspectors reviewed similar filter enclosures in the plant and observed that they had isolation valves on both sides and an uninterrupted transfer line to the discharge point. No generic issue was identified relative to similar enclosures and equipment in the facility.

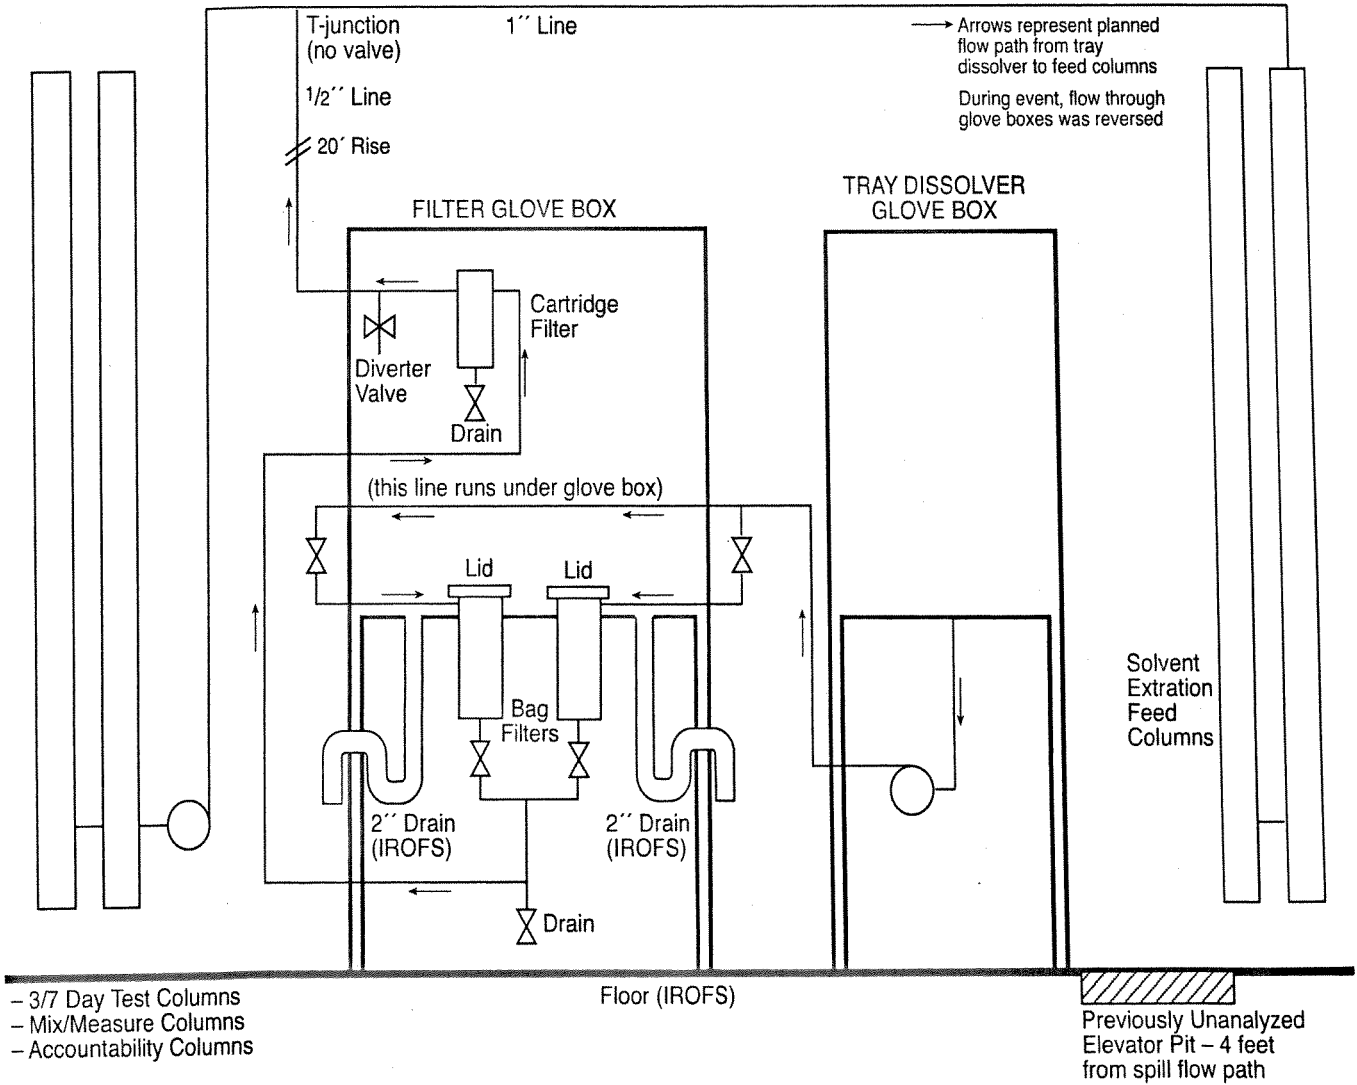
Figure 3: Tray Dissolver and Filter Enclosure Equipment Layout

The inspectors analyzed the BPF tray dissolver filter enclosure to determine how much solution would be required for a critical system. The inspectors performed the analysis using KENO IVa and used a model involving nominal reflection conditions in accordance with NCS requirements from the NFS license. The inspectors determined that a slab of the spilled solution in the shape of the tray dissolver filter enclosure with nominal reflection will become critical at 11 centimeters (4.3 inches) with 130 liters (34.3 gallons) of volume.

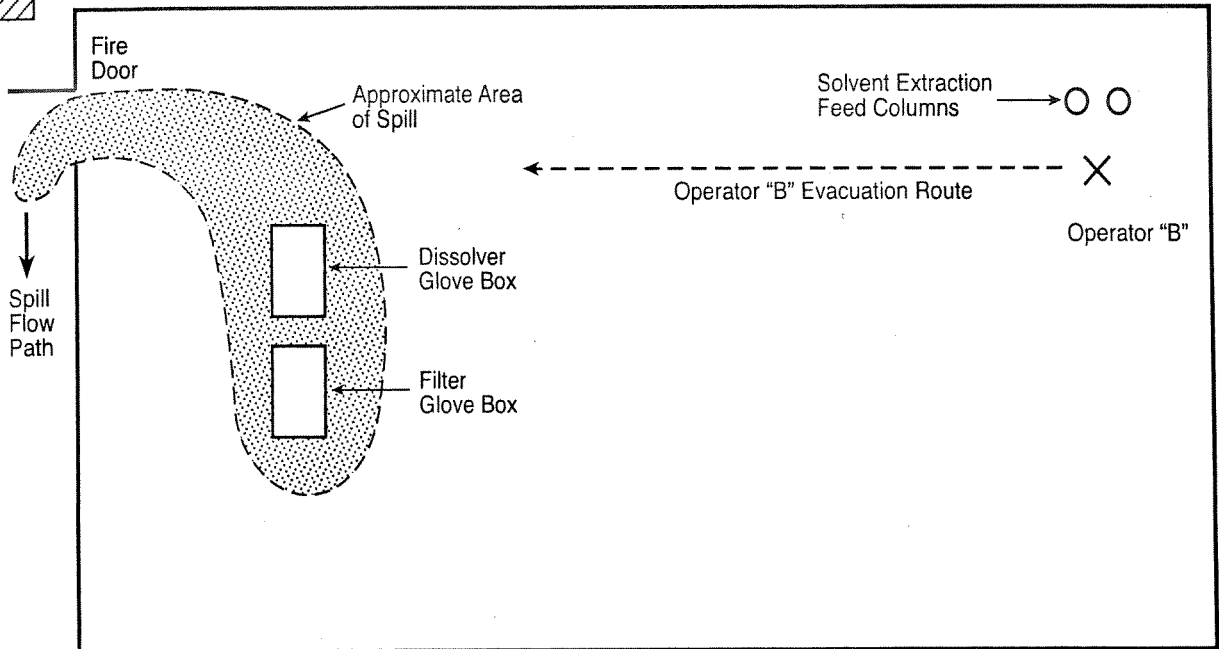
BPF Solvent Extraction Layout

The licensee identified that the floor of the solvent extraction room was compromised by an elevator pit that was not considered in previous analysis of the facility floor. The inspectors analyzed the elevator pit to determine how much solution would be required for a critical system. The inspectors performed the analysis using KENO IVa and used a model involving a nominal reflection condition on top of the fissile slab. The inspectors determined that a slab of the spilled solution in the shape of the elevator pit with full reflection on the sides and bottom and nominal reflection on the top will become critical at 8 centimeters (3.15 inches) with a volume of 100 liters (26.4 gallons).
