Entergy – Waterford 3 Meeting
with NRC on Steam Generator
Batwing Issue

September 6, 2007

SG 32 - Status

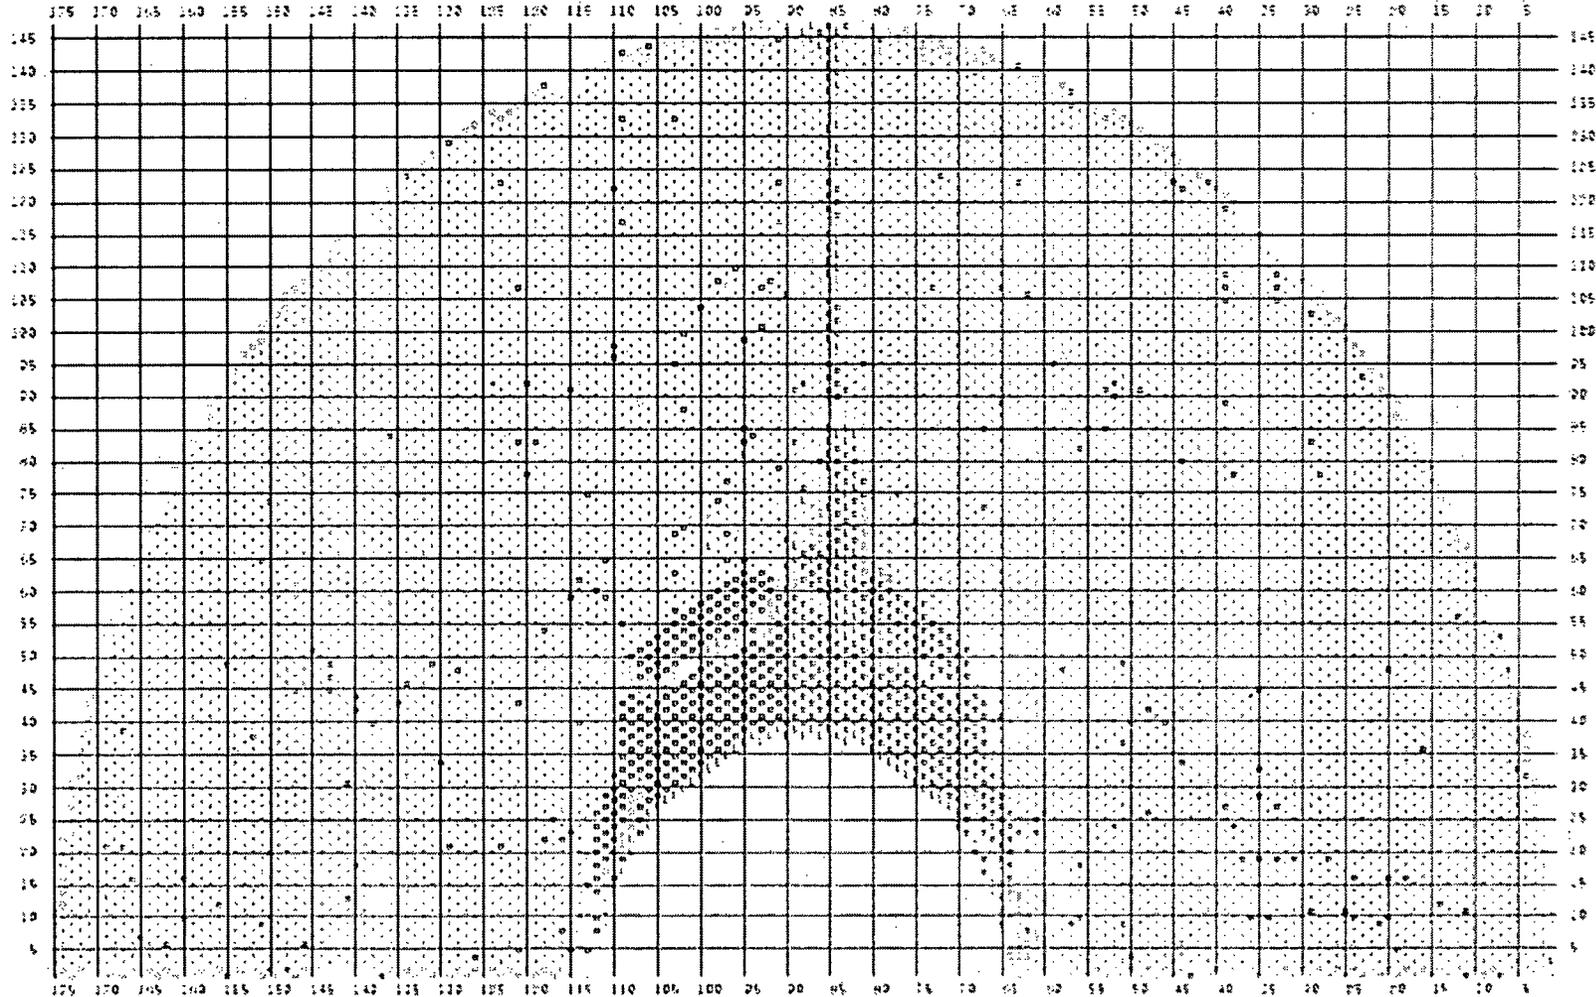
SG - 32 TUBE REPAIR HISTORY

Preventive Plugging also in SG#1

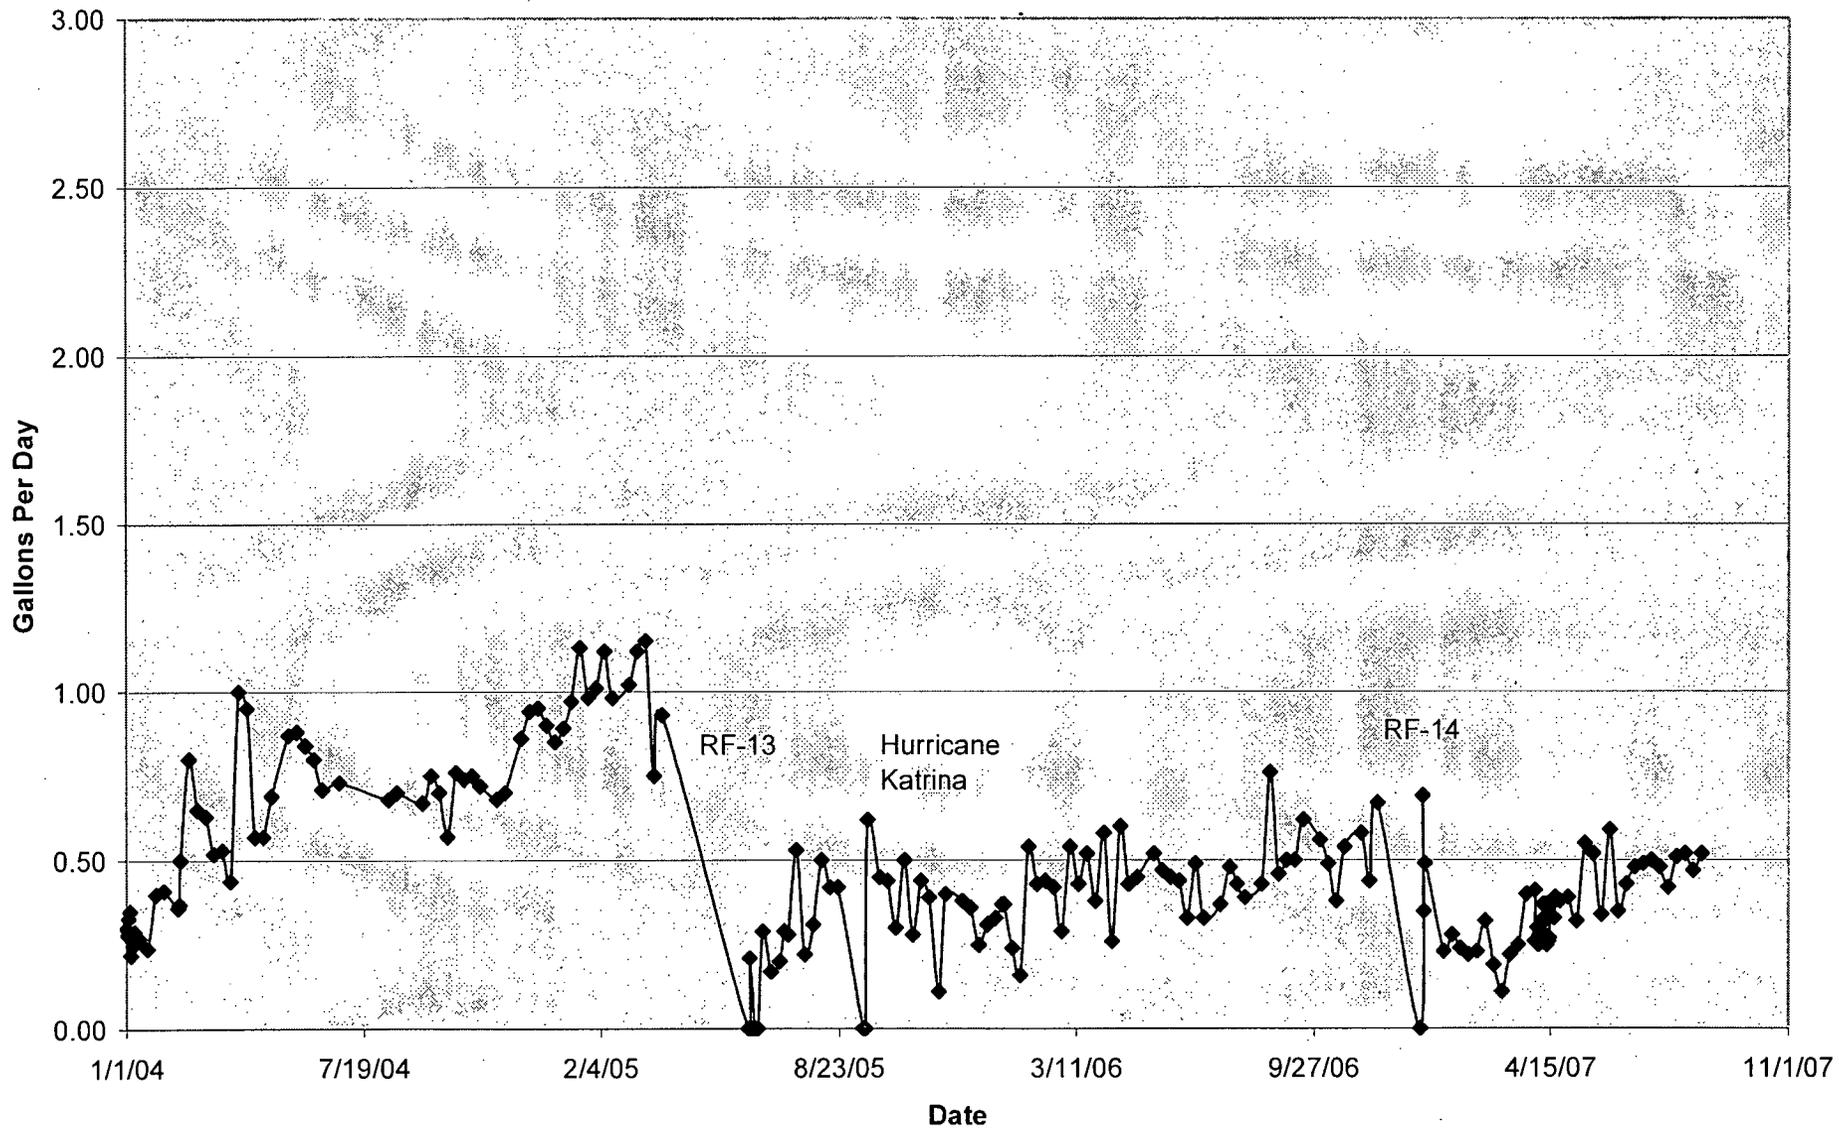
Steam Generator Primary to Secondary Leak Rate

- Dedicated loose parts monitor installed to monitor SG
 - No metallic impacts identified
- Operational Decision Making Issue for primary to secondary leak rate
 - 0.5 gpd steady and consistent with previous cycle
 - 2 gpd and 5 gpd triggers increased monitoring and evaluation
 - 5 gpd with a rate of 7.5 gpd/hr administrative shutdown
 - 15 gpd administrative shutdown
- High level of site awareness and sensitivity
 - Seven tube leak simulator training sessions this year with each operating crew
 - Operations, Engineering and Chemistry monitoring

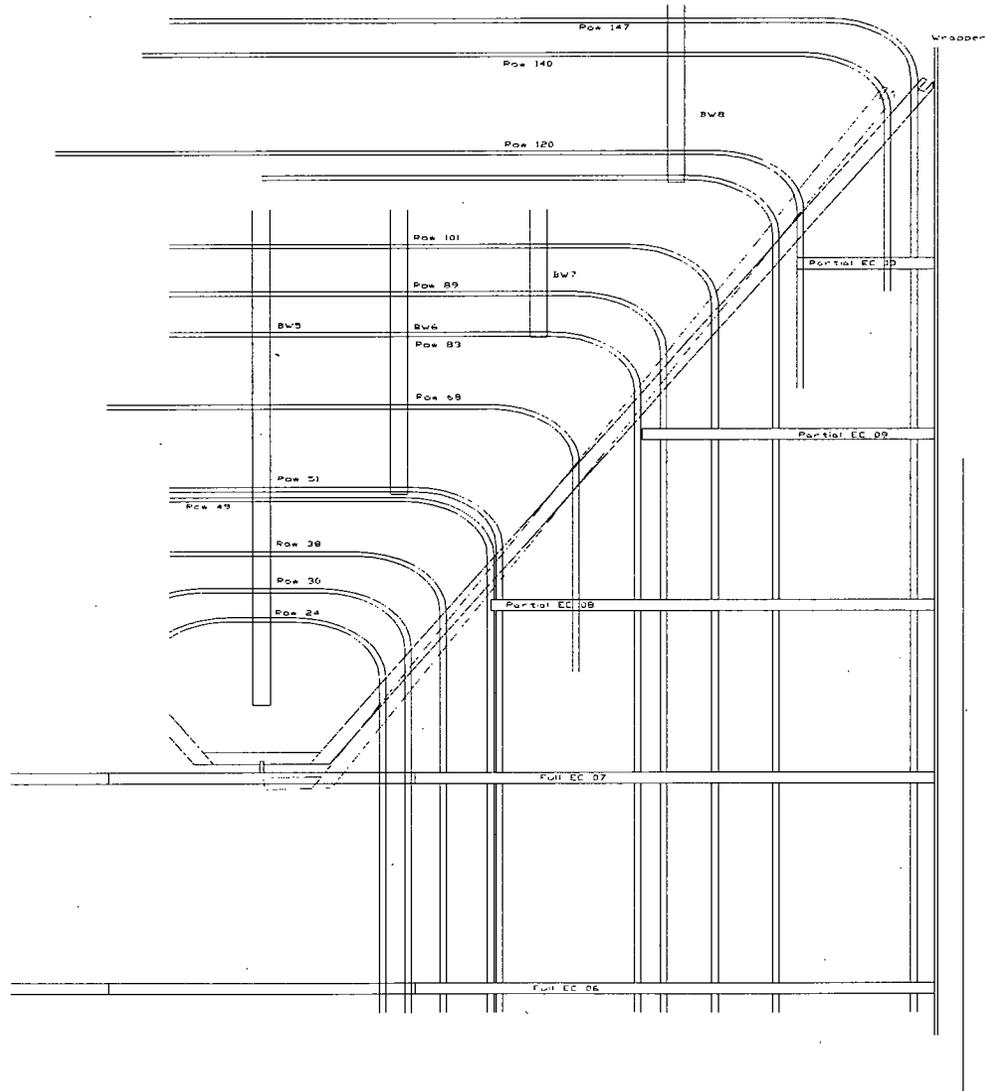
No Batwing Movement No Action

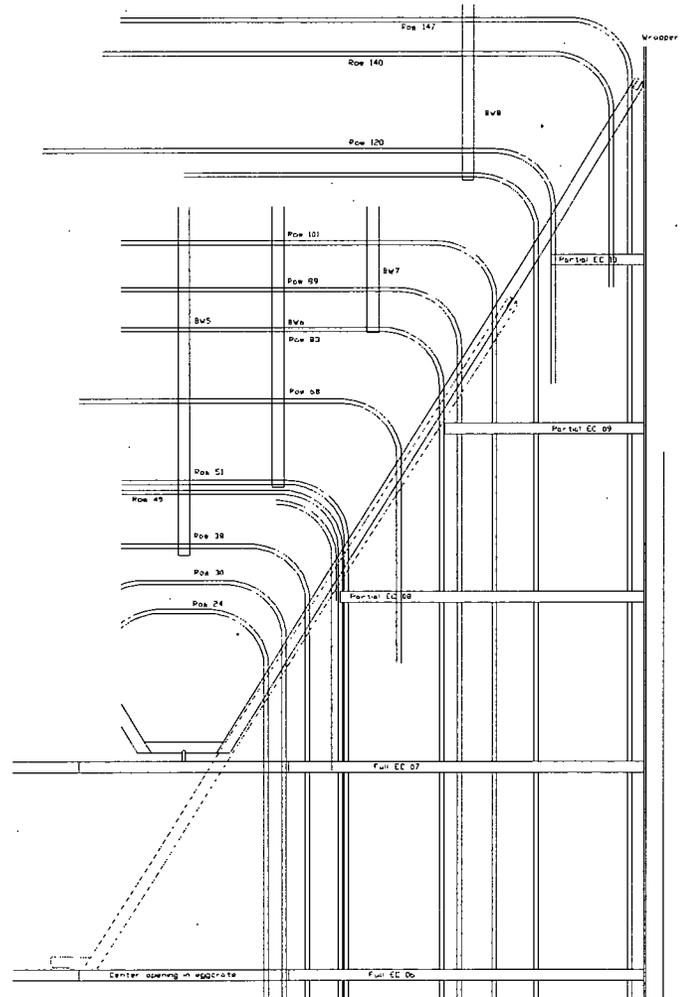
Flow forces due not rotate batwing any further from PF14 position.
As center of gravity is above pivot point, batwing slides along the contact
points created by partial eggcrates. Due to length the lower end of batwing
rests atop the 06 eggcrate

Moderate Batwing Movement Batwing Stabilization
